**AVIATION INVESTIGATION REPORT
A13O0045**

RUNWAY INCURSION AND RISK OF COLLISION

**SUNWING AIRLINES VEHICLE AND
AIR CANADA EMB190 C-FLWH
TORONTO LESTER B. PEARSON INTERNATIONAL AIRPORT
11 MARCH 2013**

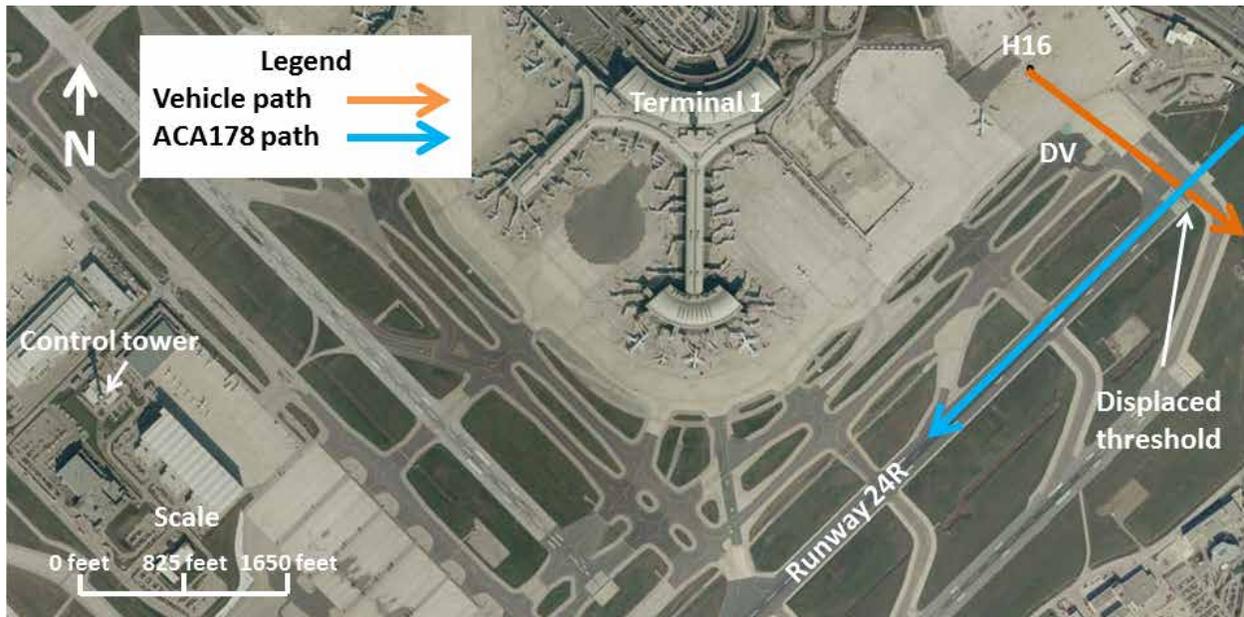
Figure 1. Occurrence map

Sunwing Airlines Inc. (Sunwing) is a charter operator based at Toronto–Lester B. Pearson International Airport (CYYZ), Ontario. A large portion of the company's fleet undergoes maintenance and grooming during the evenings. Generally, these routine tasks are performed while the aircraft are parked at gates set aside for this type of operation on the east side of Terminal 1 (Figure 1).
