AVIATION INVESTIGATION REPORT A15C0146

Engine failure and collision with terrain

Oceanview Helicopters Ltd.

Hughes 369D (helicopter), C-FOHE

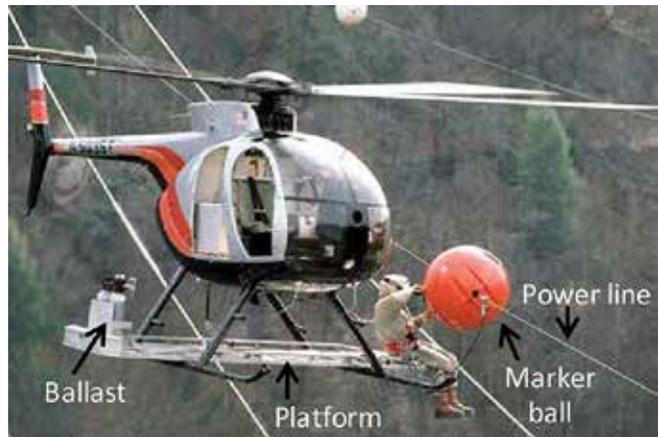
Photo 1. Marker ball installation (Source: P&R TECH, with TSB annotations)

Helicopters are used to install marker balls when ground equipment cannot be used because of the terrain or the height of the power lines. The helicopter is equipped with an external work platform mounted to the top of the landing gear skid. The external platform worker sits on the platform and is secured using a lap belt and torso tether. The marker ball is placed on the worker's lap for takeoff. The helicopter then approaches the power line to allow the worker to install the marker ball

(Photo 1). Ballast weights are secured onto the opposite side of the external work platform to counter the weight of the platform worker and to provide lateral stability for the helicopter.
