# AIR TRANSPORTATION SAFETY INVESTIGATION REPORT A17C0146

## **LOSS OF CONTROL AND COLLISION WITH TERRAIN**

West Wind Aviation L.P.  
Avions de Transport Régional ATR 42-320, C-GWEA  
Fond-du-Lac, Saskatchewan  
13 December 2017

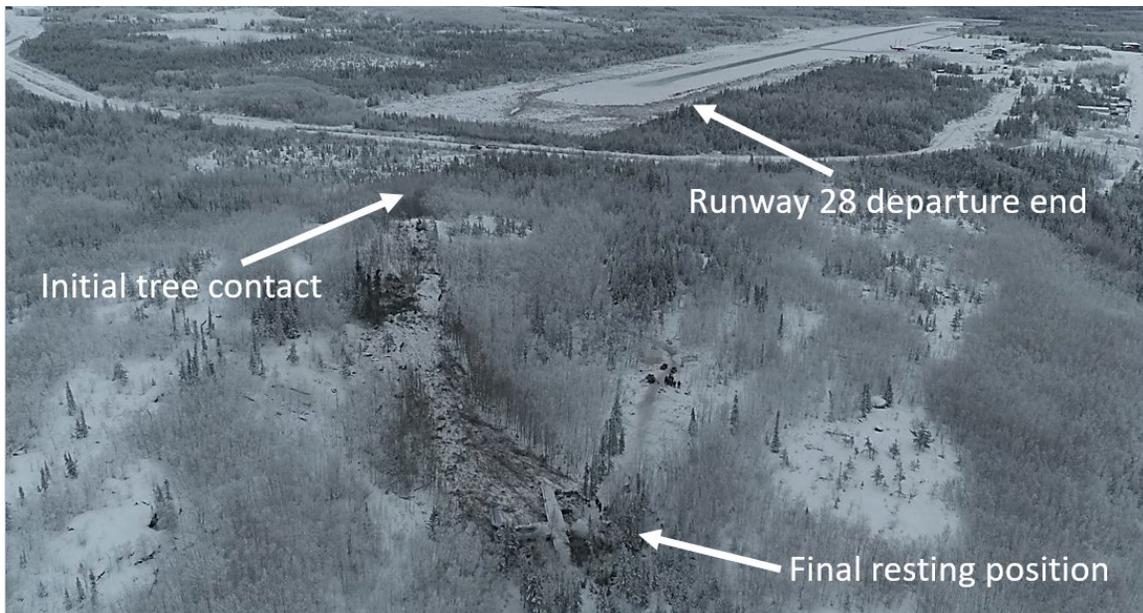
Figure S2. Aerial view of occurrence site (Source: Royal Canadian Mounted Police, with TSB annotations)

The aircraft collided with the ground in a relatively level pitch, with a bank angle of 30° left. As a result of the sudden vertical deceleration upon contact with the ground, the aircraft

suffered significant damage, which varied in severity at different locations on the aircraft due to impact angle and variability in structural design.

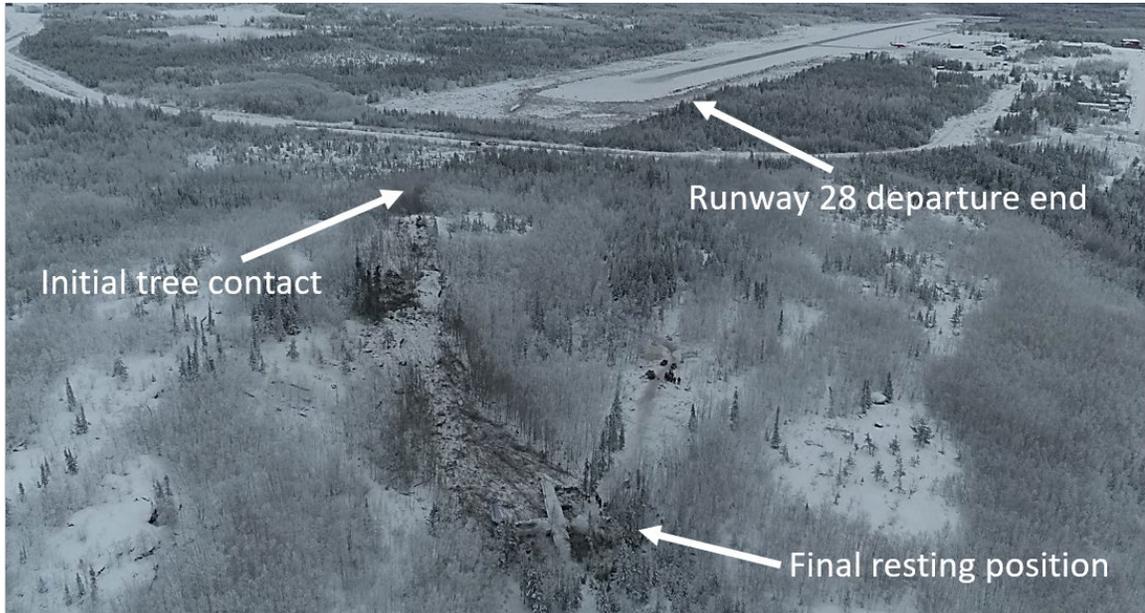
Figure 6. Aerial view of occurrence site (Source: Royal Canadian Mounted Police, with TSB annotations)

The terrain in the wooded area rises slightly, and the aircraft struck treetops in this area before contacting the ground near the top of the hill. As it made initial contact with the ground and then a secondary ridge, the aircraft left a debris trail before coming to rest. In relation to the departure end of the runway, the aircraft's final resting position was 600 m away, on a bearing of 270°T (Figure 6).

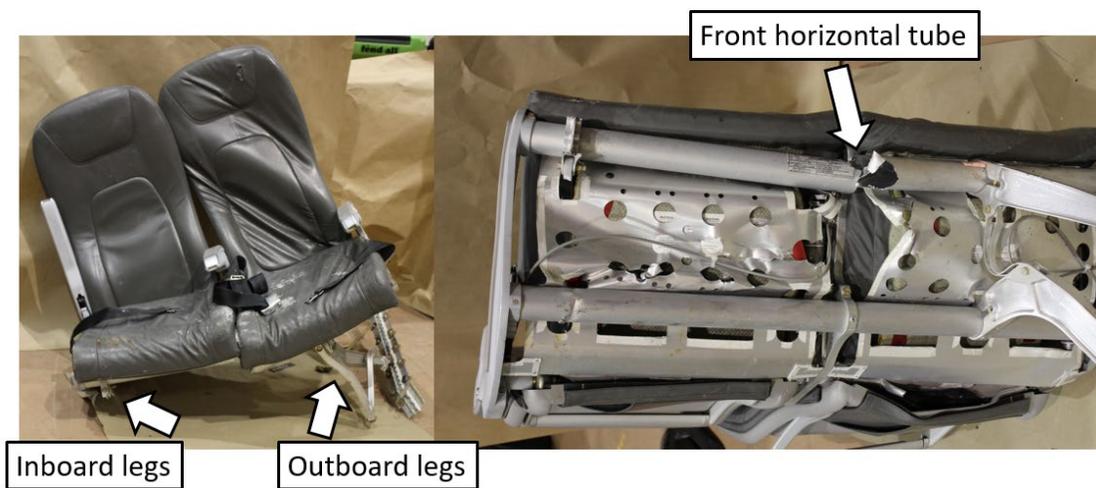
Figure 14. Photo showing damage to the left-side seat pair from row 6 (Source: TSB)

The only seats that showed a different damage pattern were the 2 left-side seats in rows 5 and 6 (Figure 14). On both of these seat pairs, the inboard legs had fractured, and the front outboard legs were deformed into a crossbow shape. This damage is consistent with an inertial load in a vertical (downward) direction from the occupants.

The front horizontal tube of the seat frames had fractured at their lateral centre, which is consistent with bending failure caused by large inertial load in a vertical (downward) direction from the occupants.

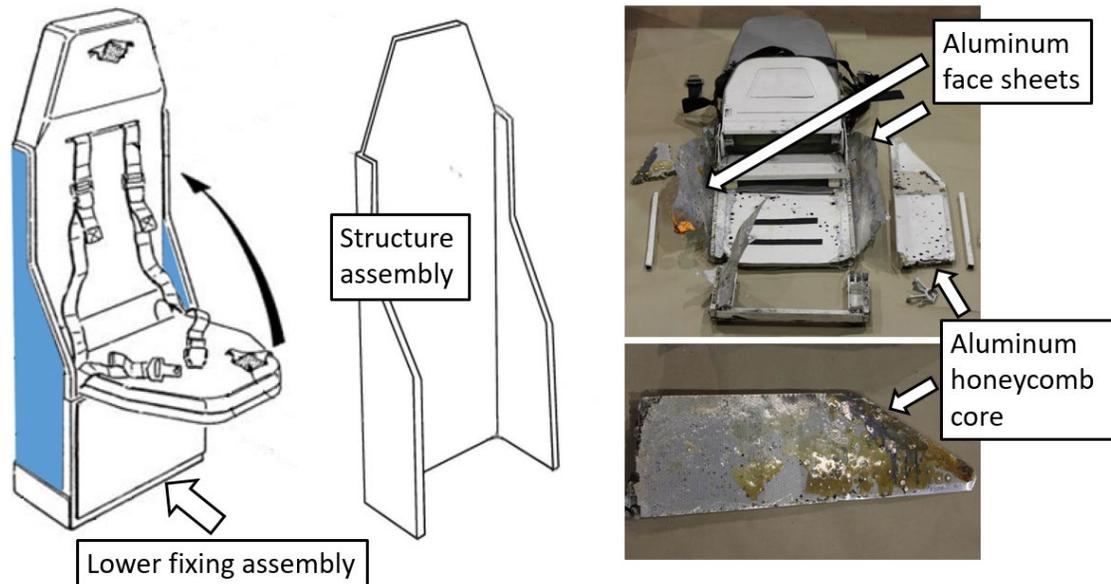
As a result of unapproved repairs, the flight attendant seat failed on impact, resulting in injuries that impeded her ability to perform evacuation and survival actions in a timely manner.

The cabin floor between the main entrance and emergency exit showed no sign of damage or deformation; however, the FA seat was missing and was found later, broken into pieces. The seat's bottom mounting structure was found still fastened to the floor tracks.

The structure assembly was found broken into pieces. Both the left and right legs had separated from the back panel and from their lower portions, which were still inserted into the slots of the lower fixing assembly.

Both left and right legs of the seat-structure assembly failed when their aluminum honeycomb core separated from the aluminum face sheets. The separated face sheets showed no trace of adhesive, which is consistent with adhesive failure (i.e., failure at the interface between the face sheet and adhesive).

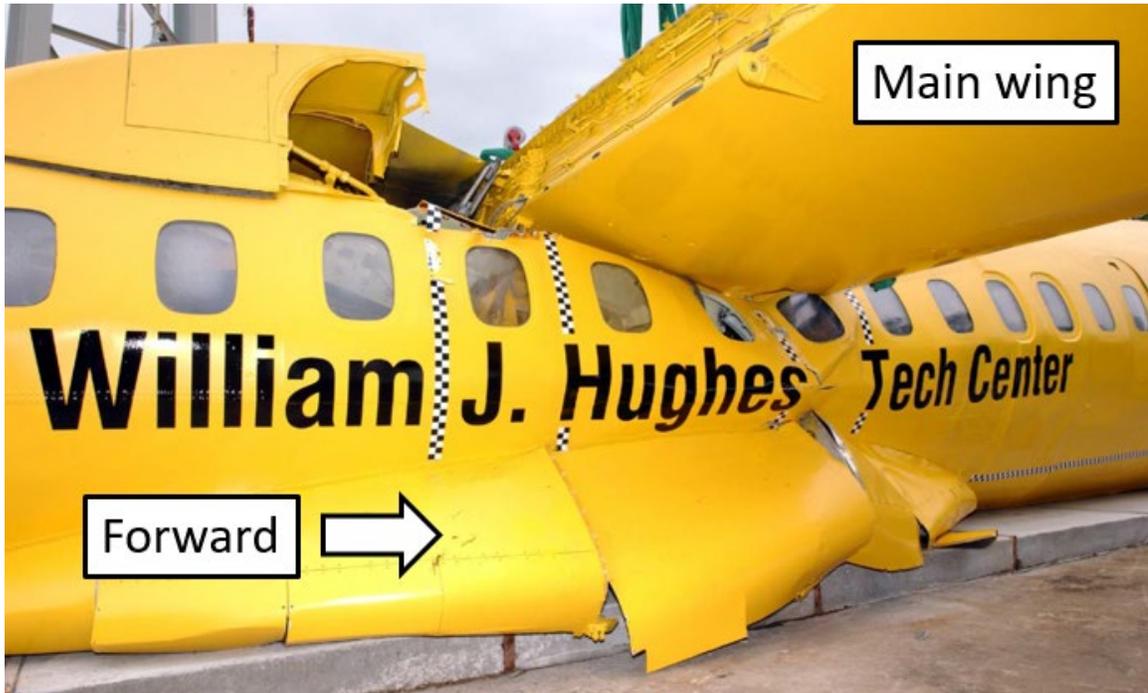
Figure 19. Photo of main wing collapsing into the centre fuselage during 2006 drop test (Source: U.S. Federal Aviation Administration, with TSB annotations)

In 2006, the FAA performed a vertical drop test on the ATR 42 to determine the impact response of the fuselage, fuel system, floor tracks, seats, and anthropomorphic test dummies when subjected to a severe, but survivable, simulated crash impact (figures 19 and 20).

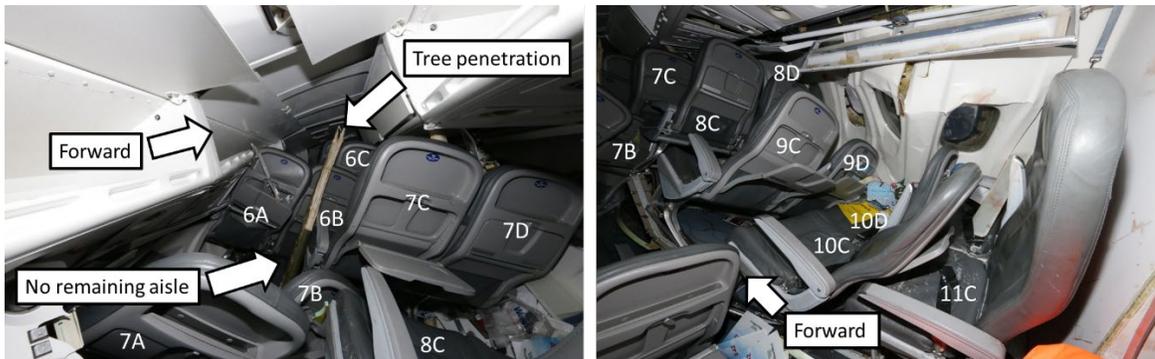
Figure 21. Photos of the displaced cabin seats in rows 6 to 11, a tree that had penetrated the cabin (left), and the obstruction to the aisle (right). Seats are labelled by row number (6 to 11) from front to back, and seat designator (A to D) from left to right. (Source: TSB)

Inside the cabin, the last row of passenger seats was upright; however, the seats in the remaining rows were progressively displaced vertically toward the ceiling of the passenger cabin due to the upward movement of the cabin floor. Objects penetrated the cabin, and the aisle became unusable as a result of the displacement of the seats and floor (Figure 21).

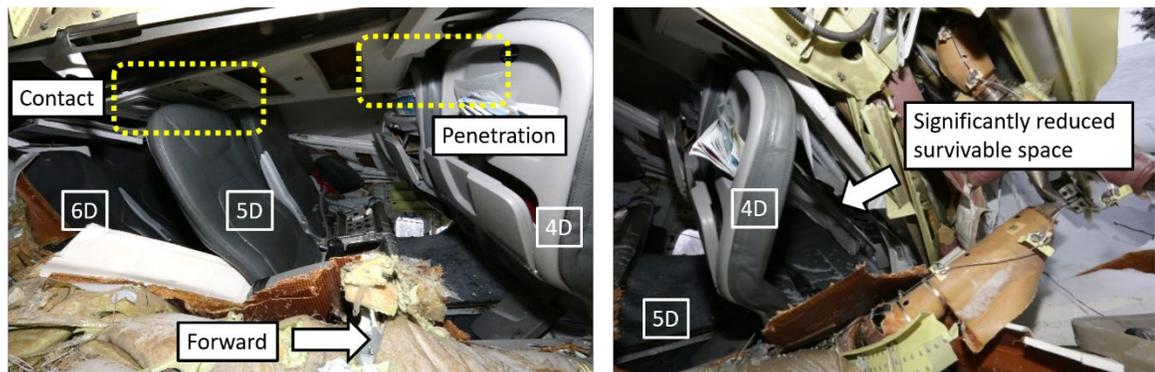
Figure 22. Photos showing the reduced survivable space in rows 4 to 6, with seatbacks contacting or penetrating overhead luggage compartment (Source: TSB)

The reduced survivable space between the floor above the main landing gear and the collapsed upper fuselage caused crushing injuries, such as major head, body, and leg trauma, to passengers in the middle-forward left section of the aircraft. Of the 3 passengers in this area, 2 experienced, serious life-changing injuries, and 1 passenger subsequently died.

The tops of the seatbacks of the seats in rows 4 and 5 on the right side of the aisle had contacted or penetrated the overhead luggage compartment. The survivable space for each seat in rows 4 to 6 had been reduced to 1 to 2 feet, and the head space had been reduced in many other nearby rows (Figure 22).

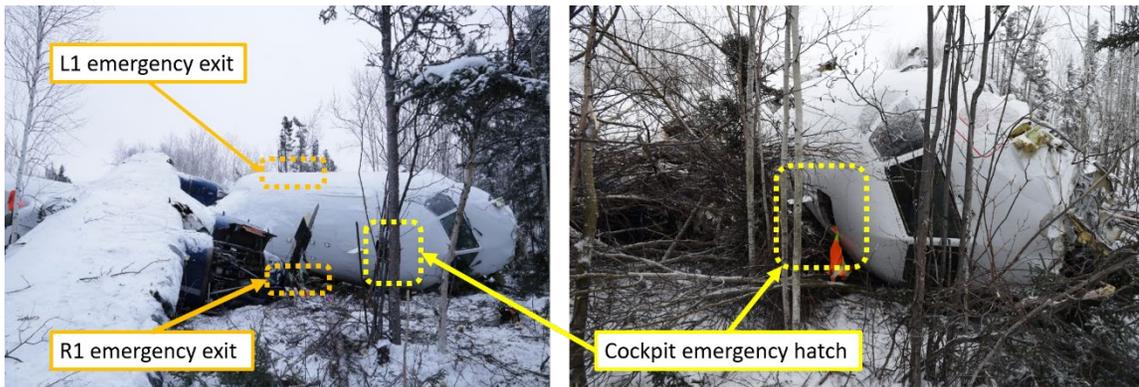
Figure 28. Orientation and access to emergency exits L1 and R1 (left image) and the cockpit emergency hatch (right and left images) (Source: Royal Canadian Mounted Police, with TSB annotations)

The forward part of the aircraft, including the cockpit, rolled 90° to the right and came to rest lying on its right side. Emergency exit R1 was squashed at the bottom of the fuselage, and emergency exit L1 was vertically at the top. The 90° orientation also placed the cockpit emergency hatch on the side of the aircraft, where it was partially blocked by trees (Figure 28).

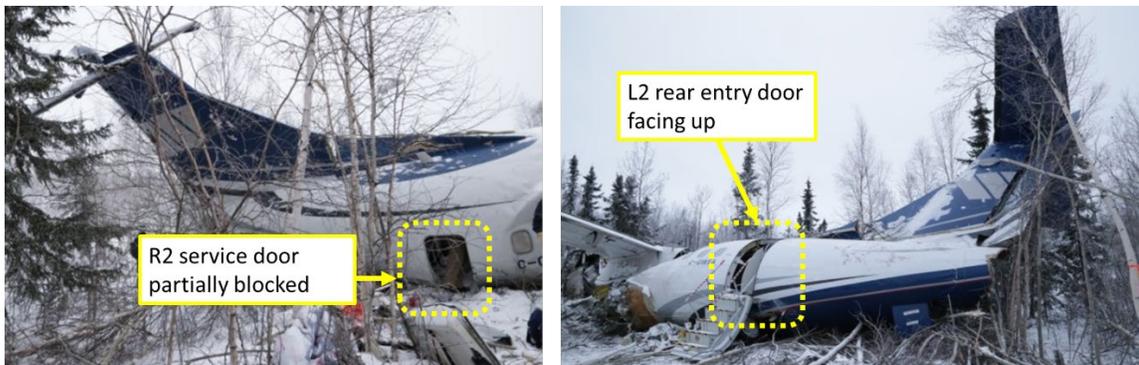
Because the main passenger cabin had rolled approximately 40° to the right, the service door (R2) was partially blocked by external terrain. The main exit point, the rear entry door (L2), was facing up, making it difficult to be opened (Figure 29).

Figure 29. Orientation of the service door (R2) (left image) and the rear entry door (L2) (right image) (Source: TSB)

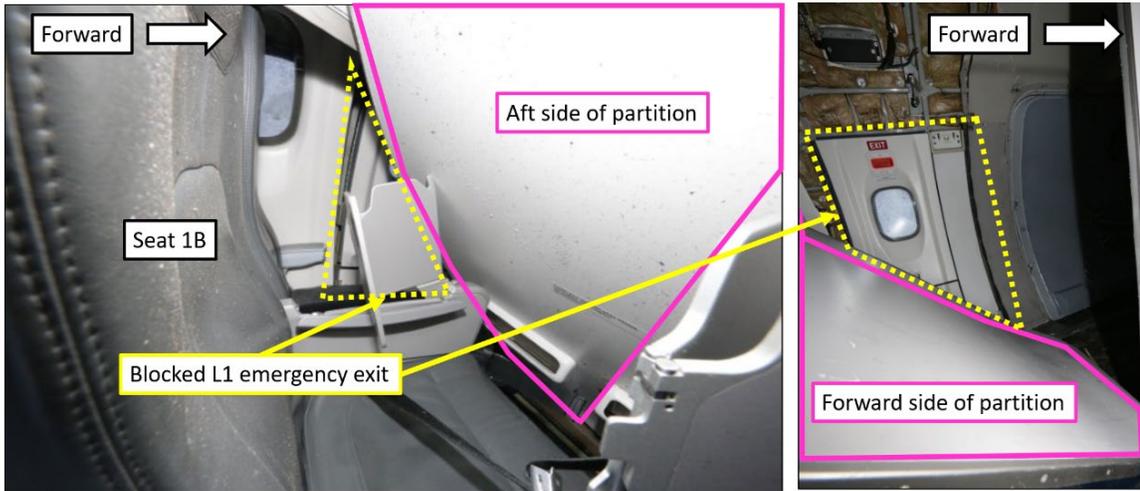
During the accident sequence, many of the partitions became dislodged. The partition that separated the forward cargo area from the passenger cabin had dislodged and fallen into seats 1A and 1B, blocking access and identification of the L1 emergency exit (Figure 30).

Figure 30. Photos of the L1 emergency exit (dashed line) blocked by displaced partition (solid line) (Source: TSB)

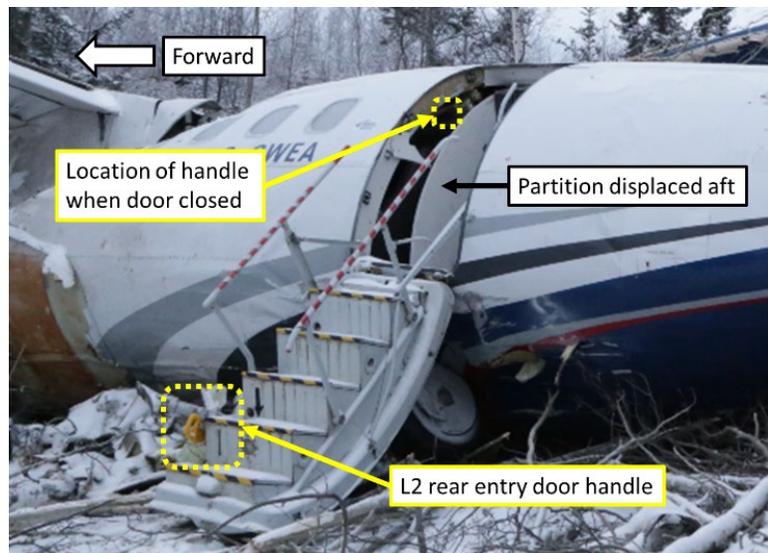
The partition that separated the passenger cabin from the rear entry door (L2) was also dislodged and fell across the door, blocking access to the door handle, which was on the other side of the partition (Figure 31).

Figure 31. Partition displaced toward the aft, blocking access to the L2 rear entry door handle (Source: TSB)

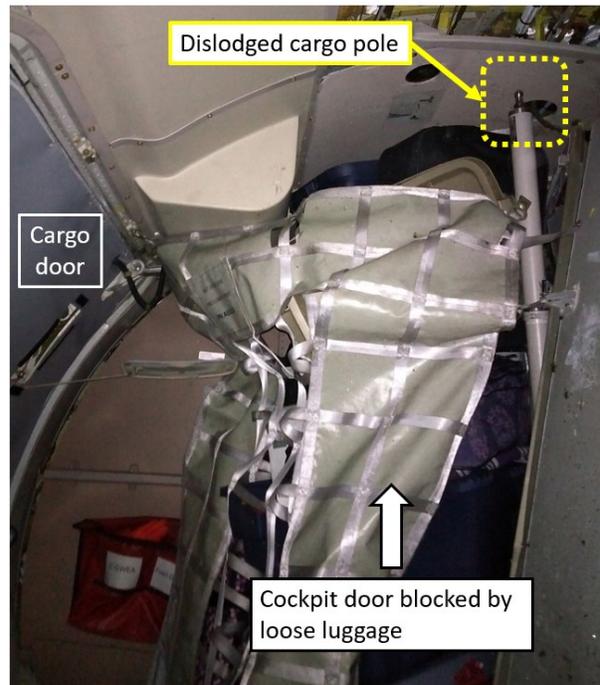
hooked onto vertical cargo poles. These cargo poles were latched into the aircraft structure. During the accident, the cargo poles became dislodged, and, although the nets remained attached, the luggage that was retained by the poles and nets came loose. The loose luggage and the dislodged poles and nets blocked the cockpit door, preventing egress from the cockpit into the main cabin of the aircraft (Figure 32).

Figure 32. Main cockpit door blocked by loose luggage as a result of dislodged cargo pole (Source: TSB)

The FO was able to free himself from the right-hand seat. He assessed the normal exit route through the cockpit but found it was blocked by luggage that had become loose in the main cargo area.

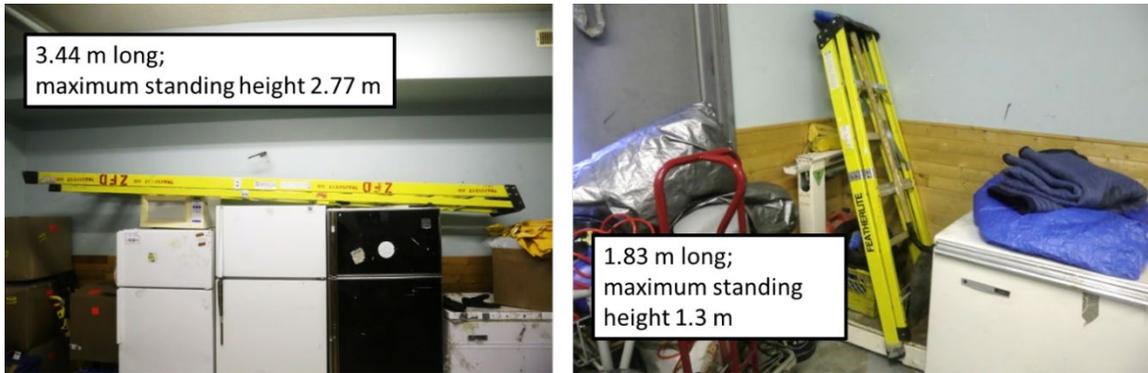
At CZFD, there was no equipment available that would enable someone to visually inspect the top portion of an ATR 42’s critical surfaces, given their height, nor to reach them to apply de-icing fluid. The only equipment available were 2 ladders, 1 approximately 3.44 m and the other 1.83 m (Figure 37). The 3.44 m ladder had a maximum standing height of 2.77 m.

Figure 37. Photos showing ladders available at the Fond-du-Lac Airport terminal (Source: TSB)

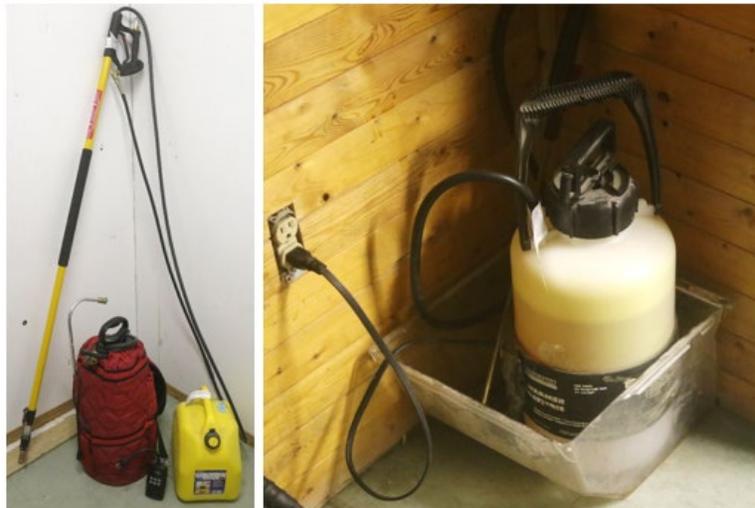
West Wind's de-icing spray equipment at CZFD consisted of a hand-held spray system with a small-capacity heated fluid reservoir and 20 L container of additional type I fluid.<sup>269</sup> Another air operator also had a small (20 L), heated hand-held spray system in the terminal building that was available to West Wind personnel on request (Figure 38).

Published de-icing standards recommend that the fluid quantity required to de-ice an aircraft is 1 L/m<sup>2</sup> of aircraft surface. In the case of an ATR 42 aircraft, more than 66 L would be required.<sup>270</sup>

Figure 38. De-icing equipment available at Fond-du-Lac Airport: West Wind's equipment on left, another operator's equipment on right (Source: TSB)
