**AIR TRANSPORTATION SAFETY ISSUE
INVESTIGATION REPORT A17O0038**

Runway Incursions Between the Parallel Runways at Toronto/Lester B. Pearson International Airport, Ontario

Released 31 January 2019

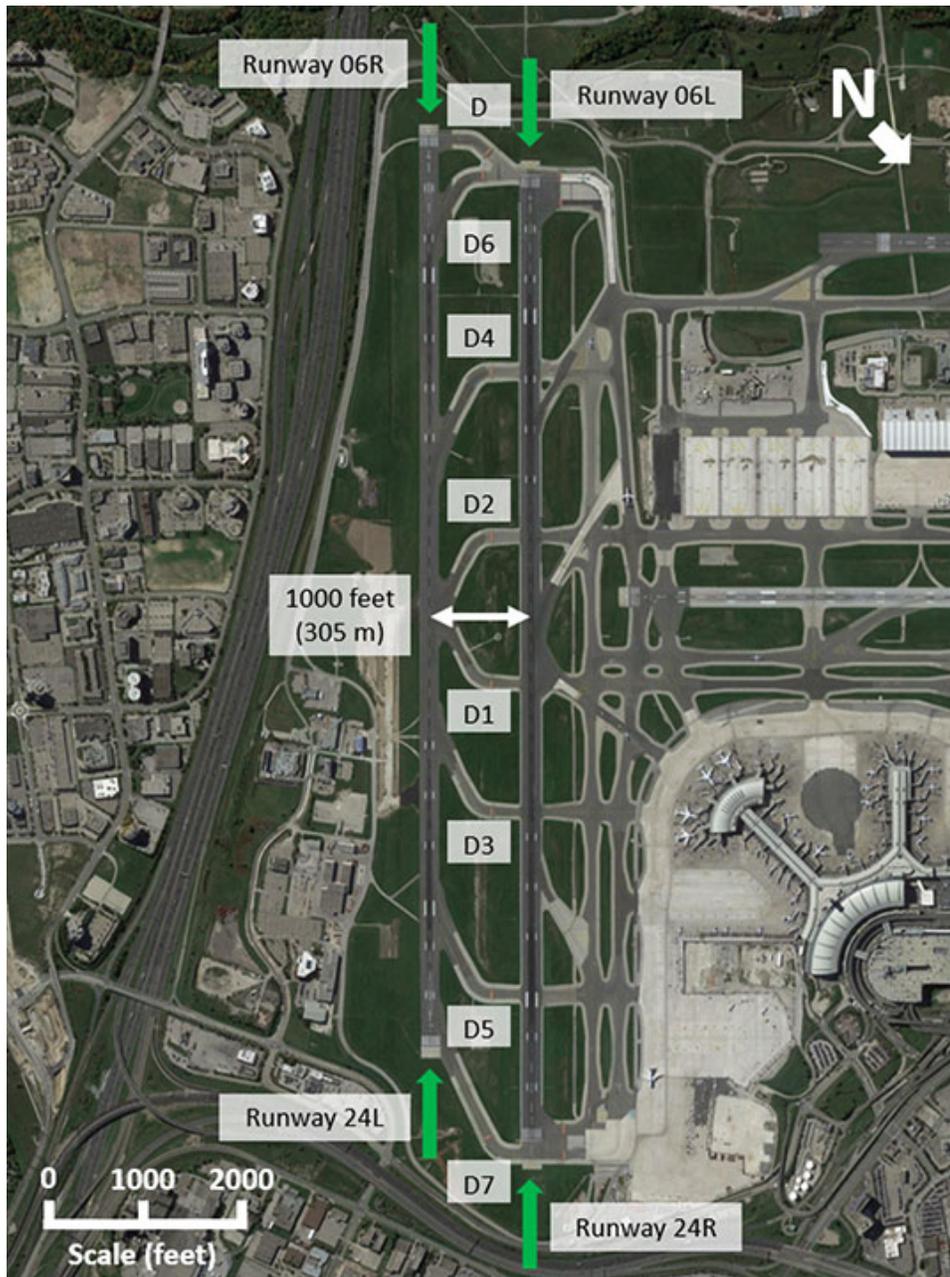
Figure 4. CYYZ's south complex runways and rapid exit taxiways (Source: Google Earth, with TSB annotations)

During periods of high-volume traffic, all 3 east-west runways are used; this is referred to as triple-runway operations. Runways 05/23 and 06R/24L are used for arrivals at these times, and runways 05/23 and 06L/24R, for departures. Aircraft landing on Runway 06R/24L are required to exit the runway via one of the RETs (D1 through D7) and to hold short of the inner runway (06L/24R) (Figure 4).

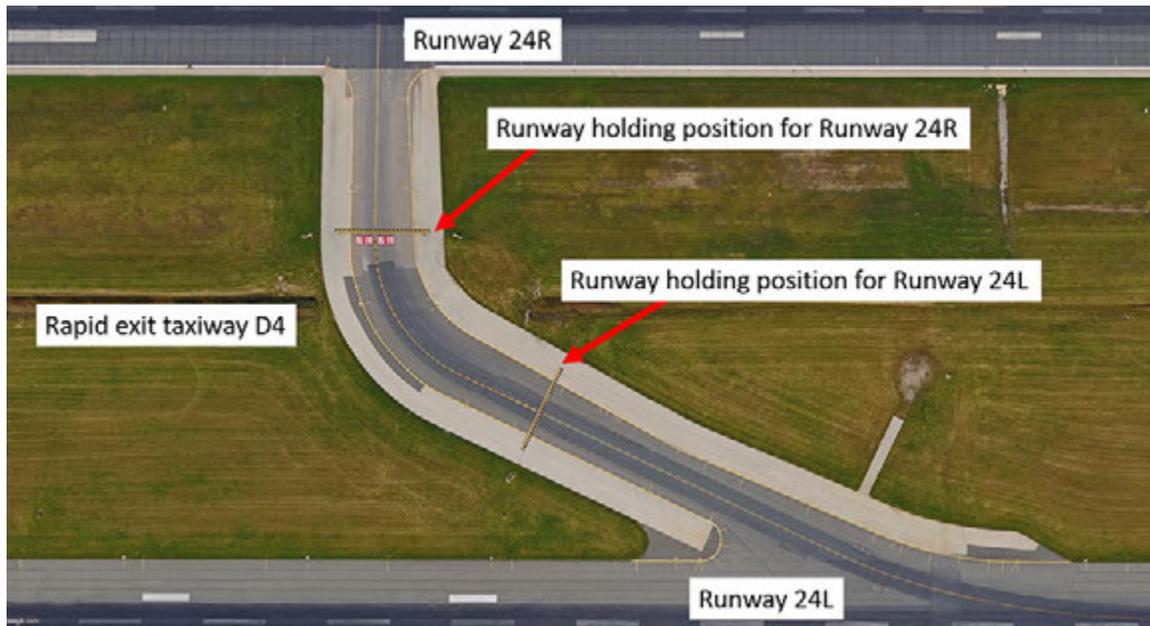
Figure 5. The runway holding positions on rapid exit taxiway D4 (Source: Google Earth, with TSB annotations)

Each RET between the parallel runways has 2 runway holding positions: 1 designating the protected area for Runway 06R/24L (normally the landing runway) and 1 for the protected area for Runway 06L/24R (normally the departure runway). Each position is designated by markings, lighting, and signage (Figure 5).

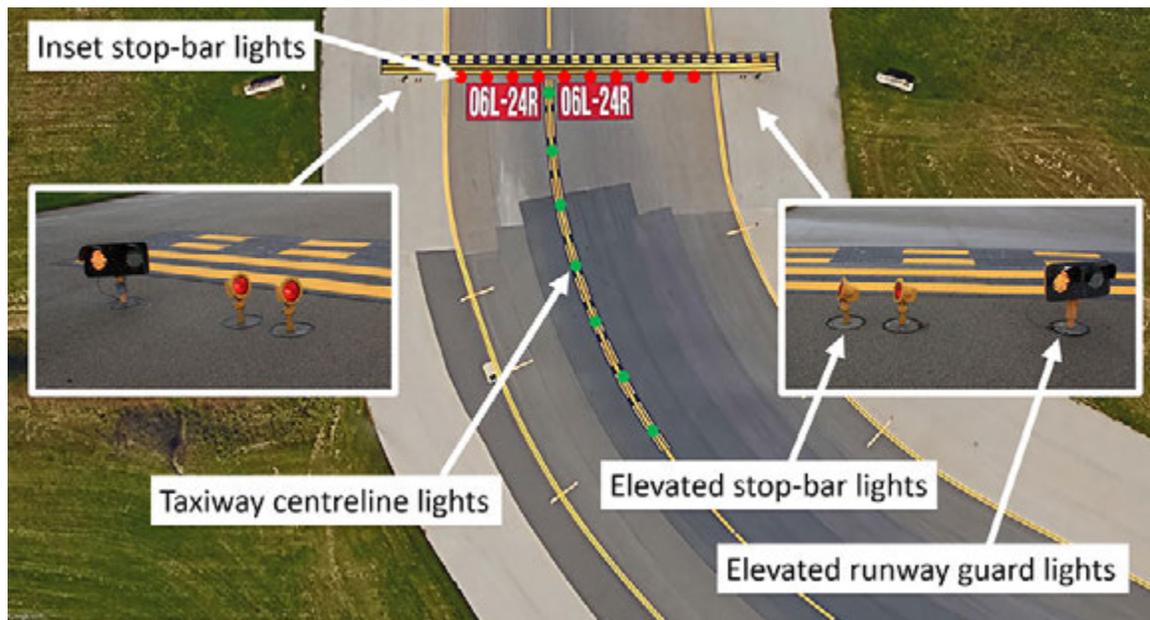
Figure 8. Current lighting at the runway holding positions of rapid exit taxiways at Runway 06L/24R (Source: Google Earth, with TSB annotations [green and red dots added for contrast])

All of the RETs between the parallel runways and their associated runway holding positions are equipped with identical lighting. This lighting system is more complex than lighting systems used on a typical runway, as Runway 06L/24R is certified for category III operations in poor weather conditions. The lighting at each runway holding position consists of elevated runway guard lights, inset stop-bar lights, supplemental elevated stop-bar lights, and taxiway centreline lights (Figure 8). The purpose of these lights is to draw attention to the runway holding positions.

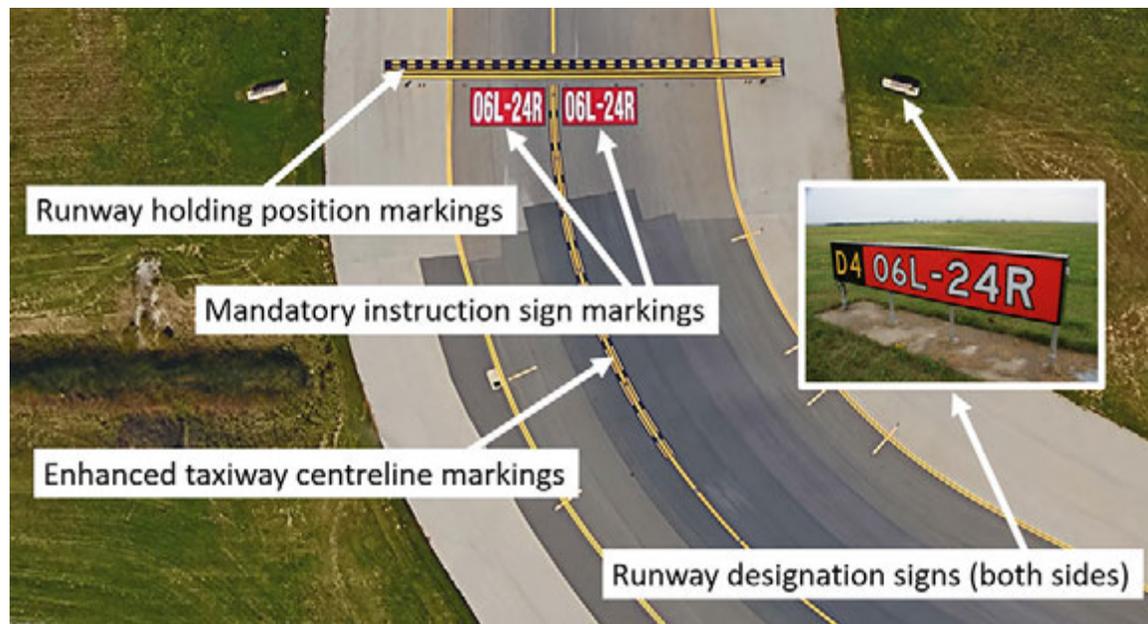
Figure 17. Markings and signage on the rapid exit taxiways (Source: Google Earth, with TSB annotations)

The runway boxes are large, red ground markings that identify the designation of the runway ahead (Figure 17).

The runway designation signs, previously lit using individual fibre-optic points, were switched in 2013 to internal illumination, consistent with lit signage in the U.S. Both lighting methods are acceptable per TP 312.

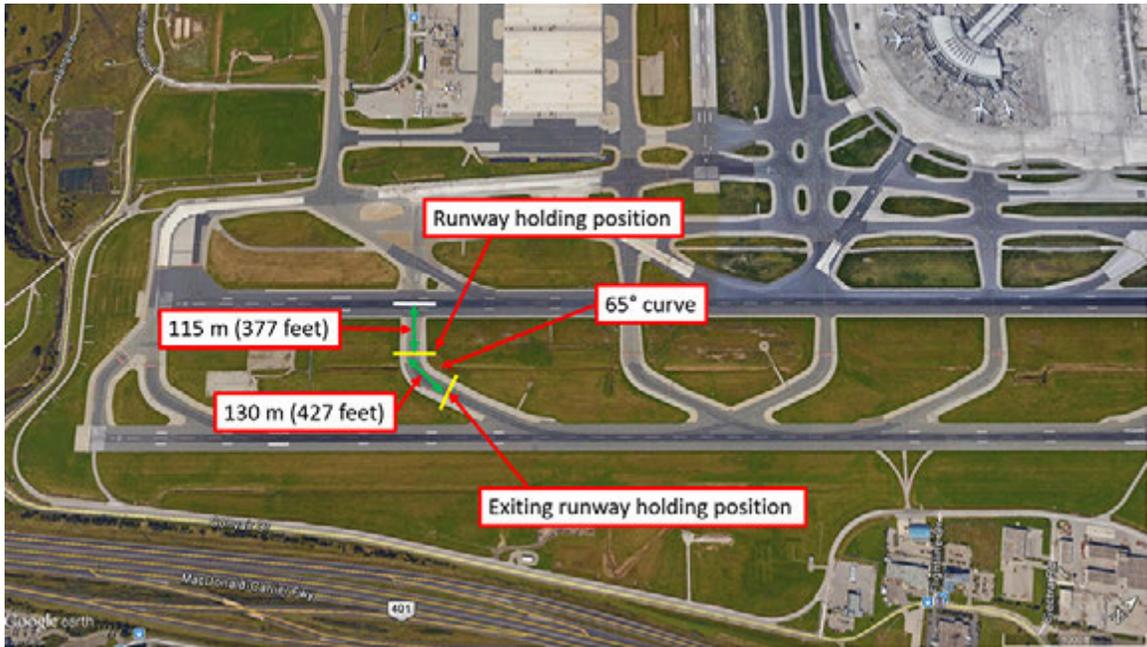
Figure 27. Current configuration of the south complex at CYYZ (Source: Google Earth, with TSB annotations)

This investigation has identified several causal, contributing, and risk factors that are directly related to airport geometry: the short distance between runway holding positions on the RETs, the direct access of the RETs to the adjacent runways, the speed at which aircraft approach the hold line, the displaced distance of the runway holding positions, and the locations of common runway crossing points (Figure 27). With the possible exception of taxiing speeds, these factors cannot be addressed by increasing conspicuity or amending operators' SOPs.

The additional taxiing surface would also mean that aircraft would no longer be going directly from the RET to the adjacent runway, which would allow flight crews more time to reduce the speed at which they approach the runway holding position. The shorter-radius 90° turn would also necessitate a reduction in speed. In addition, the runway holding positions would be returned to their typical 90 m distance, and the crossing points could be placed closer to the end of the runway (Figure 28).
