## MARINE INVESTIGATION REPORT

M04W0235

**SINKING AND LOSS OF LIFE**

**THE TUG *MANSON* TOWING THE  
CRANE BARGE *MCKENZIE* AND DECK BARGE *M.B.D. 32***

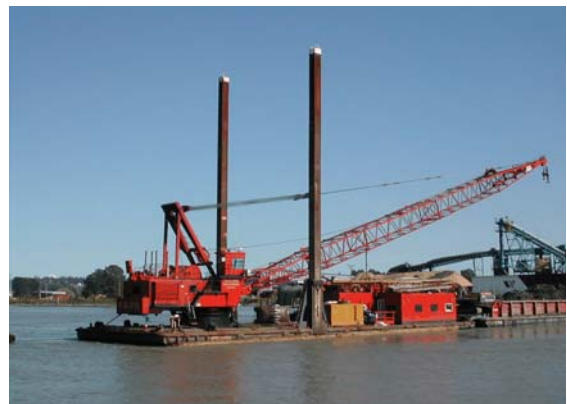
**Photo 2.** *McKenzie*

The *McKenzie* is a dedicated crane barge with a large-capacity, pedestal-mounted crane permanently fixed to its deck. Spuds, used for keeping the barge in position, are fitted near the barge's mid-length. In Photo 2, the spuds are seen in the raised position – as they were when the barge was being towed. The crane is situated near the bow, where the towing bridles were attached.

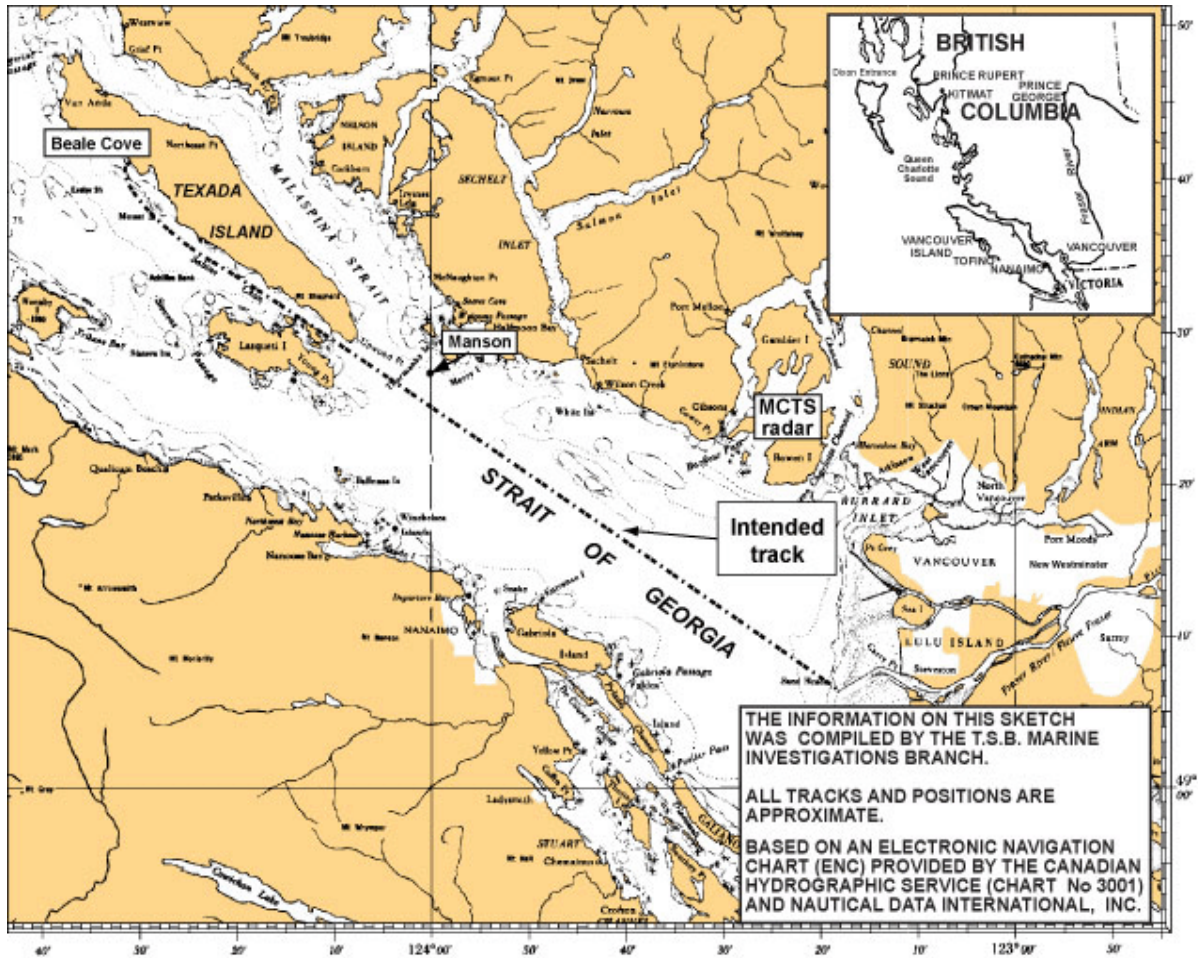
Figure 1. Sketch of the occurrence area

Shortly after 0218 on November 6, the Victoria MCTS officer observed on radar that the echo representing the *Manson* and its tow had separated into two distinct echoes. The new echo, later identified to be that of *M.B.D. 32*, was tagged. At 0226, Victoria MCTS reviewed the situation and called the *Manson* to inquire if it had lost a barge. The *Manson* responded that it would check into it. The tug and tow were now approaching the Merry Island/Ballenas Island boundary where communications are handed over to MCTS at Comox, British Columbia.

At about 0301, the speed vector for the *Manson/McKenzie* on the MCTS radar reduced and then disappeared as the two vessels stopped to the west of the *M.B.D. 32*. The *Manson* was an estimated 120 m from the *M.B.D. 32*, with the *McKenzie* some 75 m astern. By 0302, the *Manson* had lost steering, and at 0305, it stopped between the two barges to investigate the steering failure.

With the vessels tethered by some 75 m of tow wire, southeasterly seas and the 25-knot southeasterly winds acting on the larger sail area of the *McKenzie*, the *McKenzie* would have drifted downwind in a northwesterly direction more quickly than the *Manson*. This difference in the rate of drift would cause the tow wire to become taut, possibly with a jerk or jarring motion, and would result in the tug eventually being dragged sideways until it was placed in irons.<sup>3</sup> This in turn would cause the tug to heel over quickly, taking on water and downflooding into the lower compartments through the open hatchways and/or the open deckhouse door. The vessel would then eventually lose all reserve buoyancy and sink.
