MARINE INVESTIGATION REPORT
M05C0063

GROUNDING

BULK CARRIER *MICHIPICOTEN*
BRUSH POINT LIGHTED BUOY G17
ST. MARY'S RIVER, ONTARIO
28 OCTOBER 2005

Report Number M05C0063

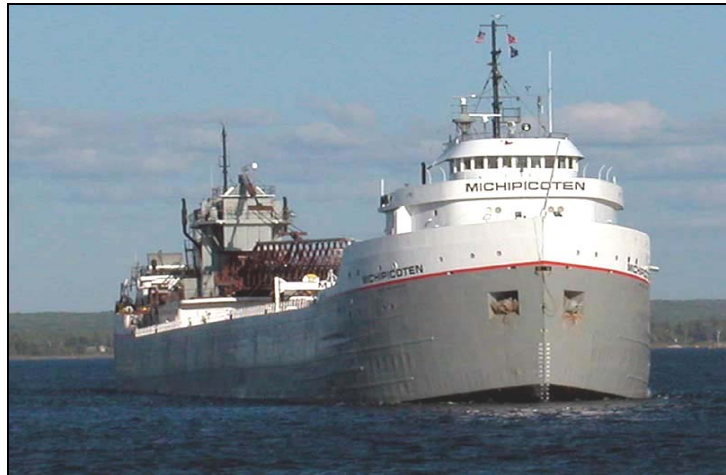
Photo 1. *Michipicoten*

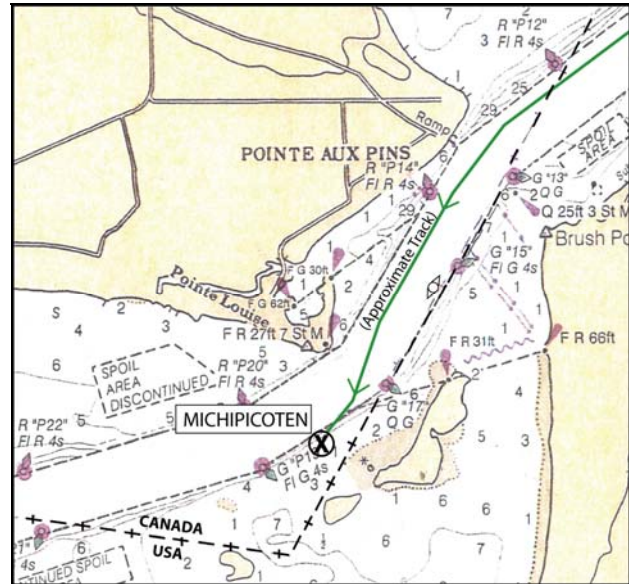
Near the line between Brush Point Buoy G13 and Pointe aux Pins, the *Michipicoten* altered course to port to follow the recommended main channel course of 210° true (T) in the direction of Pointe Louise. The next course alteration to 238° T (starboard course alteration) would take place at the line between Brush Point Buoy G17 and Pointe Louise. At approximately 0723, while approaching the next course alteration, fog had obscured the channel's easterly limit on the vessel's port side, and the master could not see the next forward set of ranges. While attempting to see buoys on the channel's easterly limit, he was in communication with Soo Traffic Control.

Figure 1. Segment from National Oceanic and Atmospheric Administration Chart 14884
