**MARINE INVESTIGATION REPORT**  
**M05L0205**

**COLLISION**

**BETWEEN THE CONTAINER VESSEL *CAST PROSPERITY***  
**AND THE TANKER *HYDE PARK***  
**LAC SAINT-PIERRE, QUEBEC**  
**26 SEPTEMBER 2005**

Report Number M05L0205

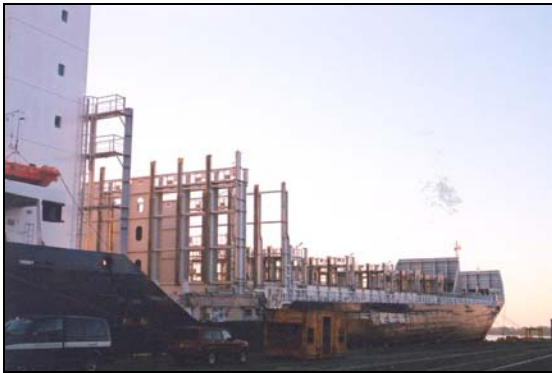
**Photo 1.** The *Cast Prosperity*

The *Cast Prosperity* sustained damage to almost the entire length of the starboard side shell plating, including a hole measuring 1.5 m by 6 m between frames 148 and 160. The deck plating was buckled in various locations, as were a number of web frames.

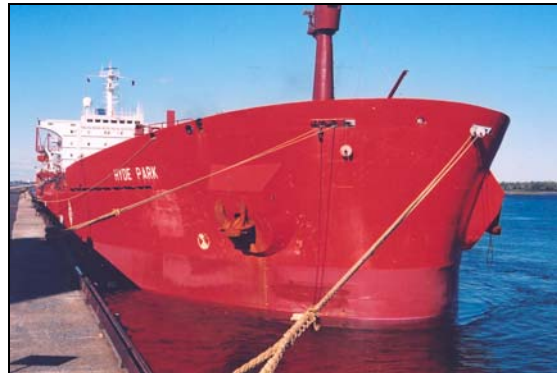
**Photo 2.** The *Hyde Park*

The *Hyde Park* sustained substantial damage to its port side shell plating adjacent to the superstructure and cargo tanks Nos. 2, 7, and 8. Numerous web frames were set in or buckled, as was the deck plating and sheer strake at various locations. Although no tanks were reported breached, the smell of gasoline could be detected on deck.
