MARINE INVESTIGATION REPORT
M09W0193

STRIKING

BULK CARRIER *PETERSFIELD*
DOUGLAS CHANNEL, BRITISH COLUMBIA
25 SEPTEMBER 2009

Report Number M09W0193

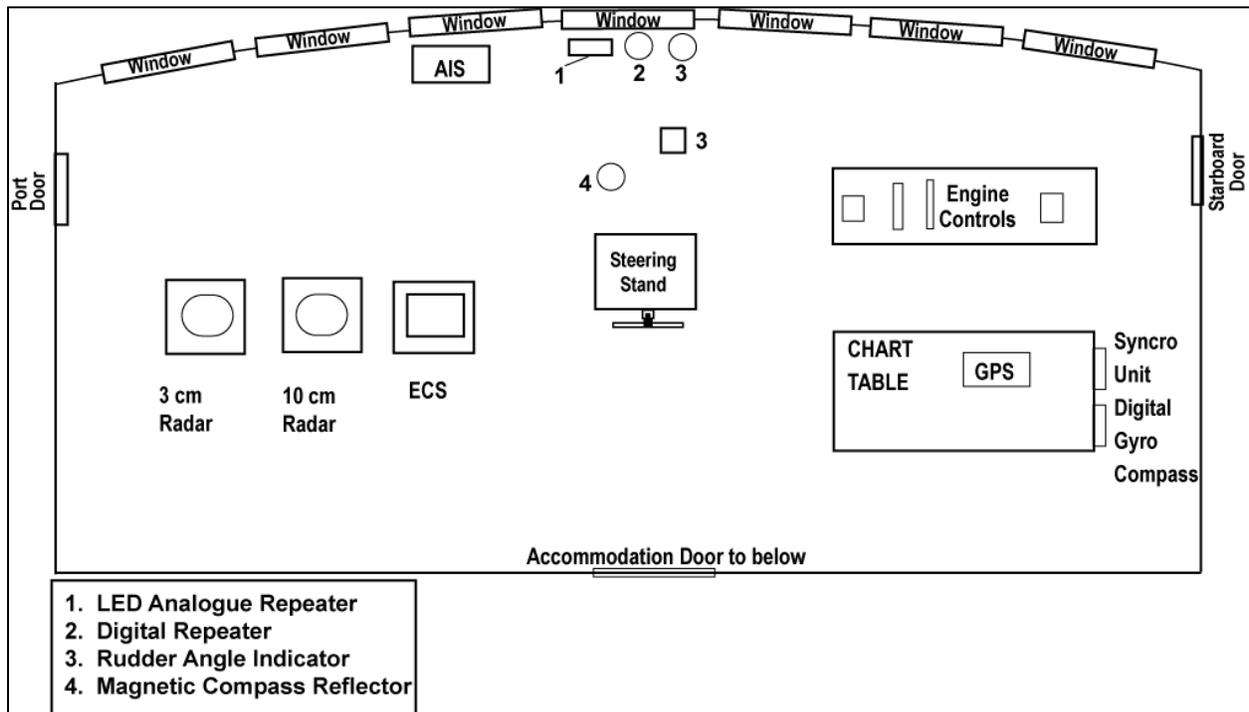
Figure 1. Sketch of the bridge wheelhouse showing where the navigation equipment is located.

Situated next to each other on the port side of the bridge were 2 automatic radar plotting aid radars – a 3 cm radar and a 10 cm radar – and an electronic chart system (ECS) (see Figure 1).
