**MARINE INVESTIGATION REPORT
M12C0058**

GROUNDING

**ROLL-ON/ROLL-OFF PASSENGER VESSEL *JIIMAAN*
APPROACHING KINGSVILLE HARBOUR, ONTARIO
11 OCTOBER 2012**

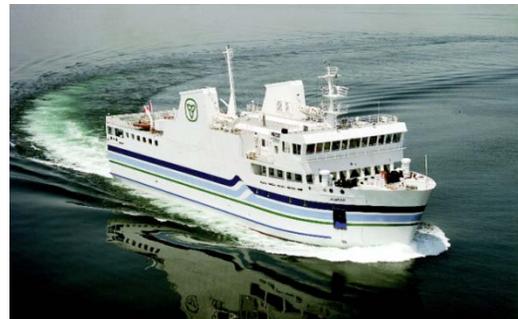
Photo 1. *Jiimaan*

The *Jiimaan* is a roll-on/roll-off passenger vessel of steel construction (Photo 1). The bridge is fitted with the required navigational equipment, including 2 radars, an electronic charting system (ECS), and an echo sounder. The vessel has a single vehicle deck with space for 40 automobiles. Day-use accommodations include a cafeteria and passenger lounge (Appendix A).

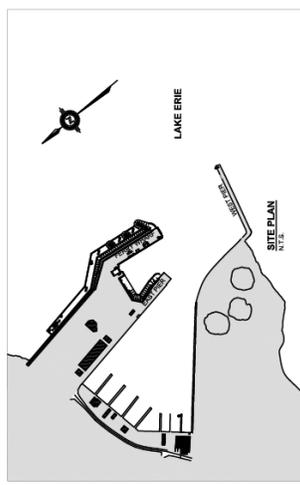
A post-grounding sounding survey conducted on 17 October determined that the least water depth along the range line was 1.7 to 1.8 m (Appendix D). On 06 November, the CCG noted that the least water depth along the range line was about 2 m and that the range line no longer marked the best water depth coming into the harbour.
