MARINE INVESTIGATION REPORT

M17C0035

Flooding

Fishing vessel *L.K.C*
Sept-Îles, Quebec, 45 nm E
21 April 2017

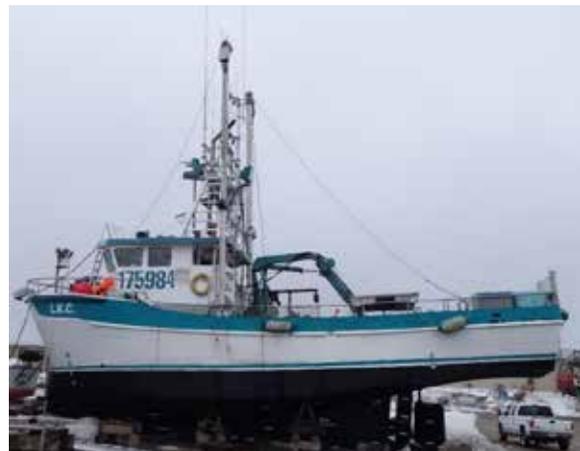
Figure 1. Fishing vessel L.K.C

The wheelhouse and accommodations are located forward, and the engine room is situated beneath the wheelhouse (Figure 1). The wheelhouse is elevated and is accessed via a door on its aft starboard side.

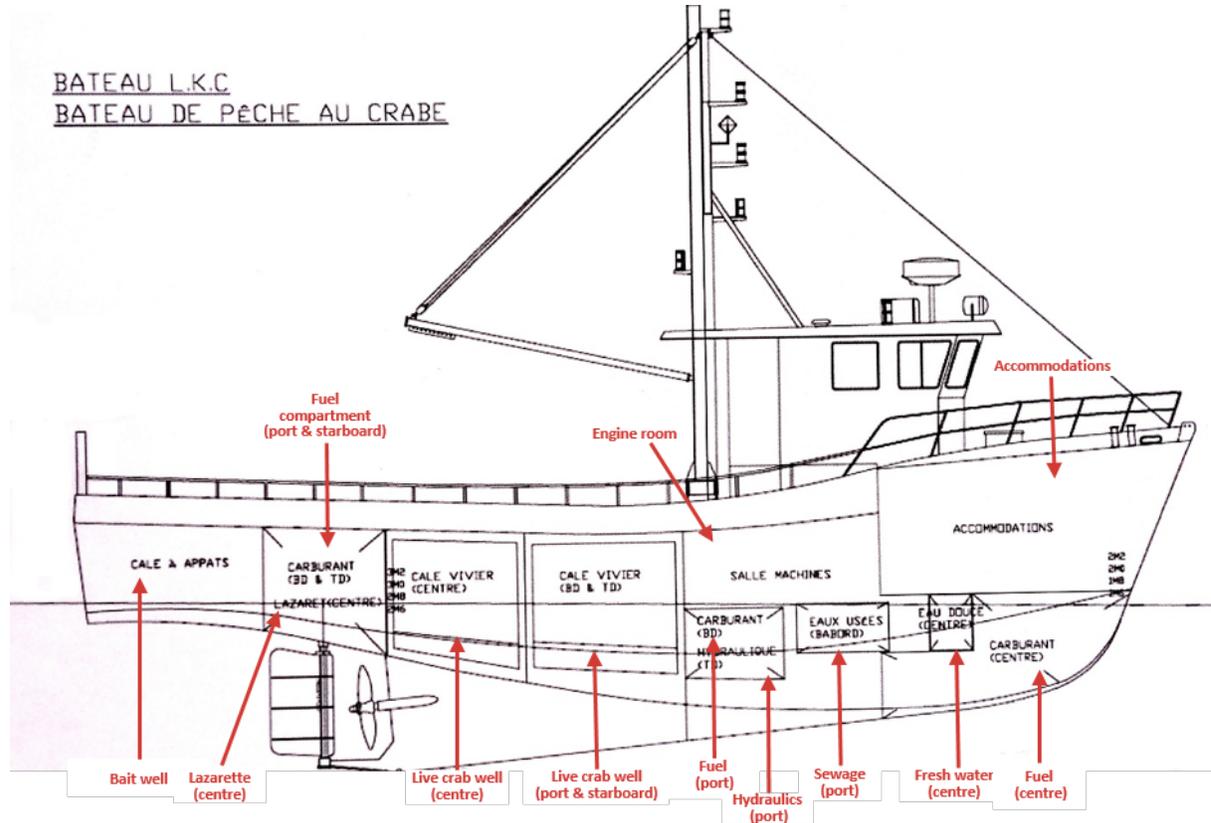
Appendix A – Profile of crab fishing vessel L.K.C

The hull is subdivided by 5 transverse bulkheads into 6 compartments, from forward: accommodations (accessed by stairs descending from the wheelhouse), the engine room, the port and starboard live crab wells, the centre live crab well, the steering gear compartment, and the bait hold (Appendix A).
