**PIPELINE INVESTIGATION REPORT  
P13H0107**

**RUPTURE**

**TRANSCANADA PIPELINES LIMITED (NOVA GAS  
TRANSMISSION LTD.)  
NORTH CENTRAL CORRIDOR LOOP (BUFFALO CREEK WEST  
SECTION) CHAINAGE 27+996 M  
NEAR FORT MCMURRAY, ALBERTA  
17 OCTOBER 2013**

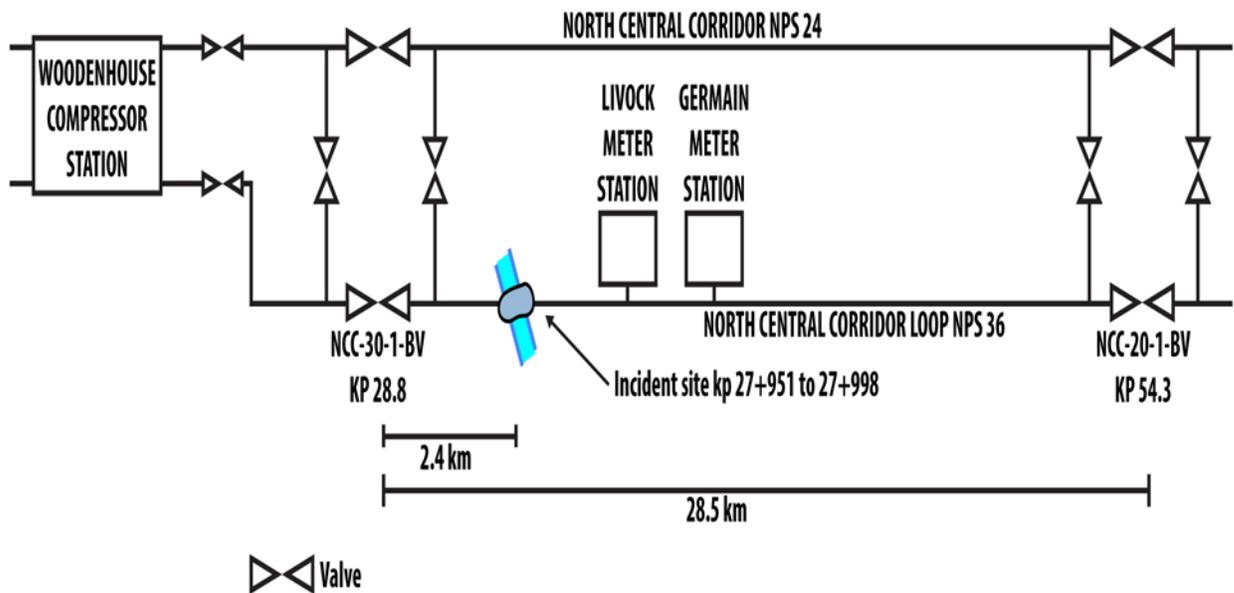
Figure 4. Pipeline schematic, including valves

To isolate the failed pipeline section, a number of valves immediately upstream and downstream of the failed location (Figure 4) were closed. Three valves then automatically closed: a block valve (NCC30-1-BV), a cross over valve (NCC30-0-D2) and the Germain sales valve (GMN10-M-1MV1-NCC). At 0754, the mainline to loop crossover valve (NCC20-0-X1) was manually activated to close by local valve control. When valve NCC20-0-X1 was manually activated to close, another block valve (NCC20-1-BV) closed automatically.
