RAILWAY INVESTIGATION REPORT
R07H0015

RUNAWAY ROLLING STOCK

RUNAWAY CUT OF CARS

SMITHS FALLS, ONTARIO

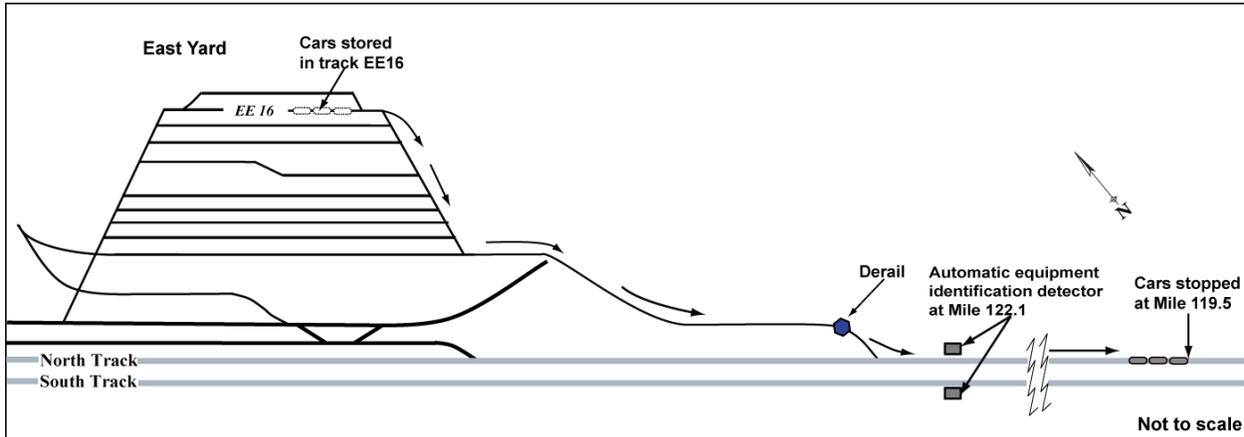
Figure 1. Incident location

The cut of cars (SOO 5002, SOO 5010 and SOO 5017), flat cars that were being used to transport track ties, had been moved the previous day (03 July 2007) by Canadian Pacific Railway's (CPR) Engineering Services employees and stored in track EE16 in Smiths Falls Yard (see Figure 1).
