**RAILWAY INVESTIGATION REPORT**  
**R08T0158**

**CROSSING COLLISION AND DERAILMENT**

**VIA RAIL CANADA INC.**  
**TRAIN NUMBER 60**  
**MILE 138.21, KINGSTON SUBDIVISION**  
**MALLORYTOWN, ONTARIO**  
**15 JULY 2008**

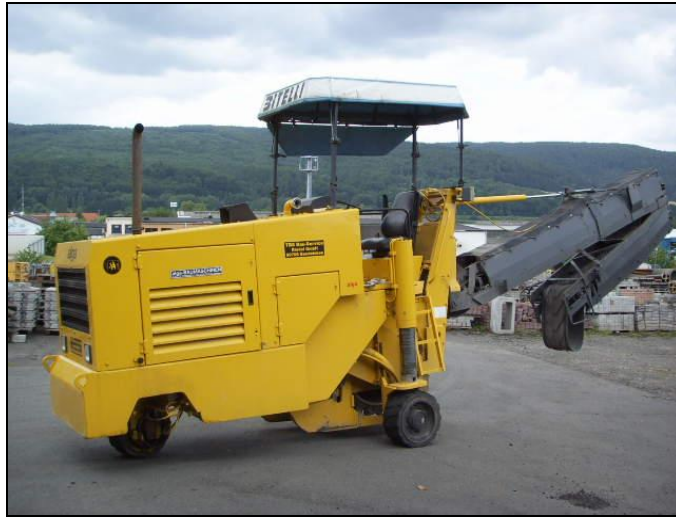
Road construction was underway on provincial Highway 2, located south and west of Mallorytown, parallel to the rail line. A cold-planer (see Photo 1) was being used to remove deteriorated roadway asphalt before repaving the road surface. After completing the assigned work, the cold-planer, which weighed approximately 11.5 tons (23 000 pounds), was loaded onto a lowboy tractor-trailer unit to be moved to another location.

**Photo 1.** Cold-planer of type being transported on lowboy trailer
