**RAILWAY INVESTIGATION REPORT
R13D0077**

DERAILMENT

**CANADIAN NATIONAL
FREIGHT TRAIN M37231-05
MILE 144.4, ST-LAURENT SUBDIVISION
TASCHEREAU YARD, MONTRÉAL, QUEBEC
06 NOVEMBER 2013**

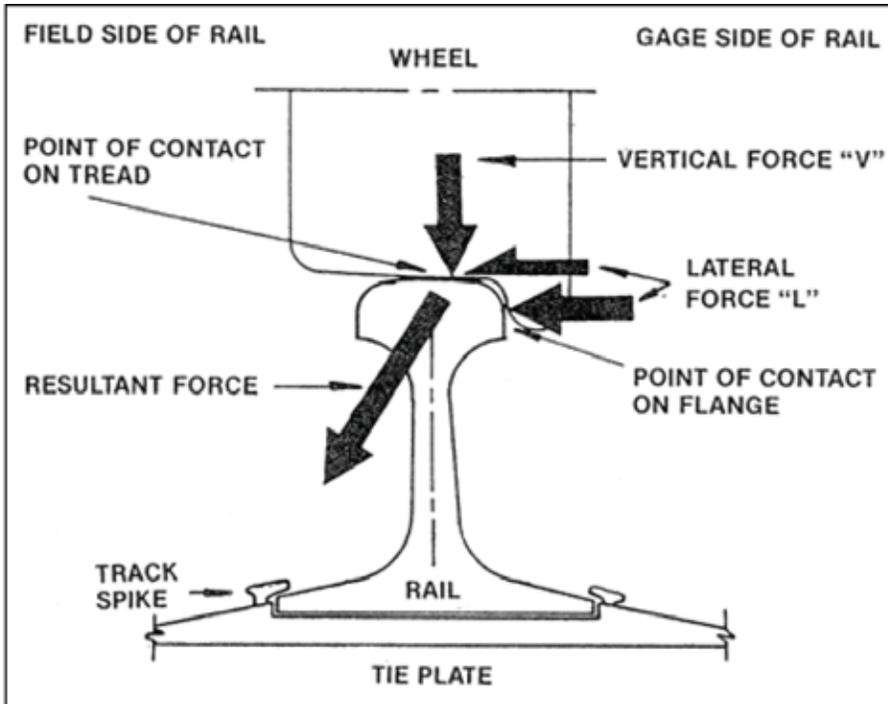
Figure 3. Forces at the wheel-rail interface

A combination of lateral (L) and vertical (V) forces exists at the wheel-rail interface (Figure 3). The ratio of lateral-to-vertical (L/V) force indicates the likelihood of a derailment. When a high lateral force and low vertical force is present (e.g., as with an empty car), the high lateral force will tend to push the wheel flange up and over the gauge face of the rail, resulting in a wheel-climb derailment.
