OPERATIONAL SERVICES BRANCH
ENGINEERING LABORATORY REPORT

LP181/2013

Locomotive Engine Fire Examination

Montreal, Maine & Atlantic Railway, Train MMA-002

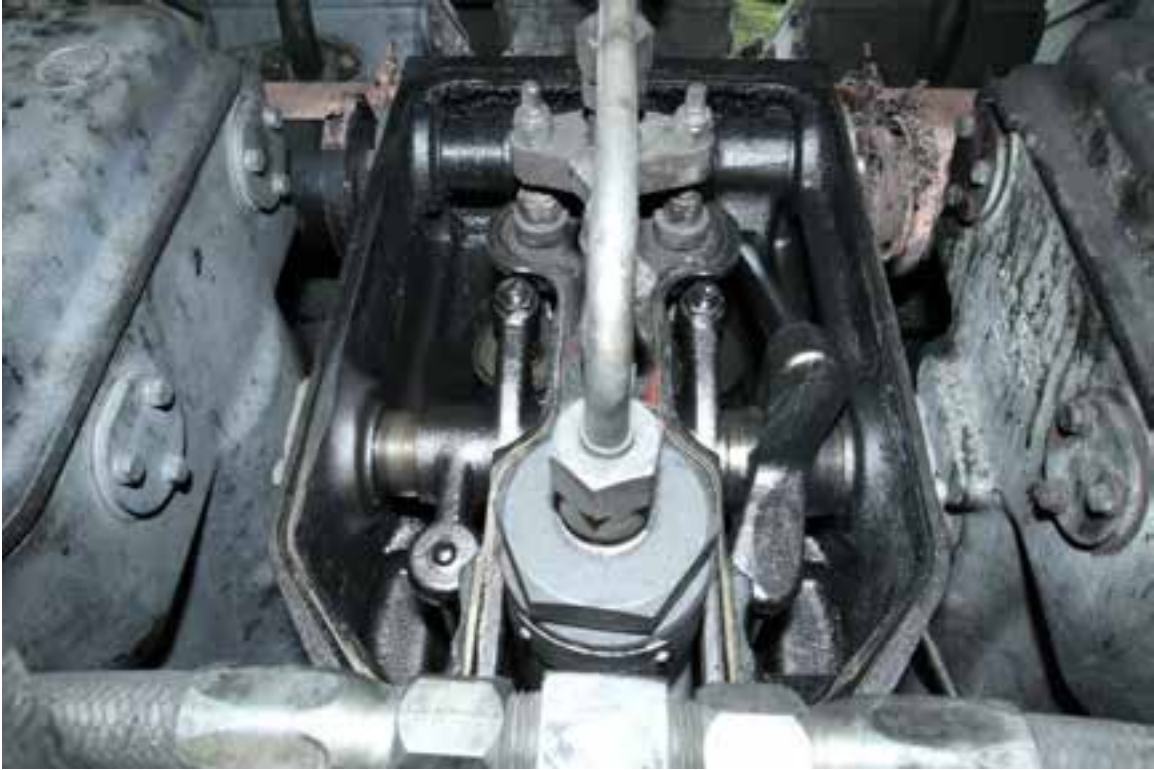
- 2.1.3 Removal of the valve covers revealed that the top of the number five power assembly on the right hand side (PA R5) was dry and coked, indicating that the valve train had been starved of oil for an extended period of time (Figure 4). The other power assemblies had a normal oily appearance (a representative example is shown in Figure 5 for comparison).

Figure 5: Normal oily valve train shown for comparison

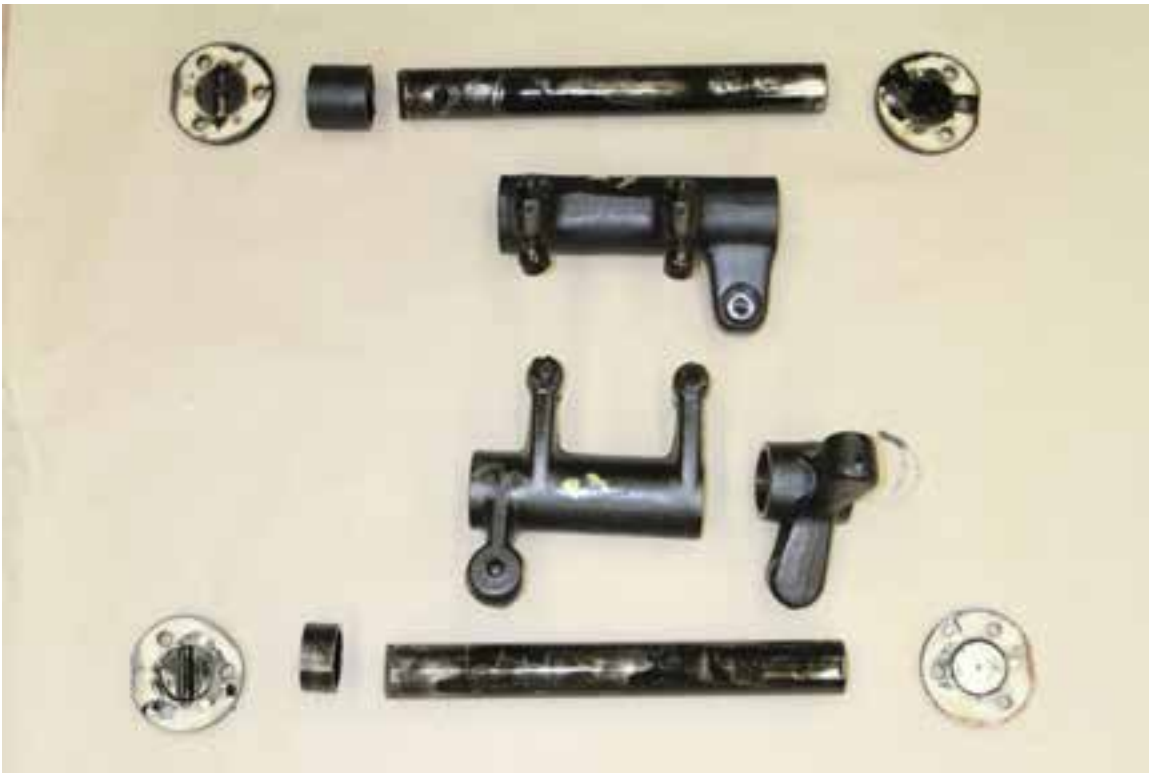
- 2.3.2 PA R4 and PA R6 were removed for examination. These assemblies were unremarkable apart from some differences in colour. The piston crown of R6 was oily and darker than the colour associated with normal operation. The piston crown of R4 was dry but still a little darker than normal (Figure 24). Removal of the rockers and rocker shafts showed that they were well lubricated and slid apart with ease (Figure 25).

Figure 25: Rockers and shafts from PA R4

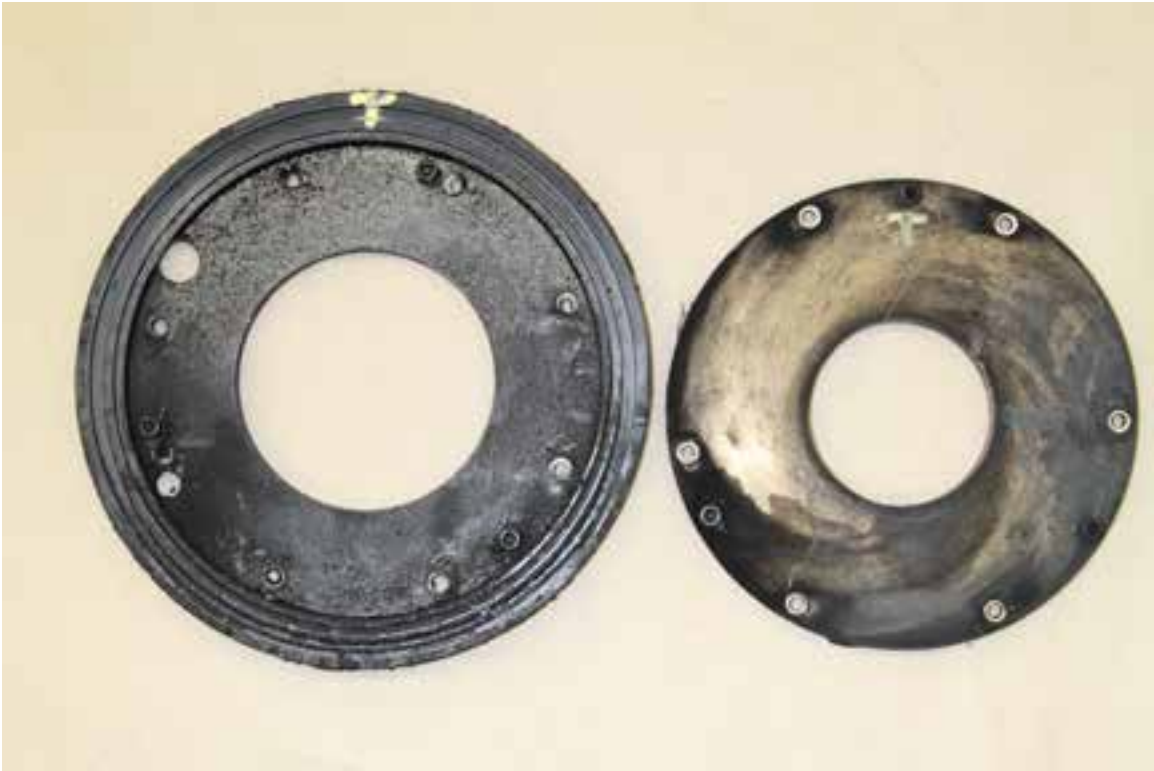
- 2.3.4 Disassembly of the turbocharger showed that approximately 12 of the 70 turbine blades had fractured (Figure 29). The turbine and compressor journal bearings and shaft showed wear damage, primarily on the compressor side (Figures 30 through 34). The wear areas on both the turbine and compressor bearings occurred in three locations radially around the bore of the bearings, between the three equally spaced oil delivery ports. A large quantity of dense oil sludge was found in the body of the turbocharger indicating that oil had been collecting in the turbocharger for some time. However, the oil seals for both the compressor and turbine bearings were in good condition and there was no sign of abnormal leakage (Figure 35).

Figure 35: Turbine and compressor bearing oil seals
