OPERATIONAL SERVICES BRANCH
ENGINEERING LABORATORY REPORT

LP185/2013

Examination of Locomotive Air Brake

Montreal, Maine & Atlantic Railway, Train MMA-002

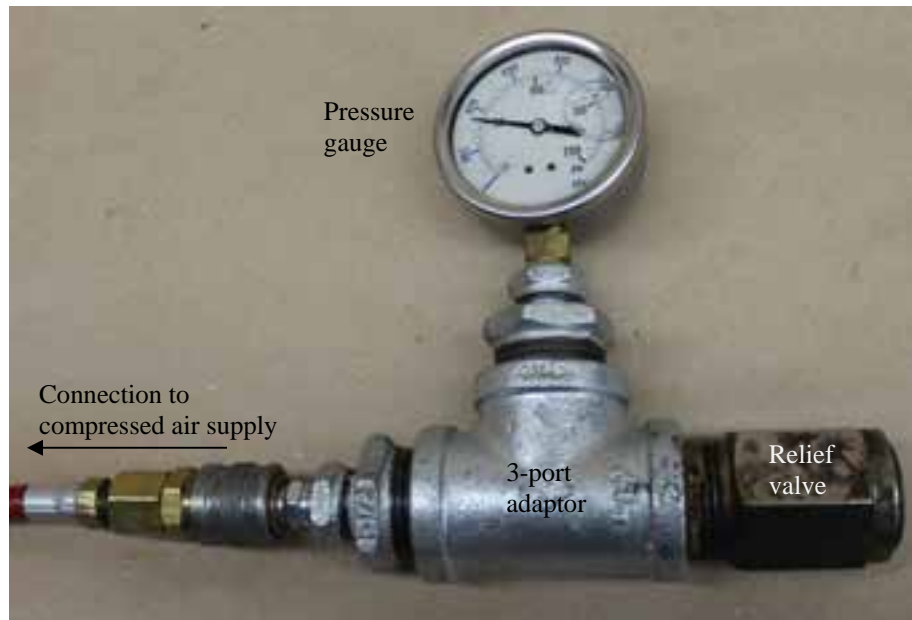
Figure 5: Setup for relief valve pop-off pressure testing

2.2.2 A testing setup was built to determine the pop-off pressure by connecting the valve to a 3-port adaptor with a pressure gauge mounted on one port. The remaining port of the adaptor was then connected to a compressed air supply as shown in Figure 5. The compressed air supply was equipped with a manual pressure regulator so it could be used to adjust the pressure of the air supply to the testing setup.

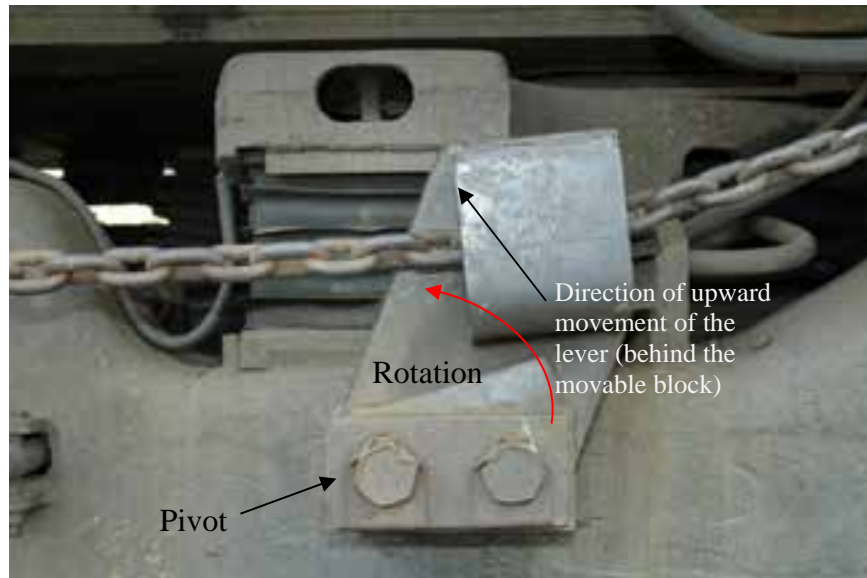
Figure 15: Photo showing a side view of the movable block and its rotating pivot point on locomotive unit MMA-5026

- 2.5.2 The direction of movement of the lever is not straight up (vertical to the ground) but at an angle of approximately 30° relative to the left of the vertical line (as indicated by the black arrow in Figure 15) because the movable block actually rotates around a pivot point when the handbrake chain is tensioned by winding.

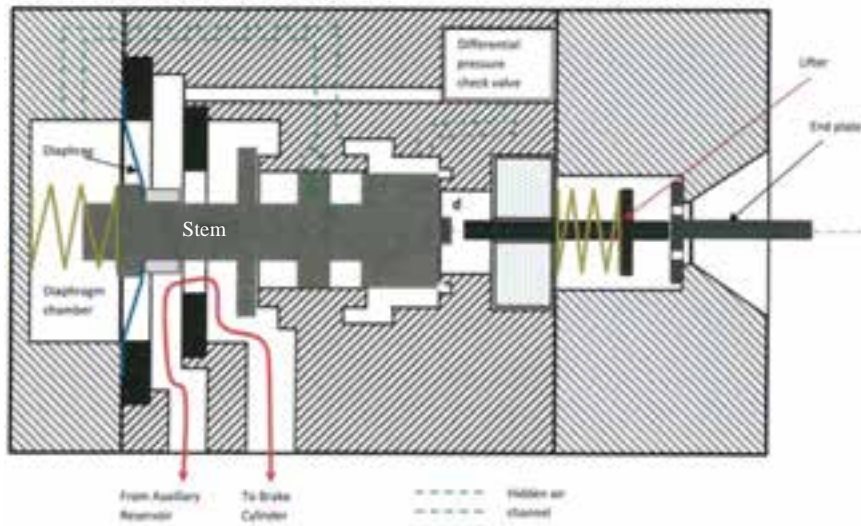
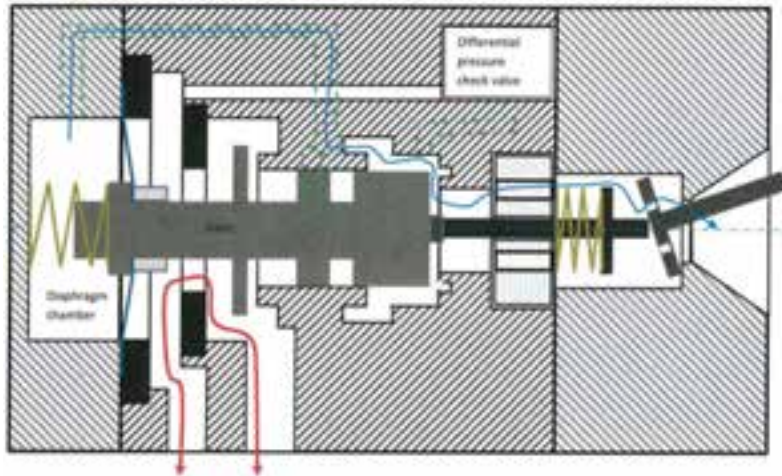
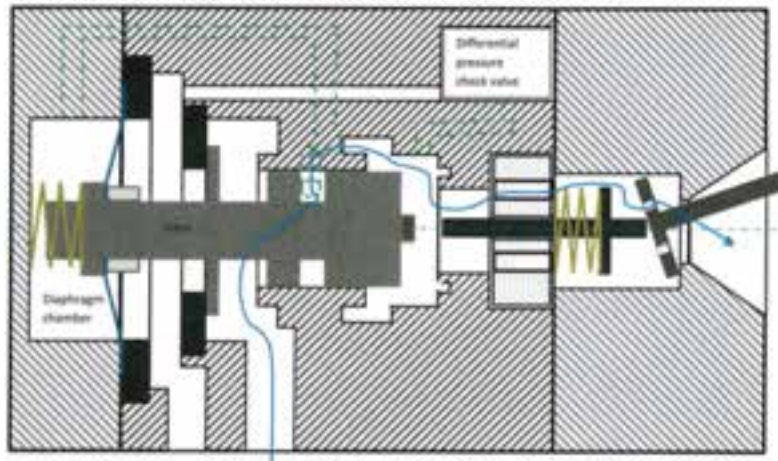
Figure 21: Schematics illustrating the working principle of the QRB valve.

3.5.2 Figure 21 is a reconstructed diagram of the QRB valve illustrating its working principle. Figure 21a shows that when the rod of the end plate is not moved up, the spring pushes the lifter to the right against the end plate, leaving a gap (indicated by the letter d on Figure 21a) between the lifter and valve's stem. When the handbrake chain is tensioned, the rod, which is connected to the handle and lever as shown in Figure 14b, moves up and the end plate pivots against the inside surface of the retaining disc on the exhaust hole. This pushes the lifter to the left, which in turn pushes the head of the valve's stem to the left. Once a small gap appears between the head of the valve's stem and the valve's main air release channel, the compressed air in the diaphragm chamber is released, following the path indicated by the blue line on Figure 21b. The pressure drop in the diaphragm chamber creates a pressure differential across the diaphragm, producing sufficient force to shift the stem to the left instantly, resulting in a quick brake cylinder air release following the channel shown in Figure 21c. At the same time, the shift of the stem to the left also closes the air passage between the auxiliary reservoir and the brake cylinder in order to preserve the air pressure in the auxiliary reservoir.

3.5.3 The working principle presented in the previous paragraph suggests that a reduction in the lifter's length due to damage (Figure 20) would be expected to affect the operation of the valve. It would increase the gap between the lifter and

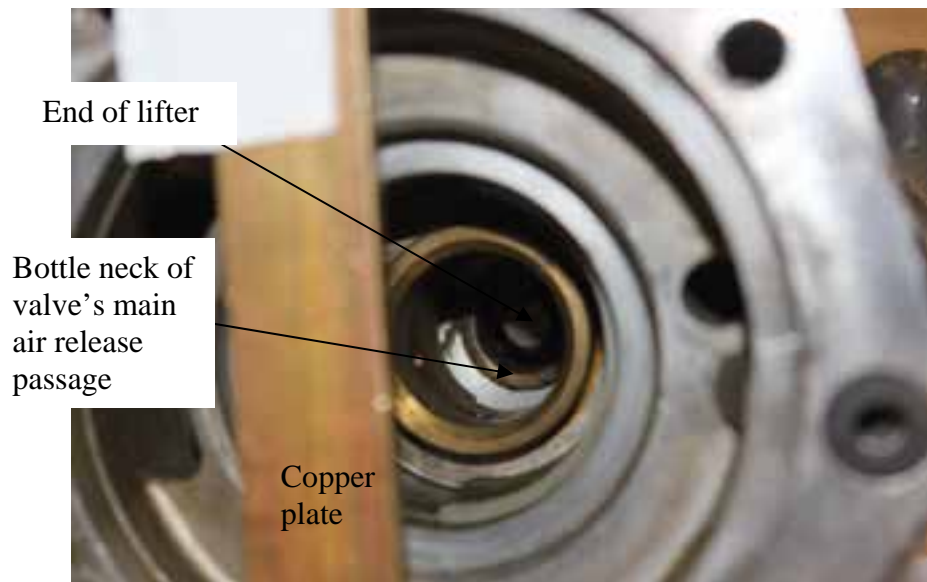
Figure B-1: Inside view of the QR valve after removing the diaphragm-related components and stem.

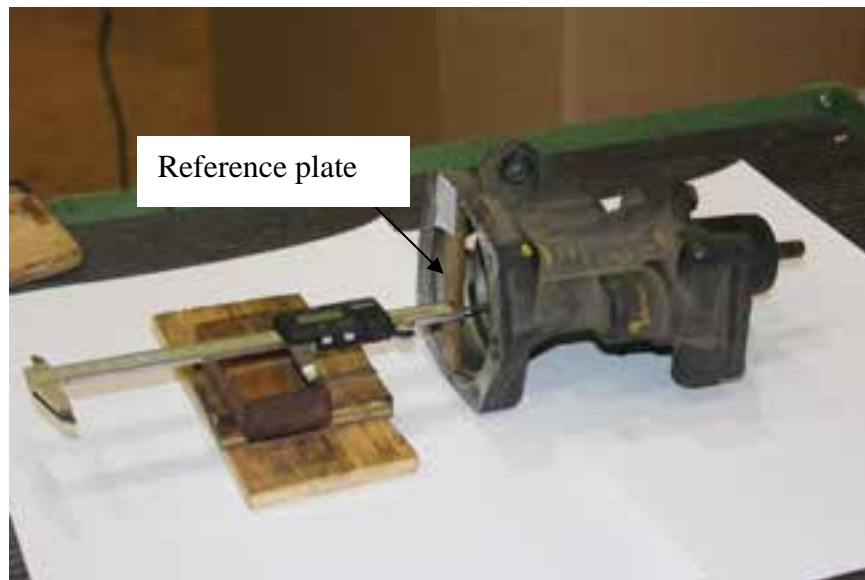
Table B-1: End Plate Pivoting Stroke for 4 Different Directions

Direction	Nominal	90° to the left	90° to the right	Opposite of nominal
Maximum stroke (mm)	6.0	6.7	6.7	6.7

Figure B-2: Pivoting stroke test setup
