AVIATION INVESTIGATION REPORT

A12W0088

LOSS OF CONTROL AND COLLISION WITH TERRAIN

ROBINSON HELICOPTER R44 II, C-GHZN

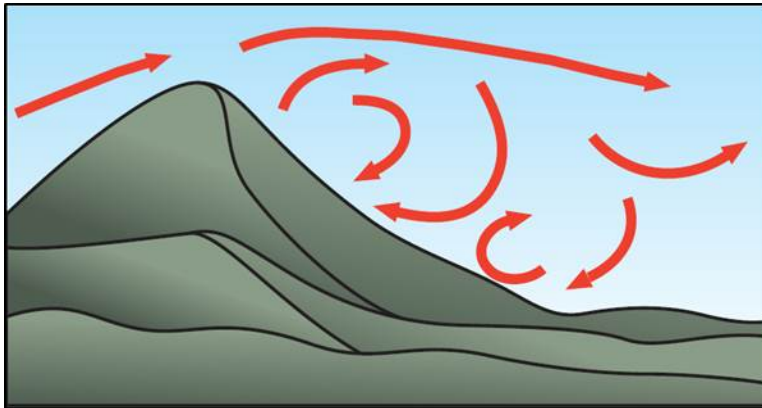
Lee effects

When the winds blow against a steep cliff or over rugged terrain, gusty turbulent winds result. Eddies often form downwind of the hills, which create stationary zones of stronger and lighter winds. These zones of strong winds are predictable, and usually persist as long as the wind direction and stability of the air stream do not change. The lighter winds, which occur in areas called wind shadows, can vary in speed and direction, particularly downwind of higher hills. In the lee of the hills, the wind is usually gusty and the wind direction is often completely opposite to the wind blowing over the top of the hills. Smaller reverse eddies may also be encountered close to the hills. ⁷

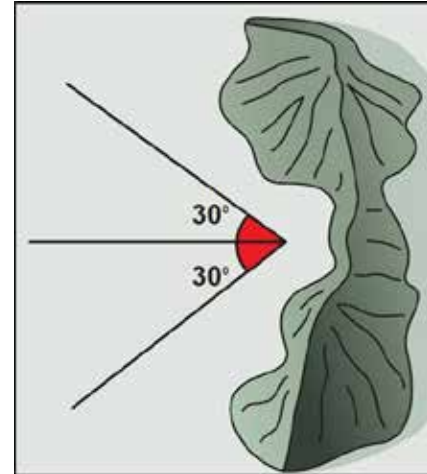
Angles for lee wave development

The development of lee waves requires that several conditions be met:

- (a) the wind direction must be within 30 degrees of perpendicular to the mountain or hill. The greater the height of the mountain and the sharper the drop-off to the lee side, the more extensive are the induced oscillations.
- (b) wind speed should exceed 15 knots for small hills and 30 knots for mountain ridges. A jet stream with its associated strong winds below the jet axis is an ideal situation.
- (c) the wind direction should be constant while increasing in speed with height throughout the troposphere. The air is stable near the mountain peaks but less stable below. The unstable layer encourages the air to ascend and the stable layer encourages the development of a downstream wave pattern.
