AIR TRANSPORTATION SAFETY INVESTIGATION REPORT A17Q0030

MID-AIR COLLISION

Cargair Ltd., Cessna 152, C-GPNP

Cargair Ltd., Cessna 152, C-FGOI

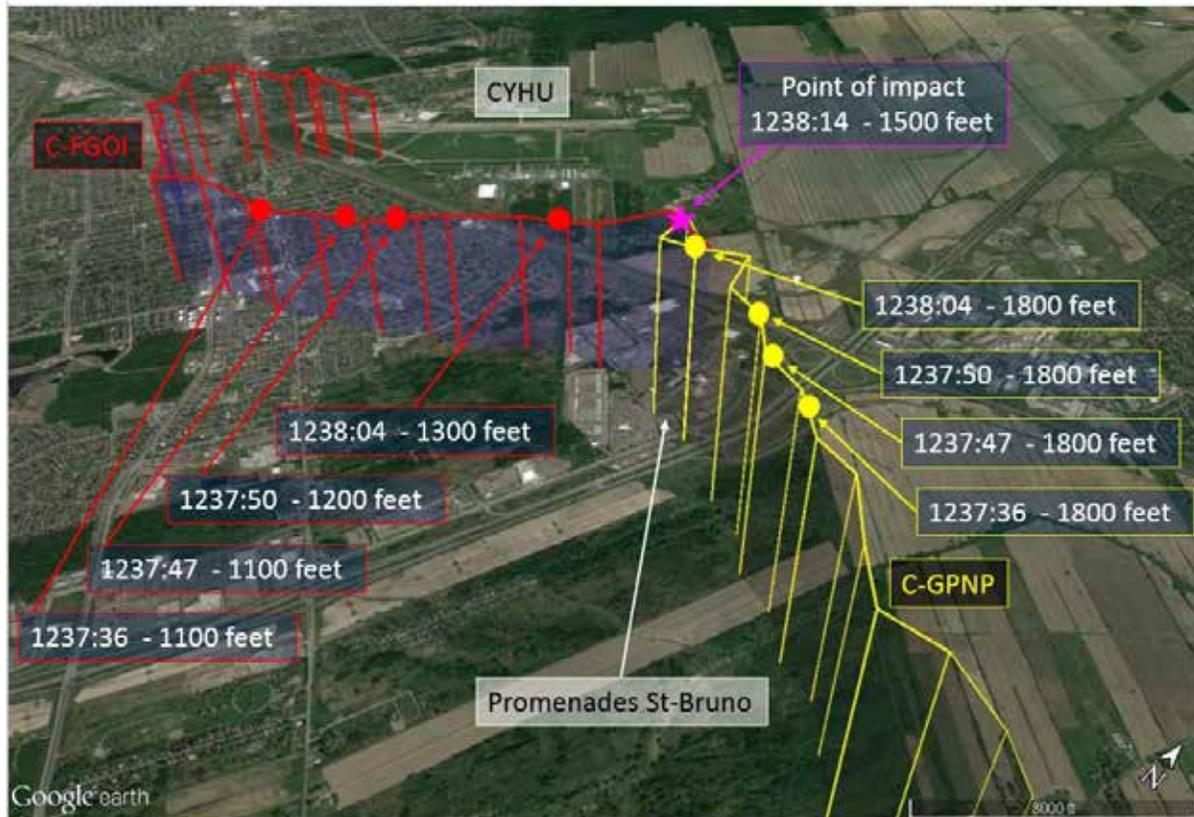
Figure 1. Flight paths of C-FGOI and C-GPNP (Source: Google Earth, with TSB annotations)

At 1237:36, the tower controller provided C-GPNP with traffic information³ about C-FGOI.⁴ The 2 aircraft were approximately 1.8 nm apart; C-GPNP was inbound from the southeast at 1800 feet ASL, and C-FGOI was at 1100 feet ASL on an east-northeast heading (Figure 1). When the controller had heard no acknowledgment from C-GPNP of the traffic information after 11 seconds, the controller repeated the transmission. The distance between the 2 aircraft had narrowed to 1.3 nm: the radar display showed C-GPNP at 1800 feet ASL and C-FGOI at 1100 feet ASL.

At 1238:04, the tower controller made a further attempt to communicate with C-GPNP, and again heard no reply. C-GPNP and C-FGOI were now approximately 0.5 nm apart; the radar display showed that C-GPNP was at 1800 feet ASL, while C-FGOI had begun climbing and was at 1300 feet ASL.

When the pilot of C-GPNP realized that the tower controller could not hear his responses, he began to troubleshoot the aircraft's radiocommunication system, and the aircraft descended below 1600 feet. By the time he saw C-FGOI, the impact was imminent and the collision could not be avoided.
