AIR TRANSPORTATION SAFETY INVESTIGATION REPORT A19O0063

GROUND COLLISION AND EVACUATION

Jazz Aviation LP
DHC-8-311, C-FJXZ
and
Menzies Aviation
Rampstar Fuel Tanker
Toronto/Lester B. Pearson International Airport, Ontario
10 May 2019

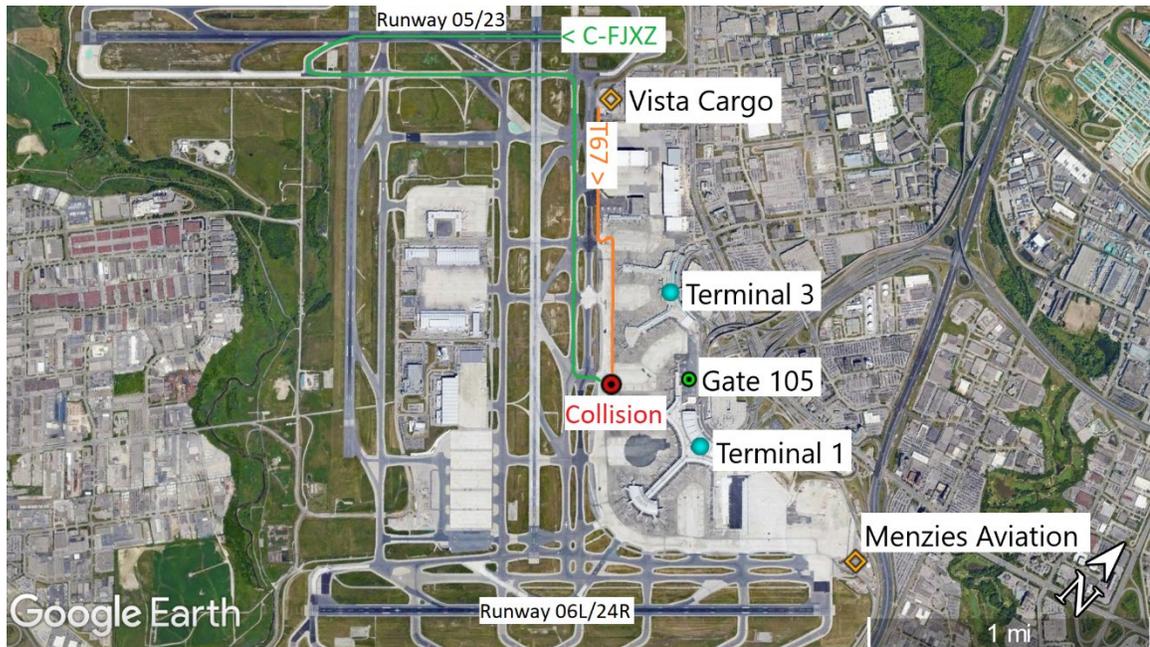
Figure 1. Overview of the airport showing the occurrence aircraft's taxi route (C-FJXZ, green line) and the fuel tanker's route (T67, orange line) (Source: Google Earth, with TSB annotations)

At 0127, the driver of a Rampstar fuel tanker operated by Menzies Aviation had been fuelling an aircraft on the Vista Cargo ramp, which was located near the northeast corner of the airport, just south of the threshold of Runway 23. Having finished his shift, the driver was returning to the Menzies Aviation facility, located to the north of the threshold of Runway 24R, at the eastern edge of the airport (Figure 1).

According to the Greater Toronto Airports Authority (GTAA) *Airport Traffic Directives*, the inner vehicle corridors shall be used to transit between gates while the outer perimeter corridors shall be used to transition between terminals, which minimizes traffic around the terminals.⁴ However, because the pavement appeared to be uneven and there appeared to be potentially hazardous conditions on the outer perimeter corridor, the driver of the fuel truck used the inner vehicle corridor.

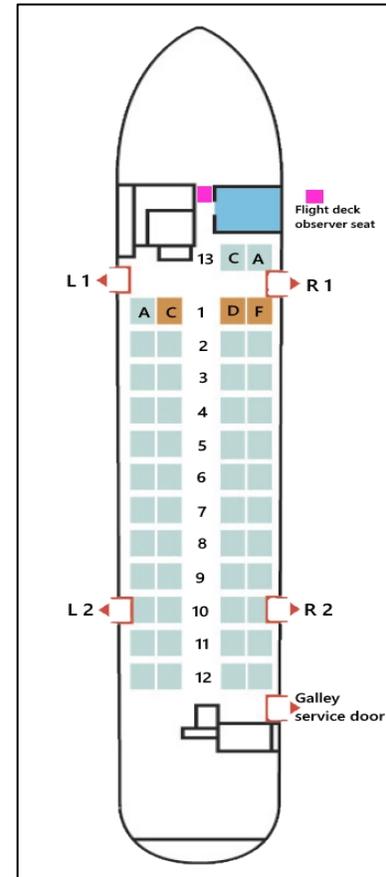
Figure 5. The occurrence aircraft's seat map (Source: Jazz Aviation LP,⁹ with TSB annotations)

The aircraft has 4 exits designated as emergency exits on the passenger briefing card, with 1 of those being the main exit door, which is designated L1 (Figure 5). Because the airstairs are incorporated into this door, the door does not contain a window or viewing port. A 2nd front emergency exit door (R1) is located across from the main door (L1). It does contain a window, and the sill height is the same as that of the main entry door (flush with the cabin floor, approximately 42 inches above ground level).

The rear emergency window exits, designated L2 and R2, are smaller than exits L1 and R1 and have a sill height of approximately 23 inches above the cabin floor and approximately 65 inches above the ground. A galley service door located behind row 12 on the right-hand side of the aircraft is not considered an emergency exit, but could be used as a means of egress as a last resort.¹⁰

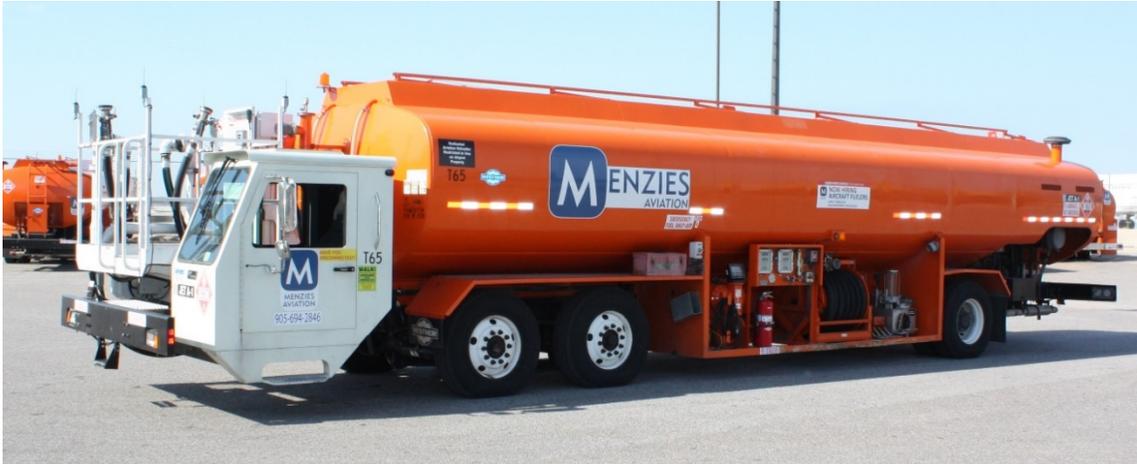
Figure 6. Rampstar fuel tanker identical to the occurrence vehicle (Source: TSB)

The fuel tanker was a Rampstar RFRD Series fuel tanker (Figure 6), (Model RF10-RD-2-1C), manufactured in 2014 by Engine & Accessory Manufacturing Inc. The company, based in Miami, Florida, United States, specializes in off-highway custom-built chassis for aviation refuelling and ground support equipment. The fuel tanker has a gross vehicle weight rating of 49 895 kg (110 000 pounds).

Records indicate that the fuel tanker was inspected and maintained in accordance with the Menzies Aviation maintenance schedule. At the time of the collision, all appropriate exterior lights were operable and switched on.

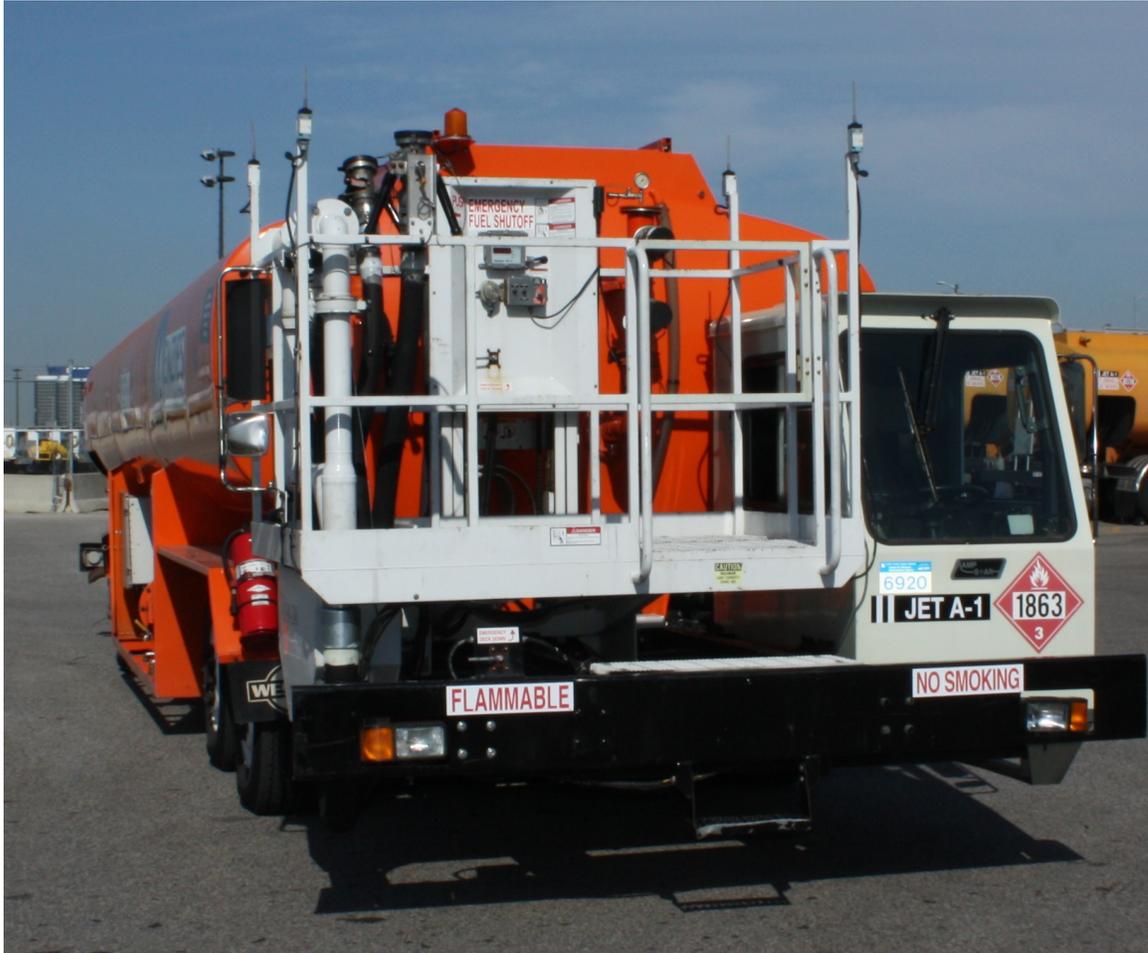
Figure 7. Front view of tanker, identical to the occurrence vehicle (Source: TSB)

The front elevating service platform is located on the front right side of the tanker, occupying approximately $\frac{2}{3}$ of the frontal area of the truck. The platform is surrounded by safety rails, which provide fall protection for the operator, as well as a structure on which to mount the hoses and nozzles required to refuel aircraft (Figure 7).

There is a side-view mirror attached to the right side of the platform: the mirror occupies one of the few areas where a sightline to the right is available to the operator. The lower horizontal bars of the guardrail, located immediately adjacent to the right-hand window in the driver's cab, directly obstruct the field of view; they are located at a position where they block a direct line of sight from the eye height of many drivers (Figure 8).

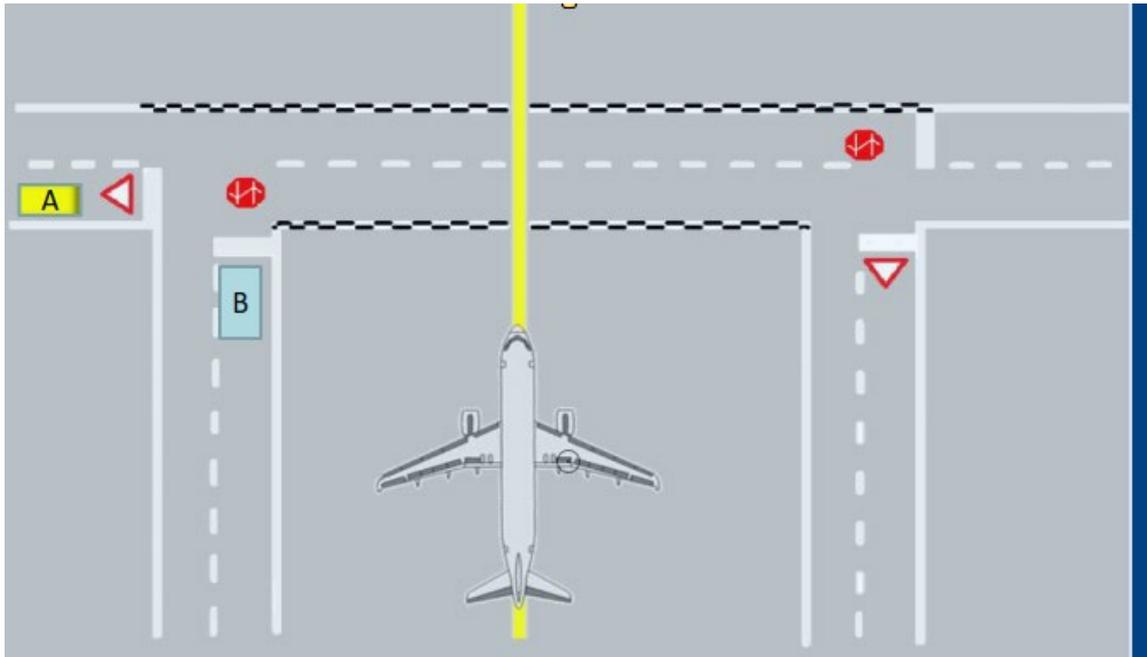
Figure 9. Paint markings outlining a connecting corridor at the Toronto/Lester B. Pearson International Airport (Source: Greater Toronto Airports Authority, D Airside Vehicle Operator's Permit (AVOP) training presentation)

Connecting corridors are marked by parallel checkered white lines on both the outer perimeter corridors and the inner vehicle corridors. They indicate areas where vehicle traffic will be crossing marked aircraft taxiways or taxilanes. They allow vehicular traffic to transit between terminal areas, as well as between the inner and outer corridors. Aircraft warning markings indicate to drivers that they are about to enter a connecting corridor (Figure 9).

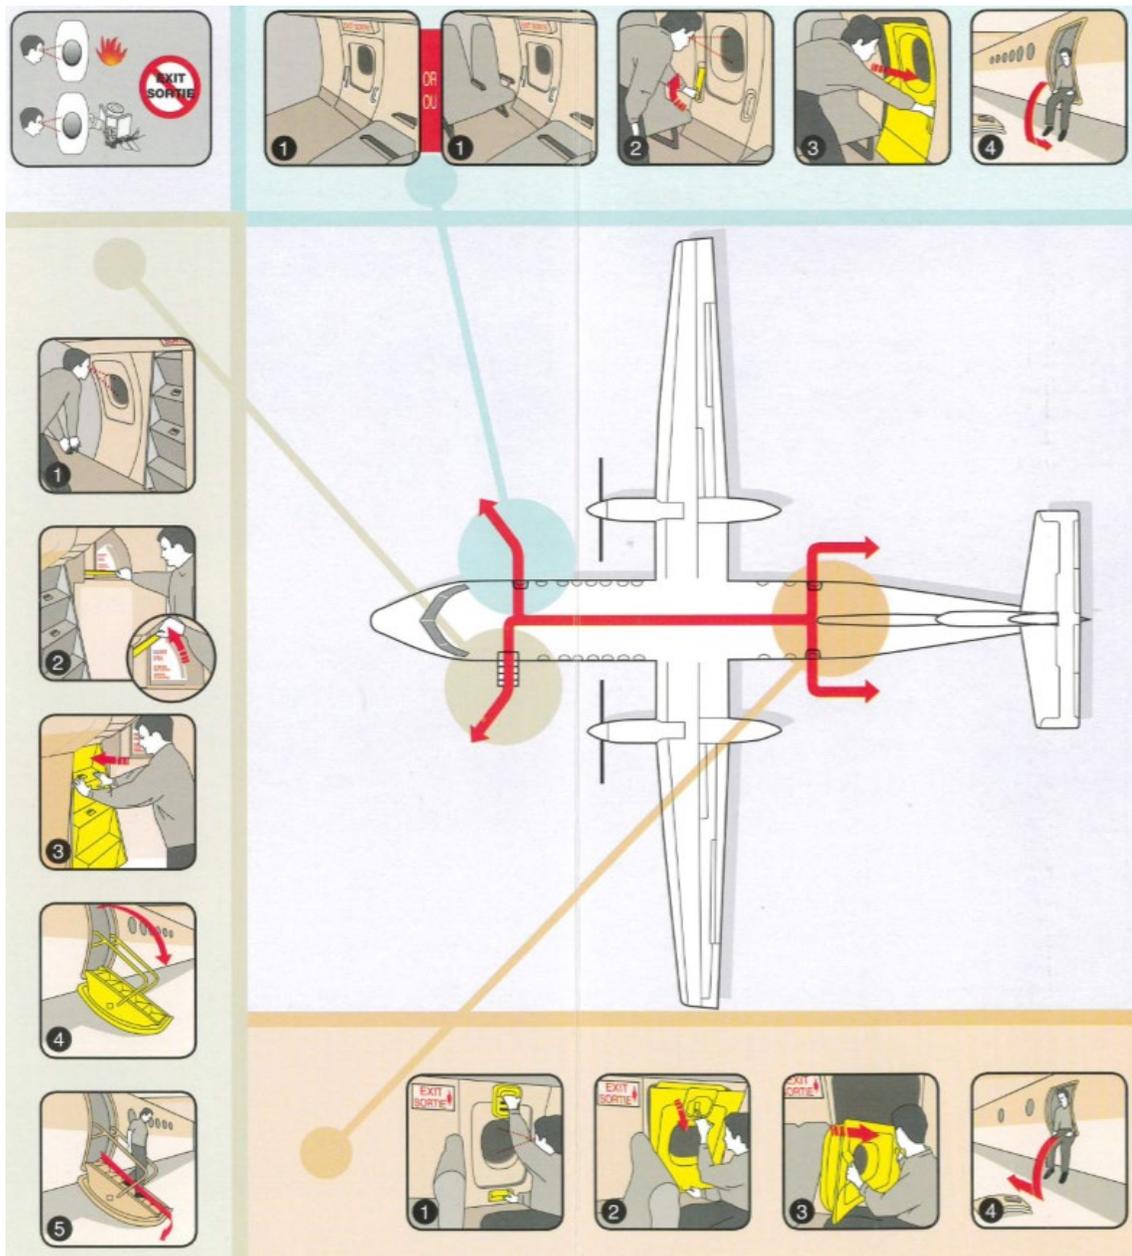
Figure 10. Jazz passenger safety briefing card excerpt showing use of emergency exits (Source: Jazz Aviation LP)

The window exit was not equipped with stairs or an inflatable slide, nor were either required by regulations. Instructions found on the passenger safety briefing card²⁰ (Figure 10) indicate that, when using the emergency window exits, passengers should first sit on the sill of the exit, then push away from the aircraft. This technique reduces the overall height of the jump. At the same time that the 2 passengers were exiting the R2 exit, another passenger opened the left-hand rear emergency window exit (exit L2), but closed it immediately because the fuel tanker was nearby, and the smell of exhaust and noise of the engines entered the cabin.
