AIR TRANSPORTATION SAFETY INVESTIGATION REPORT A21Q0090

COLLISION WITH WATER AND CAPSIZING

Privately registered
Piper PA-18S-150 (floatplane), C-FVPZ
Rivière du Lièvre, Ferme-Neuve, Quebec
24 September 2021

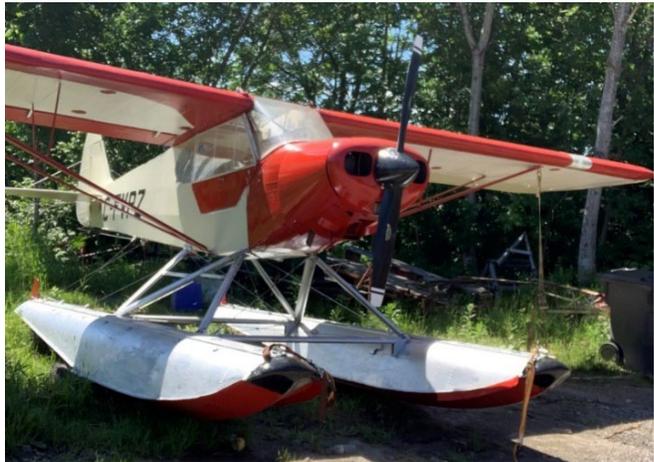
Figure 2. Photo of the occurrence aircraft (Source: Family of the aircraft owner)

The PA-18S-150 is a 2-seat tandem aircraft (the pilot is seated in the front and the passenger is seated in the rear). The occurrence aircraft was manufactured by the Piper Aircraft Corporation in 1967 (Figure 2). According to the aircraft's journey log, it had accumulated 3519.7 flight hours since it was manufactured, but flights conducted in 2021 had not been recorded in the log.
