AIR TRANSPORTATION SAFETY INVESTIGATION REPORT A22W0027

IN-FLIGHT ICING AND COLLISION WITH TERRAIN

Privately registered
Mooney M20K, C-GQMS
Calgary/Springbank Airport, Alberta, 0.6 NM S
22 April 2022

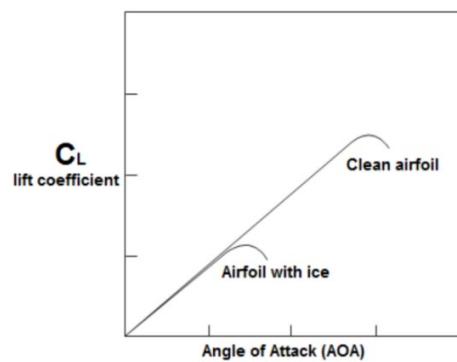
Figure 5. Graph showing how ice affects the coefficient of lift for an airfoil (Source: Federal Aviation Administration, Advisory Circular AC 91-74B: Pilot Guide: Flight in Icing Conditions [August 2015], Figure 3-5.)

As described in AC 91-74B, the accumulation of even a small amount of ice on an airfoil⁸ in flight significantly reduces the maximum amount of lift available at any given airspeed or angle of attack, and significantly reduces the angle of attack at which a stall occurs (Figure 5). It is not unusual for the maximum coefficient of lift to be reduced by 30%.⁹

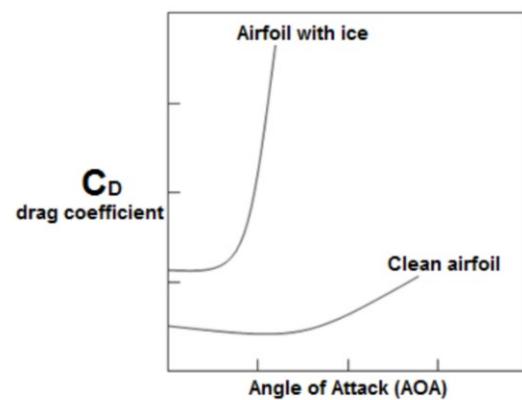
Figure 6. Graph showing how ice affects the drag coefficient of an airfoil (Source: Federal Aviation Administration, Advisory Circular AC 91-74B: Pilot Guide: Flight in Icing Conditions [August 2015], Figure 3-6.)

The accumulation of ice also has a detrimental effect on the drag of an airfoil (Figure 6). This means that as ice accumulates on the surface of the airfoil, the drag increases significantly and quickly as the angle of attack increases. It is not unusual for drag to increase by 100%.¹⁰

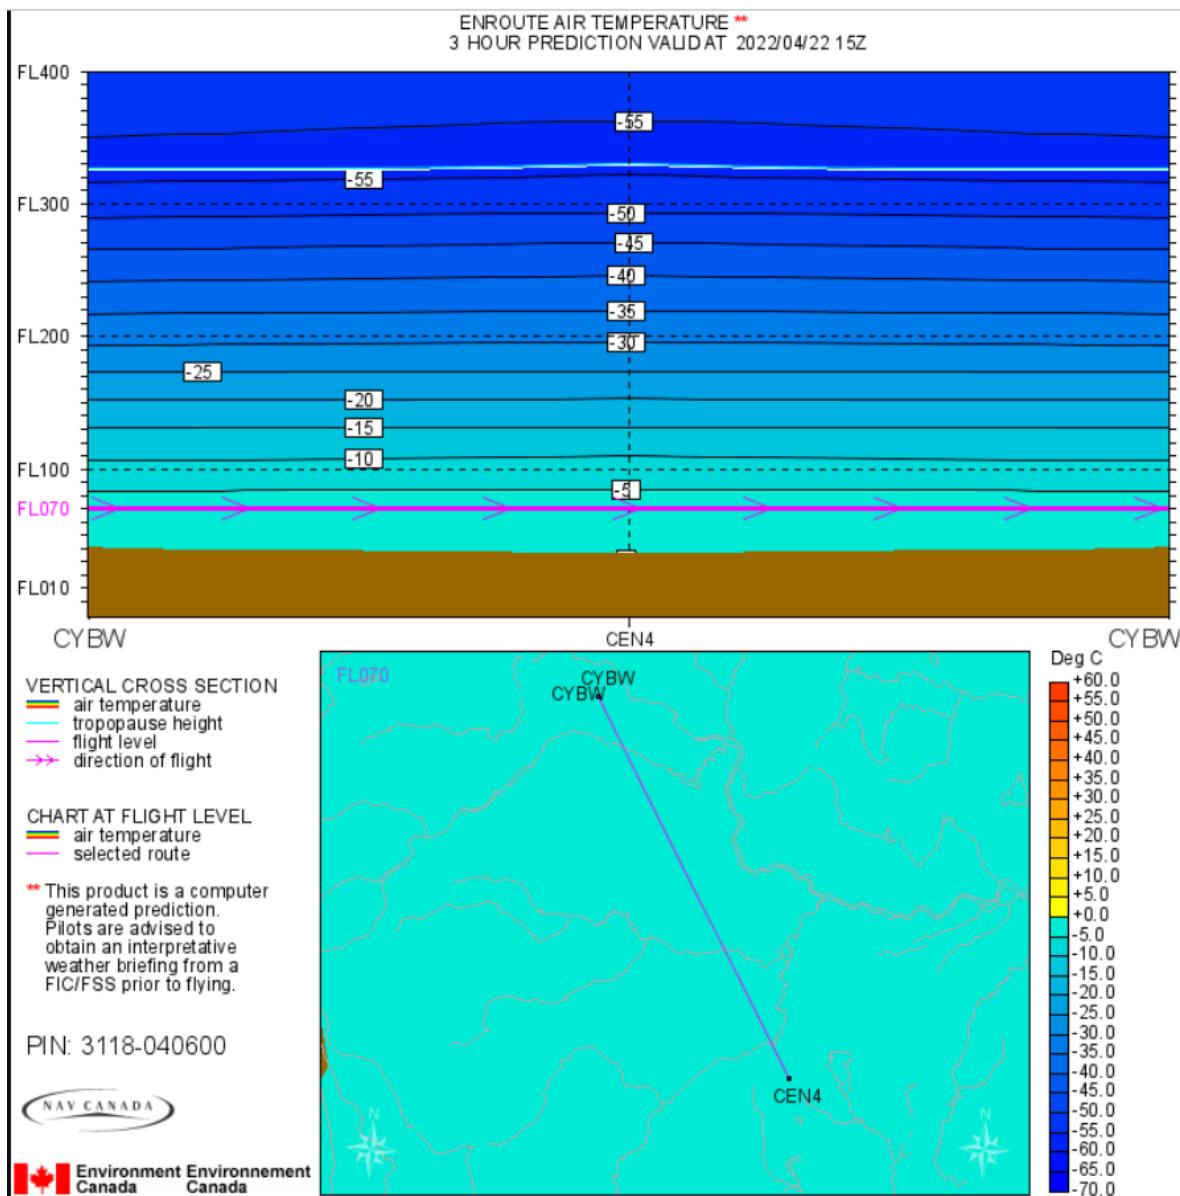
Figure A1. Enroute air temperature chart (Source: NAV CANADA)

In addition to the weather information products mentioned above, pilots can consult NAV CANADA's automated supplementary enroute weather predictions (ASEP) page from the Aviation Weather Web Site.⁵ Appendix A provides samples of the graphic depictions of the conditions between 0900 and 1200 on the day of the occurrence. These graphics depict the potential for an aircraft to experience in-flight icing in the vicinity of the planned flight route and at the planned altitude.
