**MARINE INVESTIGATION REPORT**  
**M06W0052**

**STRIKING AND SUBSEQUENT SINKING**

**PASSENGER AND VEHICLE FERRY *QUEEN OF THE NORTH***  
**GIL ISLAND, WRIGHT SOUND, BRITISH COLUMBIA**  
**22 MARCH 2006**

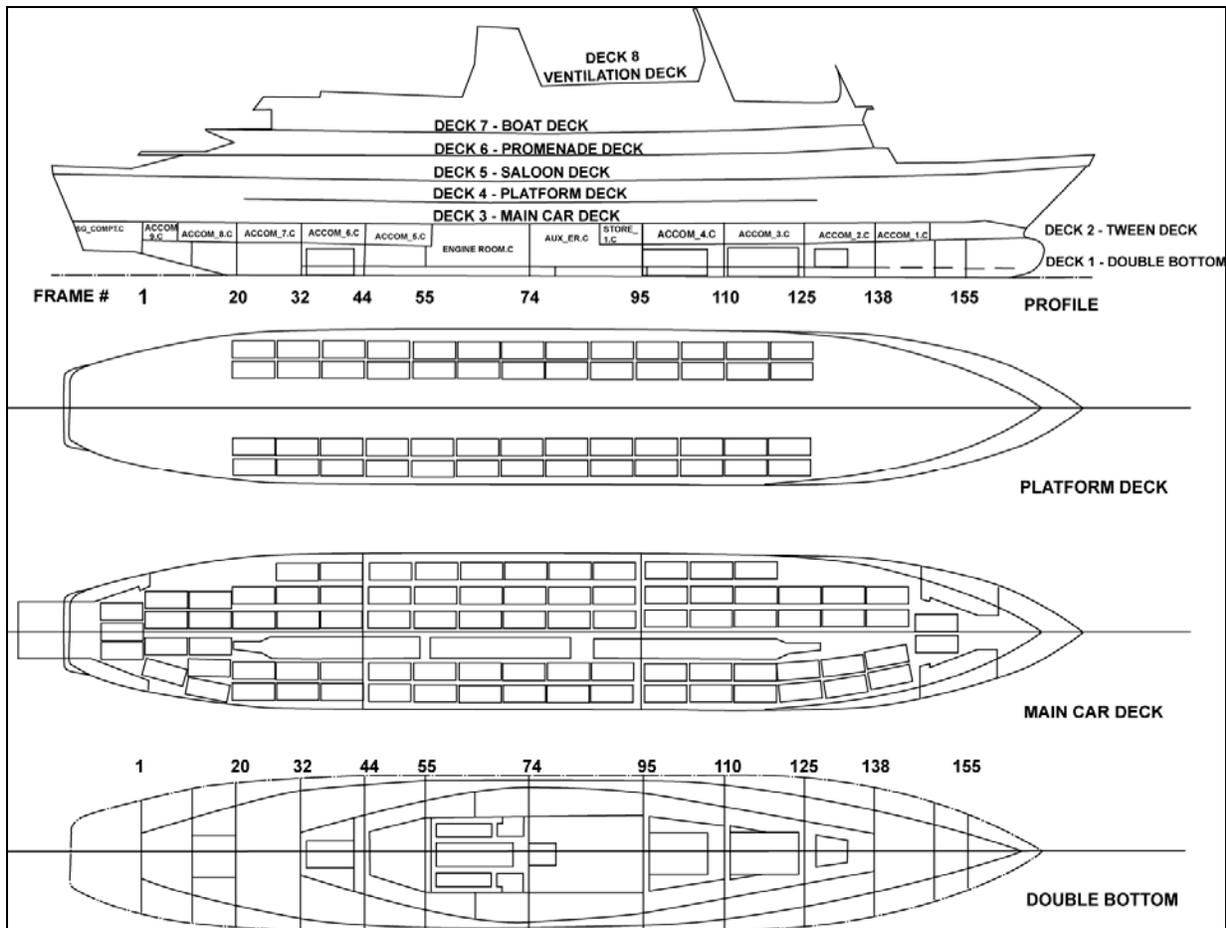
Figure 1. General arrangement

When the vessel struck the island, the starboard-side hull plating was ruptured along the keel at the forward end and also in way of at least two other main watertight compartments: the main engine room, and one crew accommodation area aft on Deck 2, including the workshop below. Although a more detailed assessment was not possible due to the limited information available from crew members and the disposition of the vessel in the silt, it is known that at least three main compartments experienced initial flooding.
