**MARINE INVESTIGATION REPORT  
M13N0001**

**LOSS OF TOW**

**TUG *CHARLENE HUNT* WITH  
PASSENGER VESSEL *LYUBOV ORLOVA*  
OFF CAPE RACE, NEWFOUNDLAND AND LABRADOR  
24 JANUARY 2013**

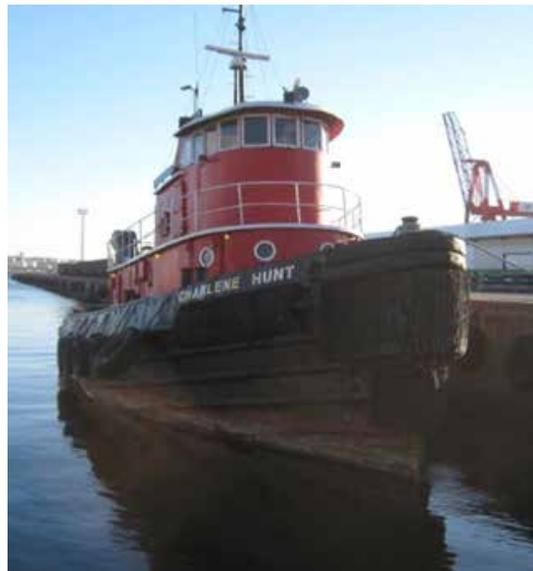
The *Charlene Hunt* is a coastal tug of steel construction that was built in 1962 (Photo 1). The vessel has a single propeller and rudder. The conning station, located in the wheelhouse that sits atop the deckhouse, is fitted with navigational equipment including radars, very high frequency radiotelephones, GPS, an automatic identification system, an electronic chart plotter, and an autopilot. The deckhouse includes a galley, storerooms, and accommodations. The towing winch is located aft of the deckhouse on the main deck. The *Charlene Hunt* also has an on-board satellite weather system used for instant access to weather and sea condition data.

Photo 1. *Charlene Hunt* (photo: Alan Knight)

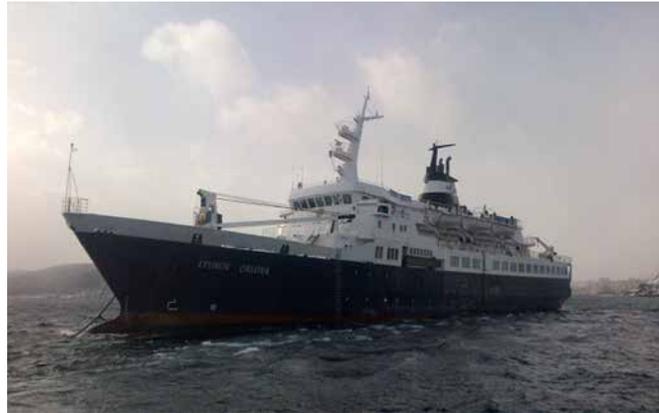
The *Lyubov Orlova* was of typical passenger vessel construction (Photo 2). It was ice-strengthened and had been used for charter adventure cruises in the Arctic prior to being decommissioned in 2010 for financial reasons. The vessel's superstructure extended three-quarters the length of the vessel. The vessel had 2 fixed-pitch propellers and 2 rudders. There was no power on board, and the vessel's dead weight was 4160 tons.

Photo 2. *Lyubov Orlova*, January 2013
