MARINE INVESTIGATION REPORT M15A0348

Person overboard and subsequent loss of life

Small fishing vessel *Cock-a-Wit Lady*
23 nautical miles SSW of
Clark's Harbour, Nova Scotia
30 November 2015

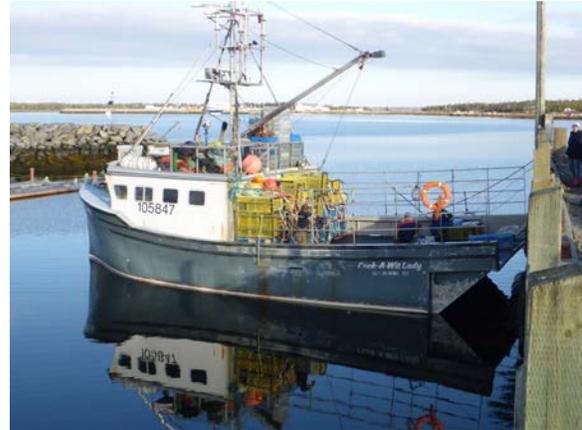
Photo 1. *Cock-a-Wit Lady*

The *Cock-a-Wit Lady* is a small, open-construction fishing vessel of the Cape Island design, built from moulded, glass-reinforced plastic. The wheelhouse and accommodation are forward of midships, and the engine room is beneath the wheelhouse (Photo 1). The wheelhouse can be accessed via doors on its starboard and aft sides. Access to the engine room is through a covered hatch in the wheelhouse.
