RAILWAY INVESTIGATION REPORT R15M0034

**MAIN-TRACK DERAILMENT
CANADIAN NATIONAL RAILWAY
FREIGHT TRAIN M30511-17
MILE 212.8, NAPADOGAN SUBDIVISION
SAINT-BASILE, NEW BRUNSWICK
17 APRIL 2015**

Railway Investigation Report R15M0034

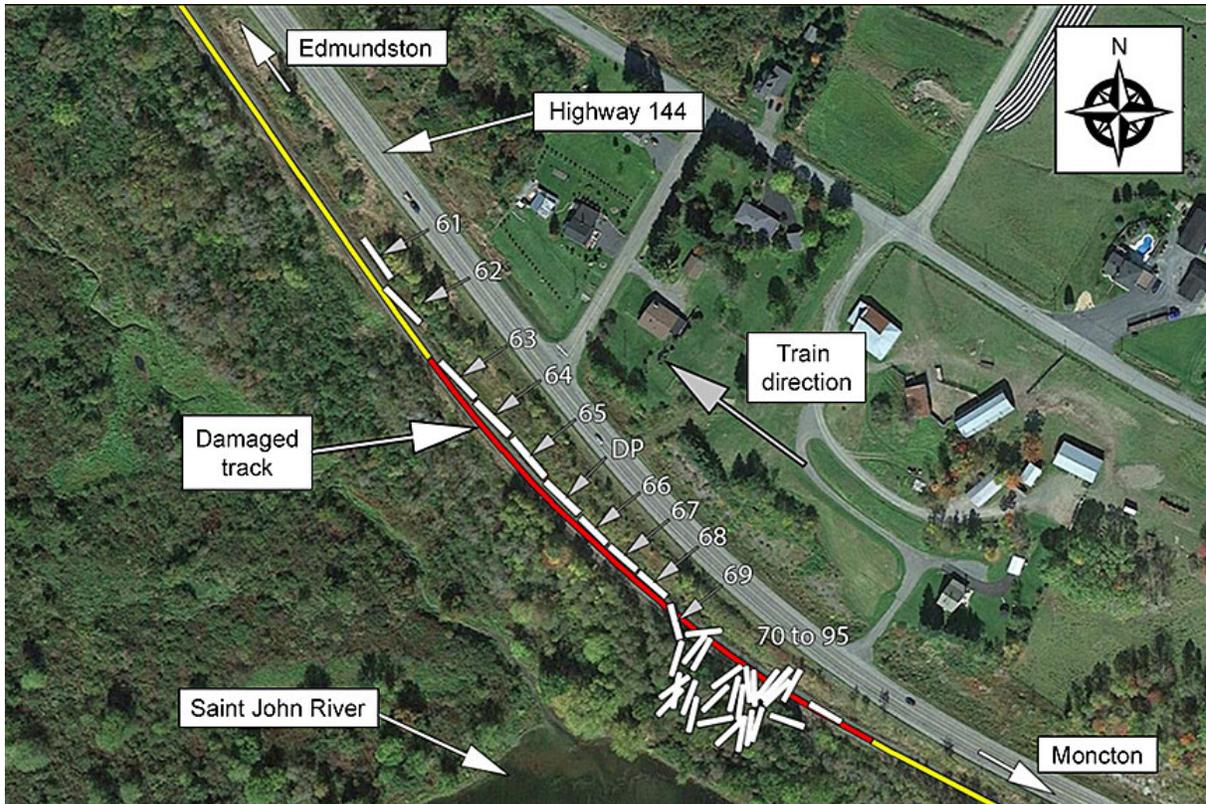
Figure 2. Site diagram identifying equipment in positions 61 to 95 (Source: Google Earth, Image © 2015 DigitalGlobe, with TSB annotations)

- The head-end locomotives and the first 60 cars had separated, and the 60th car came to a stop on the main track approximately 1500 feet west of the derailment site.
- The 61st to 95th cars had derailed (Photo 1 and Photo 2). The last derailed car was in position 95.
- The trailing 65 cars (that is, positions 96 to 160) of the train consist had remained on the track.
- The derailed cars consisted of 5 centre beam flat cars carrying lumber, 1 flat car carrying wallboard, 8 box cars carrying paper, 20 residue tank cars (Class 111) that had last contained petroleum crude oil (UN 1267, Class 3), and 1 empty hopper car.
- The DP locomotive, which was located between the 65th and 66th cars, derailed and came to rest with its leading end near Mile 212.87.
- The derailment destroyed about 900 feet of track, extending from Mile 212.93 to Mile 212.76.

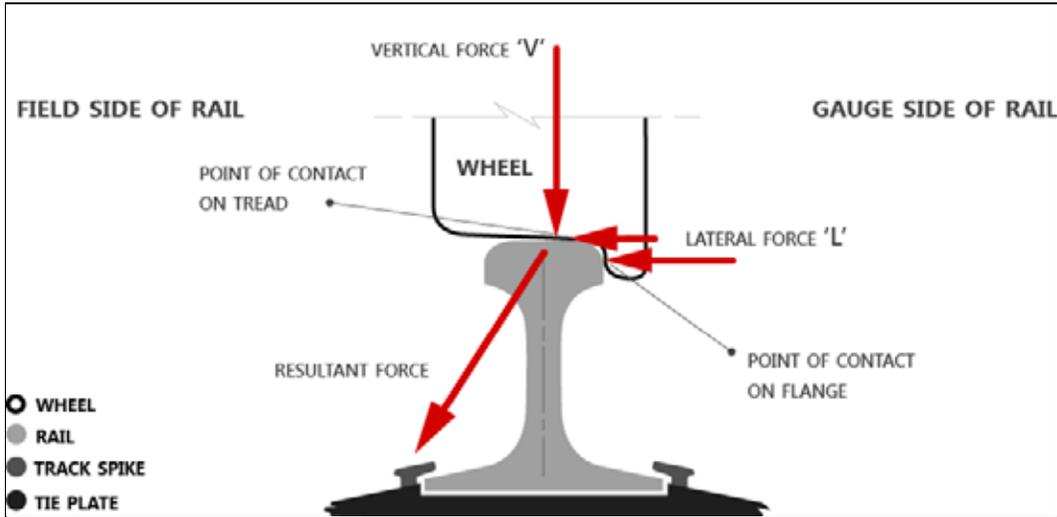
Figure 4. Lateral to vertical forces between wheel and rail (Source: Association of American Railroads)

The traditional L/V threshold for rail rollover on a loaded car is 0.65. If the resultant force acts beyond the outer edge of the rail base, rail rollover can occur (Figure 4).

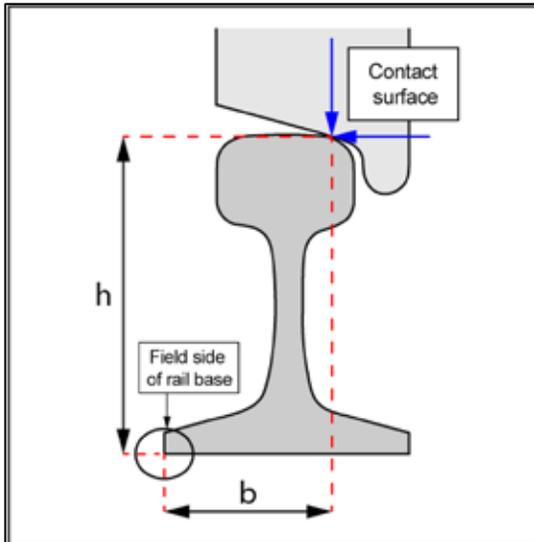
Figure 5. Rail stability diagram (Source: TÜV Rheinland Rail Sciences, with TSB annotations)

The lateral stability of a rail is linked to its b/h ratio (Figure 5). The b/h ratio represents the lateral dimension to the field side of the rail base relative to the height of the contact surface.⁸ Under equilibrium conditions, just before the rail starts to rotate and roll over, the resultant force created by the lateral and vertical forces acts at the field side of the rail base.

Under normal circumstances, the wheel-to-rail contact surface is located at the inner gauge corner of the rail head. When the wheel load is shifted toward the field side, b decreases and b/h decreases. The b/h ratio can vary from greater than 0.6 for contact at the gauge side to approximately 0.2 when the contact surface shifts toward the outer edge of the rail base (the field side), as shown for the L-1 wheel of the 62nd car (Photo 8).

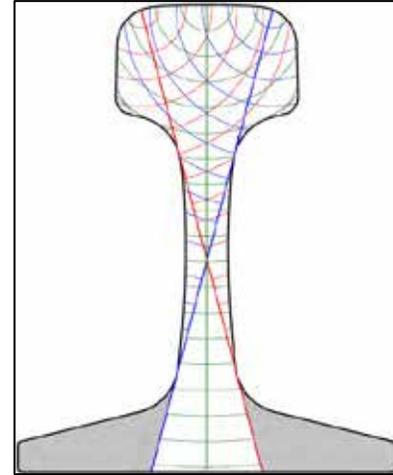
Figure 6. Grey area denotes portions of the rail base typically missed by ultrasonic rail inspection (Source: Transportation Technology Center, Inc.)

The Association of American Railroads (AAR) has determined that some defects in the base of the rail on either side of the web cannot be detected because they are outside the reflective field of current ultrasonic testing (UT) techniques (Figure 6).

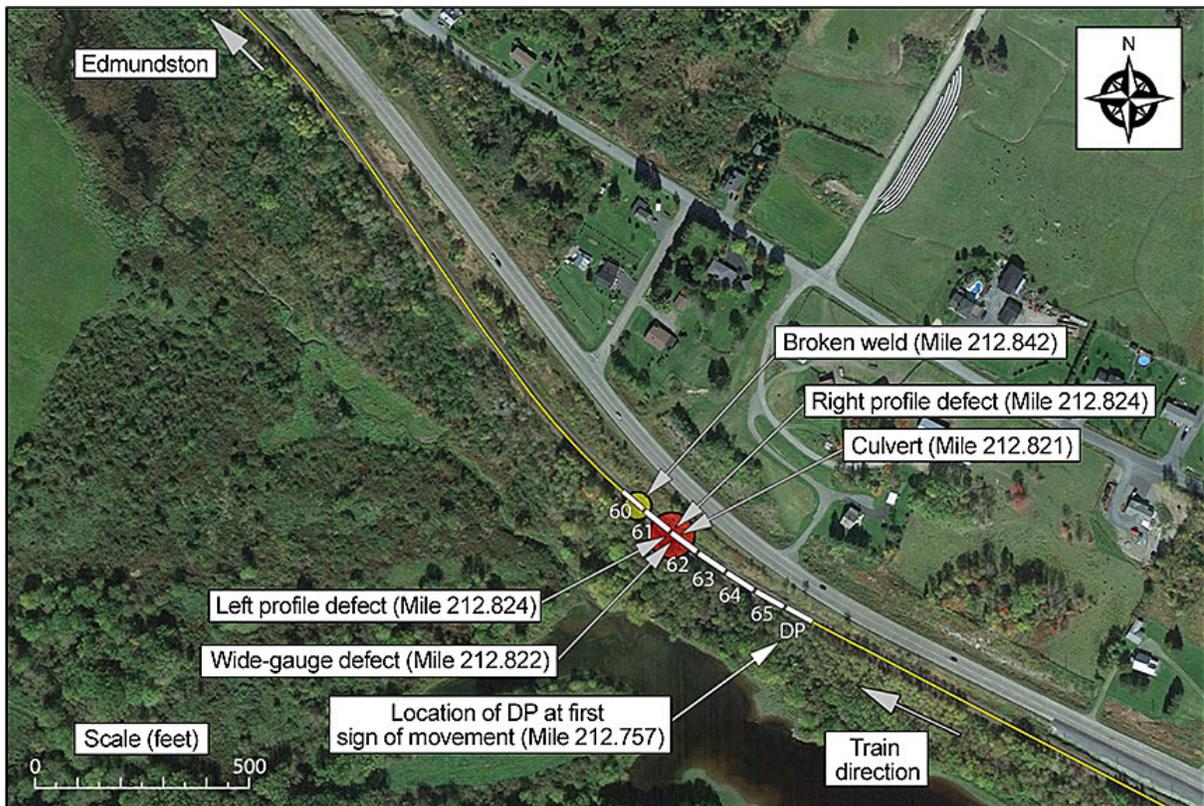
Figure 7. Location of the distributed power locomotive at first sign of movement in on-board locomotive video recording (Source: Google Earth, Image © 2015 DigitalGlobe, with TSB annotations)

When the first unusual lateral oscillation started, the DP locomotive was located at about Mile 212.75 and the second derailed car at Mile 212.82 (the location where combined gauge and surface conditions were present, as identified by the TEST car inspection). The DP locomotive came to rest approximately 600 feet west of the location where the unusual lateral oscillations began (Figure 7).
