RAIL TRANSPORTATION SAFETY INVESTIGATION REPORT R20V0185

MAIN-TRACK TRAIN DERAILMENT

Canadian National Railway Company
Freight train J60352-12
Mile 44.4, Yale Subdivision
Floods, British Columbia
14 September 2020

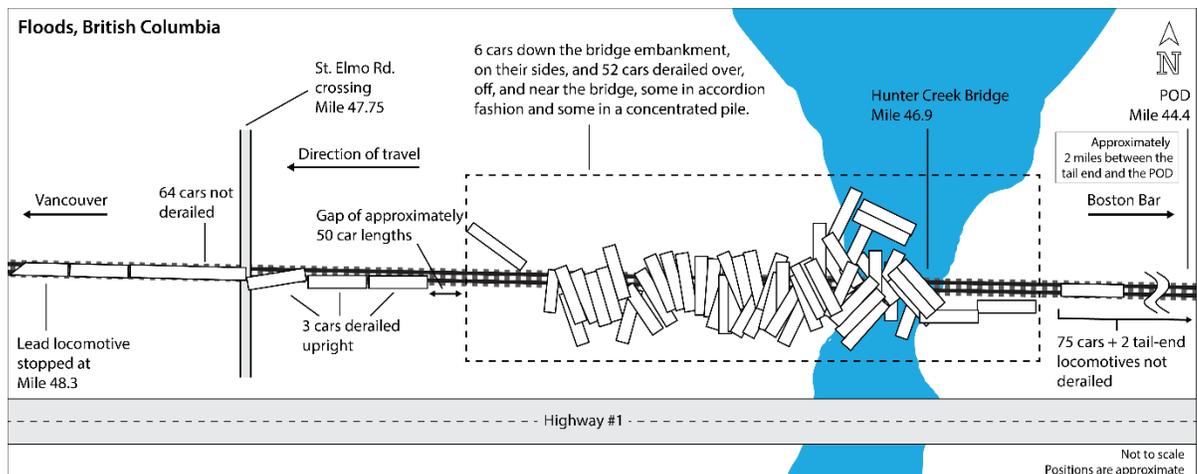
The initial point of derailment (POD) was determined to be at about Mile 44.4 of the Yale Subdivision (Figure 2).

Figure 2. Schematic of the occurrence site after the derailment (Source: TSB)

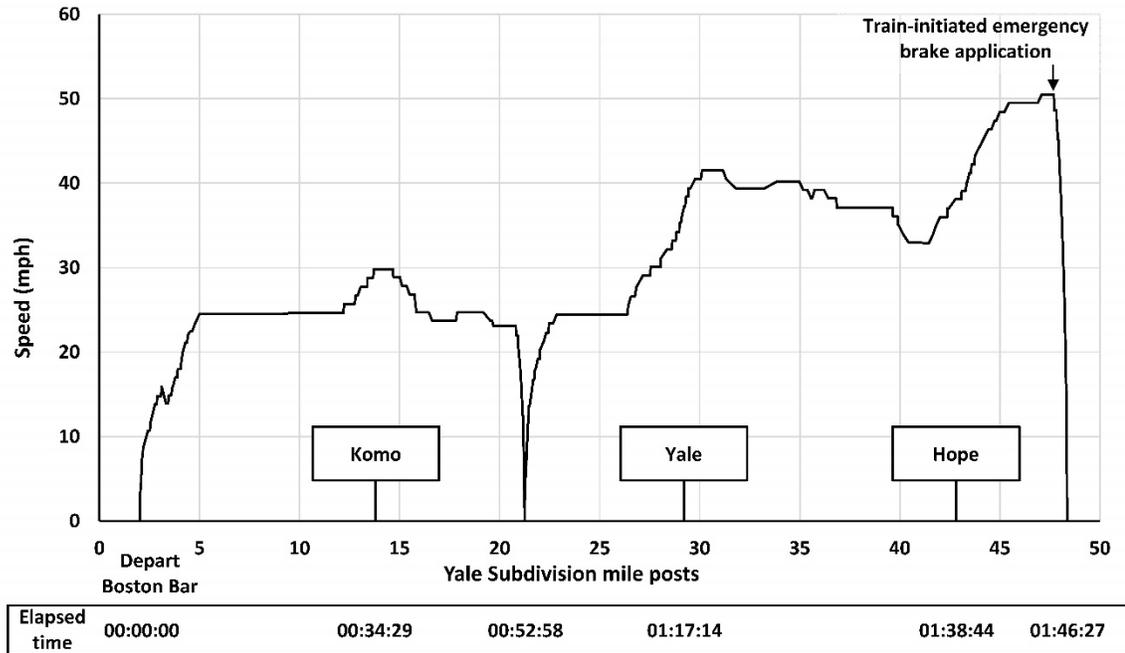
A review of the locomotive event recorder data from the lead locomotive indicates that, after departing Boston Bar and until the train-initiated emergency brake application, the train travelled just over 46 miles in about 1 hour and 46 minutes. During this time, train speed exceeded 15 mph for over 1 hour and 30 minutes and reached a maximum speed of 50 mph when the train-initiated emergency brake application occurred (Figure 13). Elevated wheel temperatures on car CNPX 3373 were sustained for the duration of the trip other than the brief 3.5-minute stop at Mile 21.2.

Figure 13. Train speed and distance travelled between Boston Bar and the occurrence location (Source: TSB)

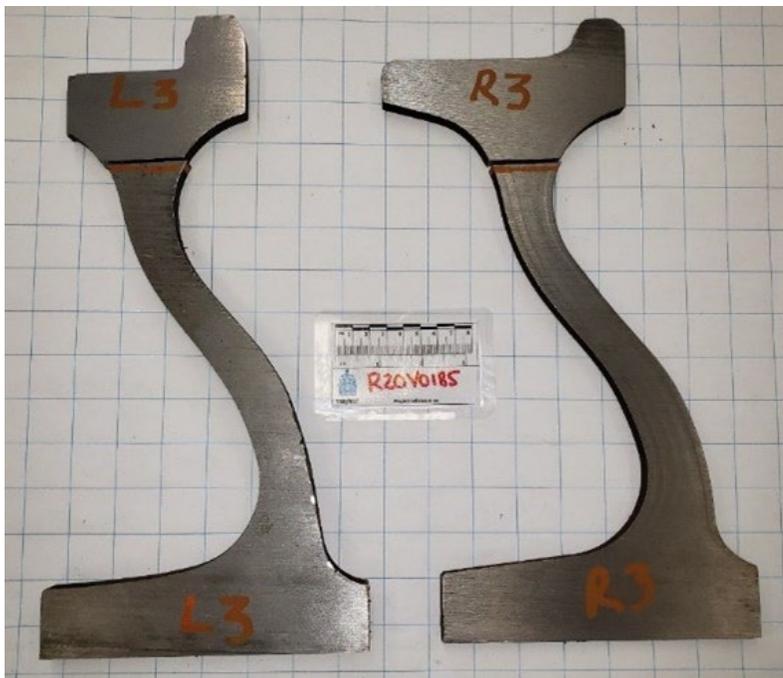
To determine axial residual stress in the L3 and R3 wheels, a radial sample from each wheel (Figure 25) was sectioned at the TSB laboratory (the rim sections were separated from the plate sections) and sent to McMaster Analytical X-Ray Diffraction Facility (MAX) for X-ray diffraction analysis.

It should be noted that the wheel tread surfaces on the R3 and L3 wheels had previously undergone some truing⁴⁸ to clean up any tread buildup and prepare the surfaces for ultrasonic inspections post-derailment. Compared to the R3 wheel, the L3 tread had required more truing due to the larger amount of scuffing damage and material buildup. To accommodate ultrasonic inspection, approximately 0.14 inches of the L3 tread surface had been removed.

Figure 25. Radial samples from the L3 wheel (on the left) and R3 wheel (on the right) sent for X-ray diffraction analysis (Source: TSB)

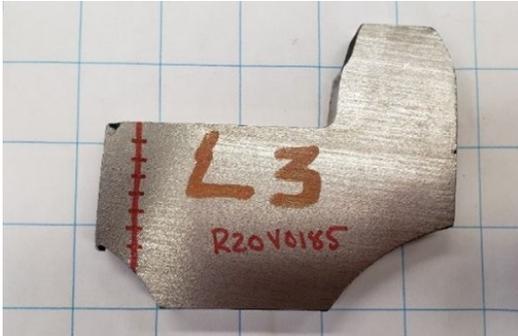
Seven measurement locations were marked along these lines (figures 26 and 27), equally spaced perpendicular to the remaining rolling surface of the tread. The distance between measurements was approximately 0.2 inches with the first measurement 0.2 inches below the worn and machined (trued) tread surface. Given that about 0.14 inches of the L3 tread surface had been removed, a measurement of 0.2 inches from the surface of the L3 section

Figure 26. Residual stress measurement locations for the L3 wheel section (Source: TSB)

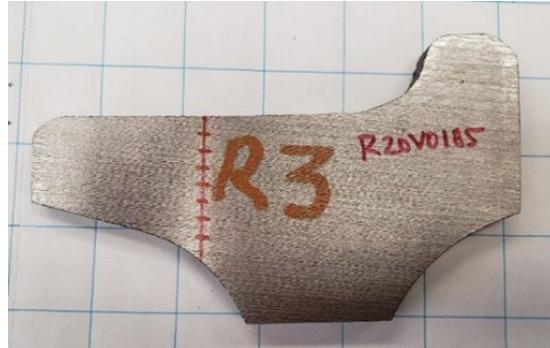
Figure 27. Residual stress measurement locations for the R3 wheel section (Source: TSB)

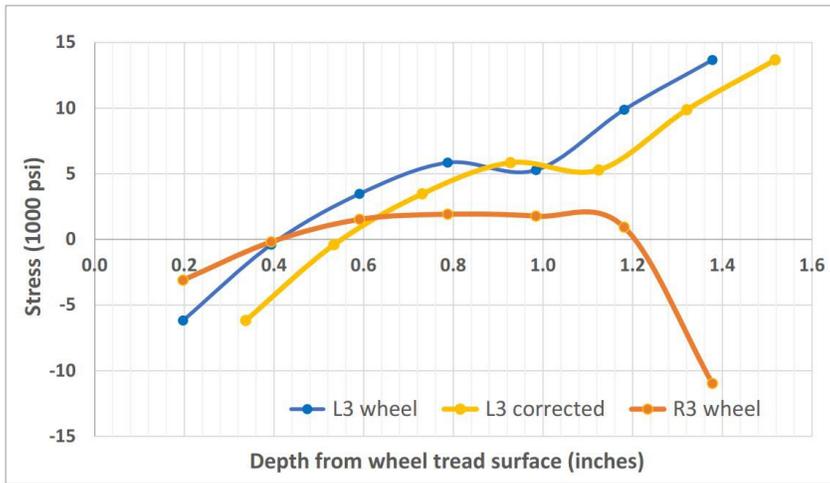
Figure 28. Axial residual stress on the L3 and R3 wheels at various depths from the tread, measured at 2 inches from the front rim face (Source of the data: McMaster Analytical X-Ray Diffraction Facility)

* The line labelled "L3 corrected" is the L3 values offset by 0.14 inches, to account for the previous wheel tread surface removal and correct the measurements to the virtual tread surface; it is thus more representative of the axial residual stress locations referenced to the original tread surface.

The data shows that the axial residual stresses were compressive in magnitude up to a depth of about 0.4 inches from the tread surface for R3 and about 0.53 inches for L3, before becoming tensile in magnitude below this depth. R3 returned to an axial residual compressive stress below about 1.2 inches. The maximum recorded axial residual tensile stress was approximately 13 500 psi for L3 and about 2000 psi for R3.

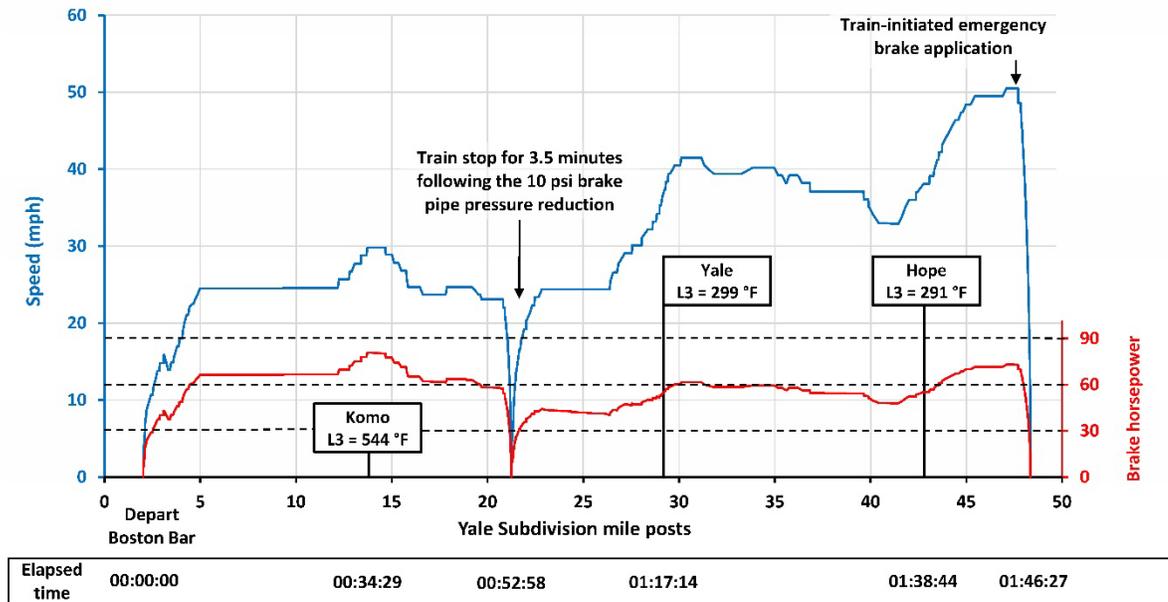
the train-initiated emergency brake application, the train travelled a distance of just over 46 miles in about 1 hour and 46 minutes; it reached a speed of 50 mph when a train-initiated emergency brake application occurred (Figure C1). During this time, train speed exceeded 15 mph for 1 hour and 30 minutes over 44.1 miles.

Figure C1. Distance-based graph showing the train speed and the calculated brake horsepower based on temperature readings of the L3 wheel from departure at Boston Bar until the major derailment near Floods (Source: TSB)*

* The graph is based on a constant brake retarding force of 1017 pounds between Boston Bar and Komo. For a fixed amount of brake retarding force, BHP varies directly with speed. Thus, for the first leg of the trip, the profile of the BHP is identical to the profile of the speed. After Komo, to model the effect of accelerated brake shoe wear, a decreasing amount of brake retarding force (and hence brake shoe force) was used in the calculations, and therefore the BHP profile does not exactly follow the speed profile.
