AIR TRANSPORTATION SAFETY INVESTIGATION REPORT A24Q0027

TOUCHDOWN SHORT OF RUNWAY

Air Inuit Ltd.

Boeing of Canada Ltd. de Havilland Division DHC-8-314, C-GAIW

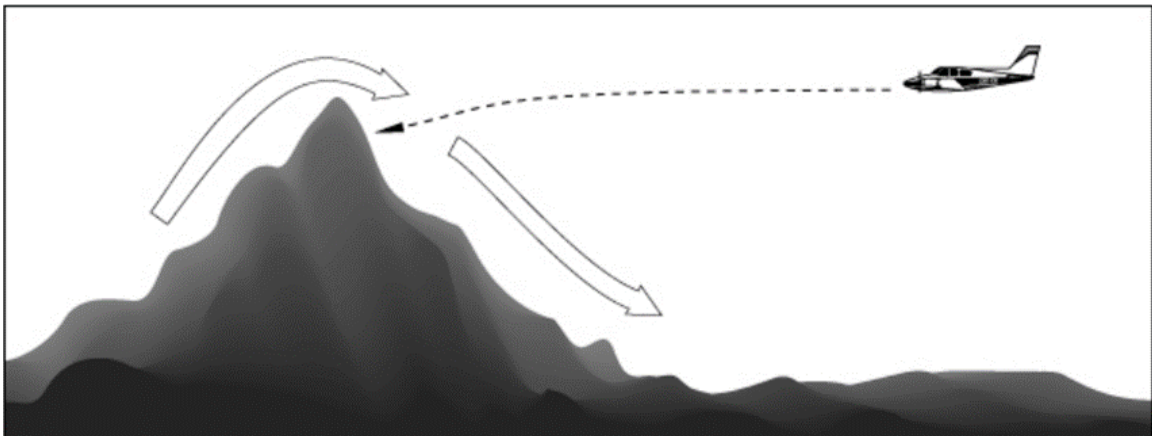
Figure 4. Windflow in mountainous areas (Source: Environment Canada, *AWARE: The atmosphere, the weather and flying* [January 2011])

When the unstable air moves over a mountain peak, which acts as a barrier, it then flows downward often in the form of relatively violent downdrafts. The speed of the descending air can sometimes exceed an aircraft's climbing ability, and cause a collision with the underfeature [Figure 4].³

Taking into account the topography around CYKG and the winds present at the time of the occurrence, the investigation determined there were likely downdrafts in the final approach area for Runway 15 at that time (Figure 5).
