AIR TRANSPORTATION SAFETY INVESTIGATION REPORT A23W0039

LANDING GEAR COLLAPSE

Northwestern Air Lease Ltd.
British Aerospace P.L.C. Jetstream Model 3112, C-FCPE
Fort Smith Airport (CYSM), Northwest Territories
14 April 2023

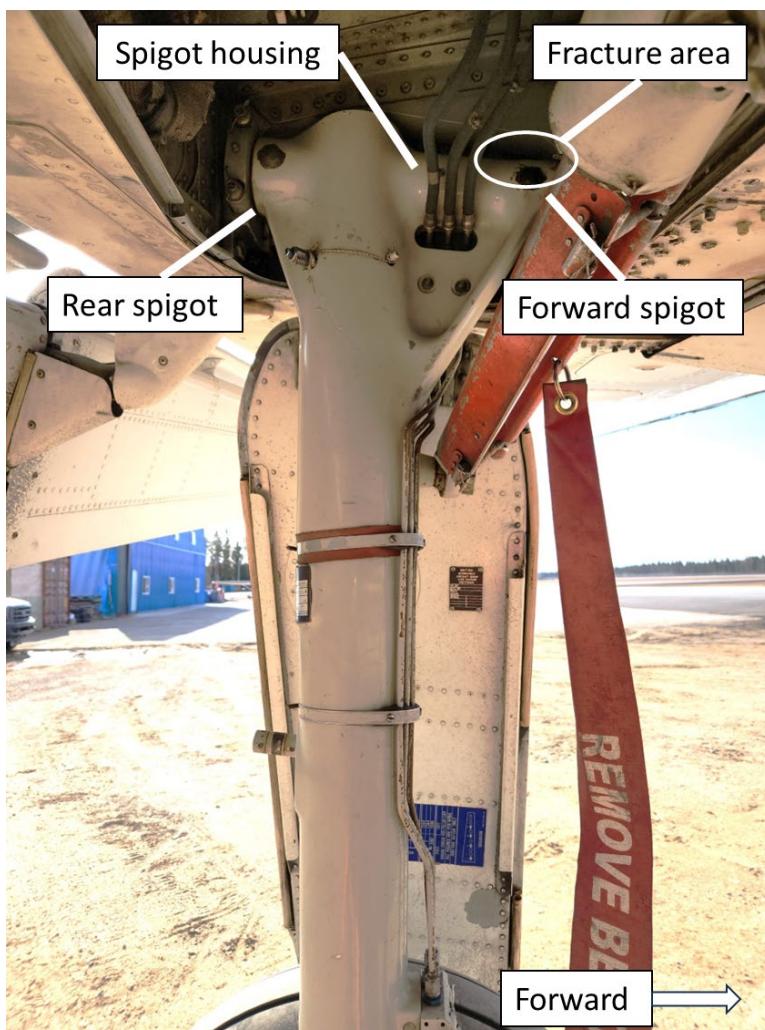
Each MLG unit is attached to the wing by half cap bearing housings mounted to the spigots through the spigot housing. During the landing of the occurrence flight, the spigot housing of the left MLG unit failed, resulting in the collapse of this MLG unit (figures 2, 3, and 4).

Figure 2. View of the left main landing gear unit on an exemplar aircraft, looking toward the wing tip (Source: TSB)

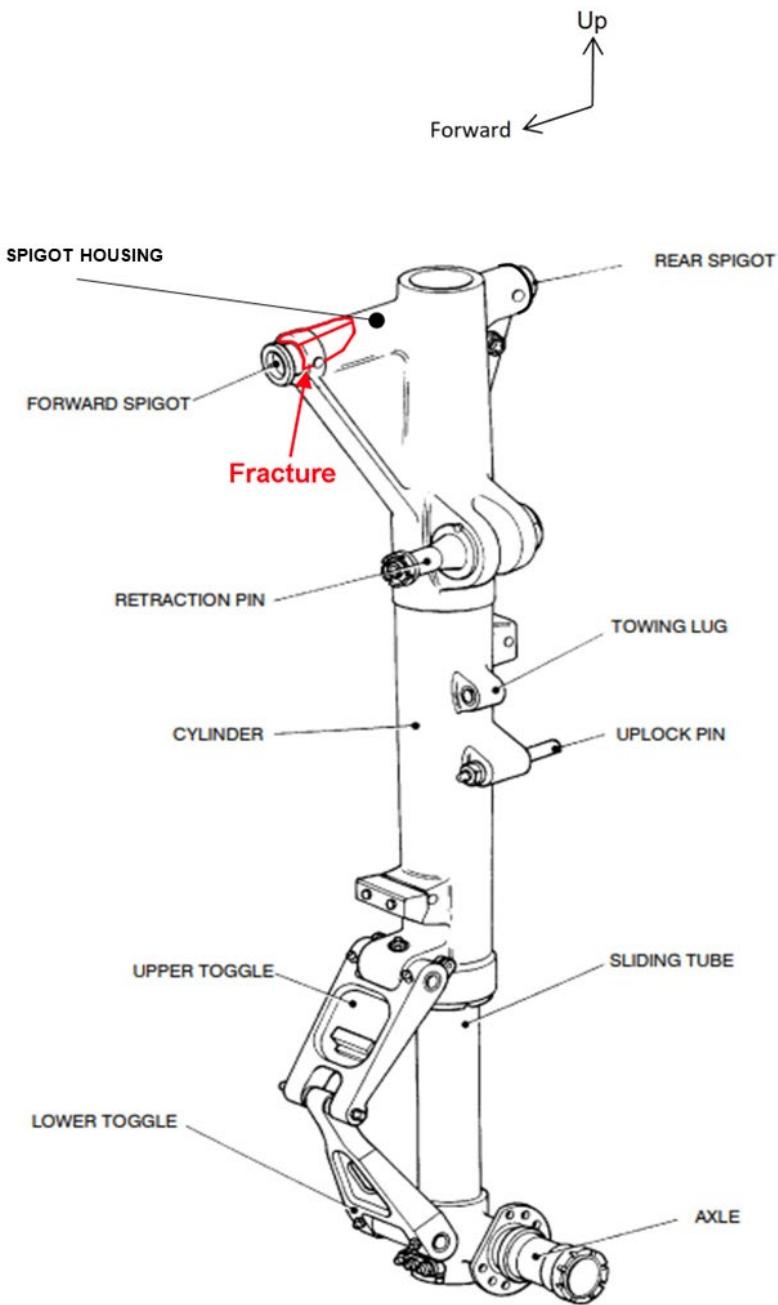
Figure 3. Schematic diagram showing the main components of the main landing gear unit (Source: APPH Ltd., Overhaul Manual 32-10-1, Overhaul Manual with Illustrated Parts List for Main Gear, Revision No. 20 [24 September 2025], Description, Operation and Data, p. 2, with TSB annotations)

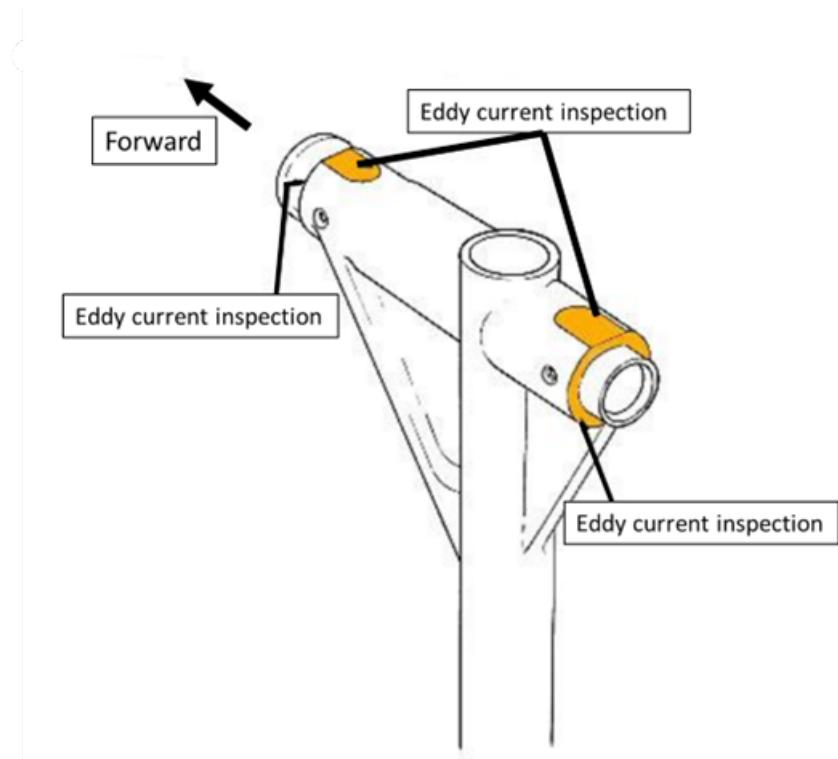
SB 32-19 lists the minimum requirements for the equipment and provides instructions for both the set-up of the instrumentation and calibration and the carrying out of the eddy current inspection. The areas to be inspected are to be cleaned, and if any of the protective finish shows signs of lifting or cracking, the areas are to be cleaned back to the bare metal. The forward and rear faces of the spigot housing as well as the forward and rear machined flat surfaces are to be inspected (Figure 9).

Figure 9. Areas to be inspected by eddy current (highlighted in yellow) on the spigot housing (Source: Héroux Devtek, Service Bulletin [SB] 32-19: MLG Assembly - Inspect Cylinder Attachment Spigot Housing, Revision 9 [03 November 2020], Figure 1: Areas of Inspection, p. 7, with TSB annotations)

As previously stated, the inspection technique is intended to detect cracks 1.27 mm or greater in length and corrosion pits 1.27 mm long by 0.13 mm deep or greater on the spigot housing faces or the machined flats.
