# RAIL TRANSPORTATION SAFETY INVESTIGATION REPORT R24C0012

## MAIN-TRACK TRAIN DERAILMENT

Canadian Pacific Railway Company, doing business as CPKC  
Freight train 119-02  
Mile 65.8, Brooks Subdivision  
Near Brooks, Alberta  
05 February 2024

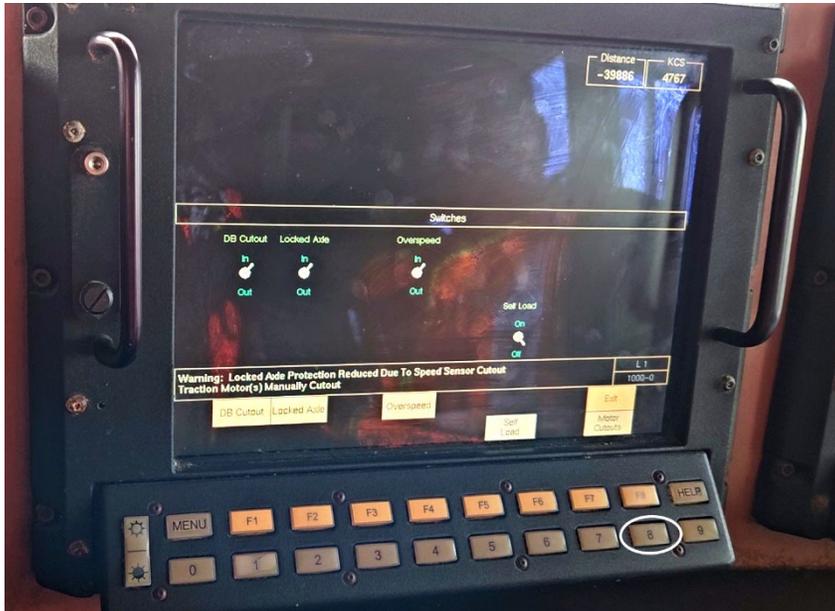
Locomotives in the ES44AC series, such as locomotive KCS 4767, have a control monitor. To interface with the feature for managing the task of cutting out a traction motor and its speed sensor on this monitor, operators start by navigating to the "Switches" screen (Figure 6).

Figure 6. Control monitor and keyboard on locomotives in the ES44AC series; the monitor is displaying the “Switches” screen, and a circle shows the location of the 8 hard key (Source: TSB)

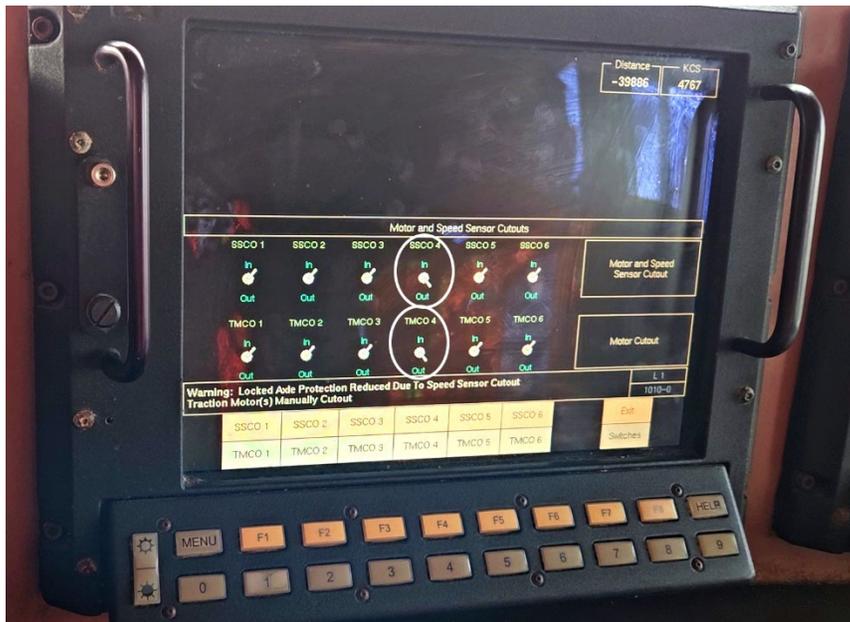
Figure 7. Control monitor and keyboard on locomotives in the ES44AC series; the monitor is displaying the “Motor and Speed Sensor Cutouts” screen, with a circle around the SSCO 4 and the TMCO 4 toggle switches (Source: TSB)

The “Motor and Speed Sensor Cutouts” screen displays the status of the motor cutout toggle switches in one row and the status of the motor and speed sensor cutout toggle switches in a separate row. The top row shows the toggle switches for each of the 6 speed sensors (SSCO 1 to SSCO 6), while the bottom row shows the toggle switches for each of the

6 traction motors (TMCO 1 to TMCO 6). The position of a toggle switch indicates the status of the component it represents: a switch pointing upward to the “In” position indicates that the component is cut in, while a switch pointing downward to the “Out” position indicates that the component is cut out. In Figure 7 above, the toggle switches for speed sensor #4 and corresponding traction motor #4 are pointing downward, indicating that they have been cut out.

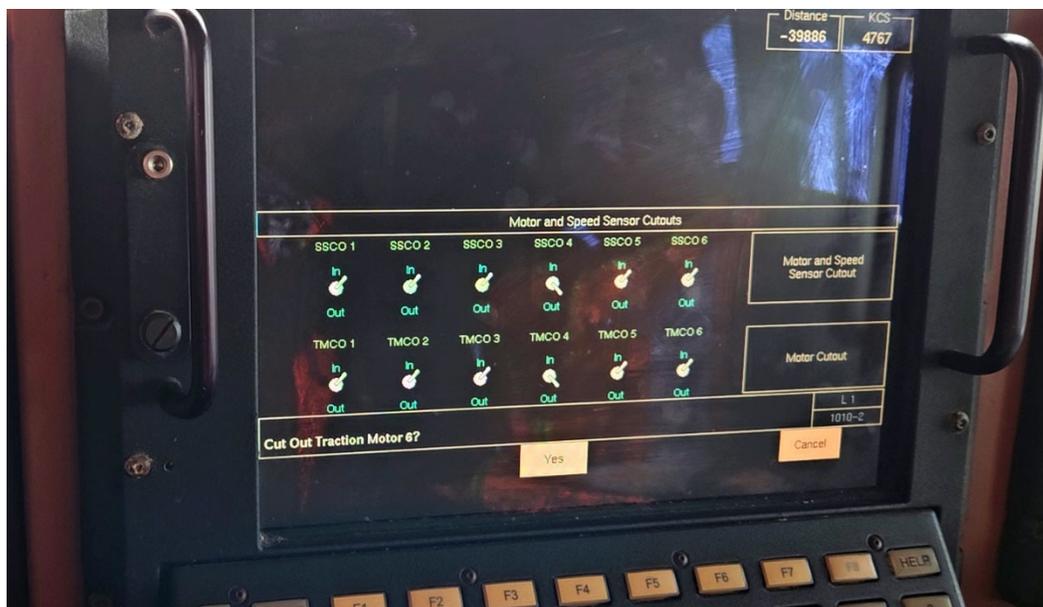
The system will display a confirmation prompt; for instance, the prompt to confirm cutting out traction motor #6 reads “Cut out Traction Motor 6?” (Figure 8). In response, the operator must press the F4 hard key for Yes (or F8 to Cancel).

Figure 8. Motor and Speed Sensor Cutouts screen on a locomotive in the ES44AC series, showing a prompt to confirm cutting out a traction motor (Source: TSB)
