# AIR TRANSPORTATION SAFETY INVESTIGATION REPORT A24P0092

## COLLISION WITH TERRAIN

West Coast Helicopters Maintenance and Contracting Ltd.  
American Eurocopter an EADS Company AS350 B2 (helicopter), C-GWCT  
Brooks Peninsula, British Columbia  
15 August 2024

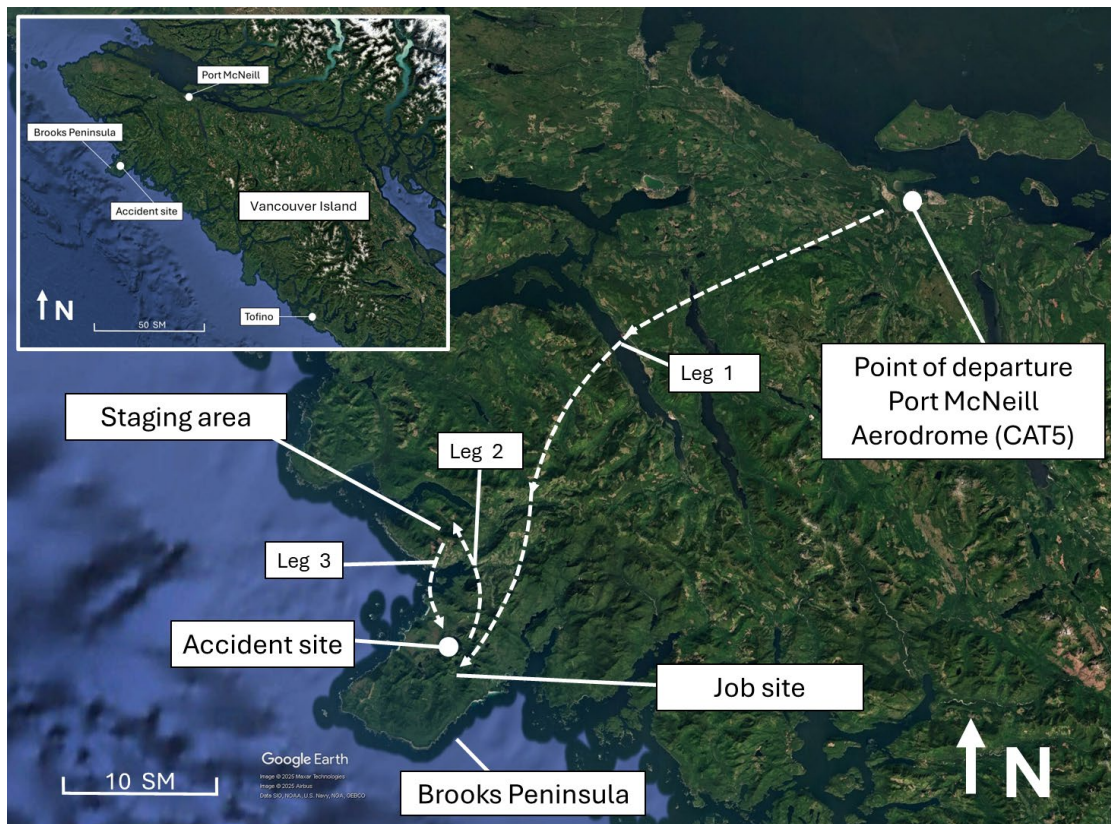
Although the itinerary for the day included 9 flight legs, only 3 were initiated (Figure 1):

- Leg 1: from CAT5 to the job site to confirm where equipment would be delivered (Figure 1).
- Leg 2: from the job site to a staging area, approximately 11 NM to the north, where the passenger would be dropped off and a load of equipment would be attached to the helicopter's longline to be delivered back to the job site.
- Leg 3: from the staging area back to the job site.

Figure 1. Map showing approximate flight legs flown on the day of the occurrence, with wider area view in inset (Source of main image and inset: Google Earth, with TSB annotations)

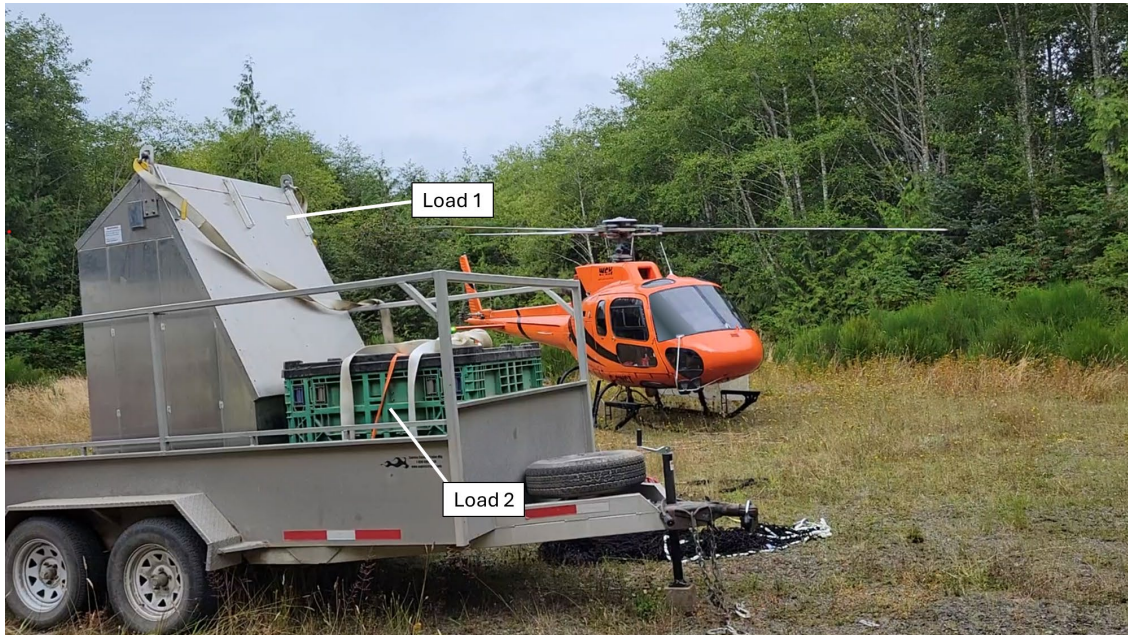
The flight to the job site was uneventful. After landing, the pilot and passenger remained in the helicopter and discussed the proposed cargo drop locations at the job site. They then flew to the staging area, where the pilot and passenger exited the helicopter. The pilot connected the longline equipment, returned to the helicopter, and then lifted off, remaining in a hover while the passenger and 3 customer technicians prepared 2 loads to be transported to the job site. One of the loads weighed approximately 1400 pounds and the other weighed approximately 600 pounds (Figure 2).

Figure 2. The helicopter and equipment to be transported from the staging area to the job site (Source: Natural Resources Canada, with TSB annotations)
