# AIR TRANSPORTATION SAFETY INVESTIGATION REPORT A23O0122

## LOSS OF CONTROL AND IMPACT WITH RUNWAY

Perimeter Aviation LP  
Fairchild SA227-DC Metro 23, C-GJVW  
Detour Lake Aerodrome (CDT9), Ontario  
07 September 2023

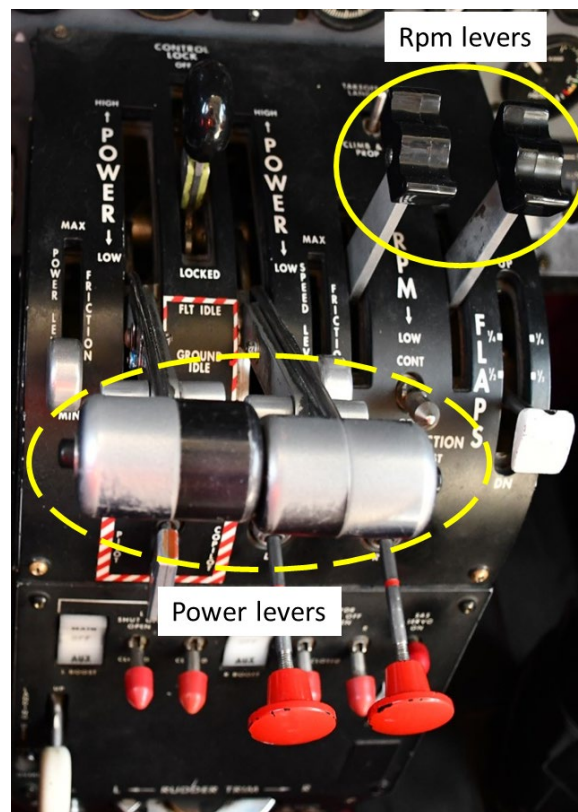
Figure 4. Throttle quadrant, showing the location of the rpm levers (solid circle) and the power levers (dashed circle) (Source: TSB)

The engine is designed to run at a constant speed, and each engine is controlled by using a power lever and an rpm lever mounted side-by-side on the throttle quadrant in the cockpit (Figure 4).

The power levers (Figure 4) control the torque by moving the fuel valve in the fuel control unit. The fuel valve adjusts the fuel flow (power) in direct response to the power lever position.

During cruise, the rpm is set to 97%, per the aircraft flight manual (AFM). When the aircraft is on the ground and placed in BETA mode, with the power lever aft of the flight idle stop, the rpm lever's low and high positions will set the rpm range of the under-speed fuel governor between 71% and 97%.

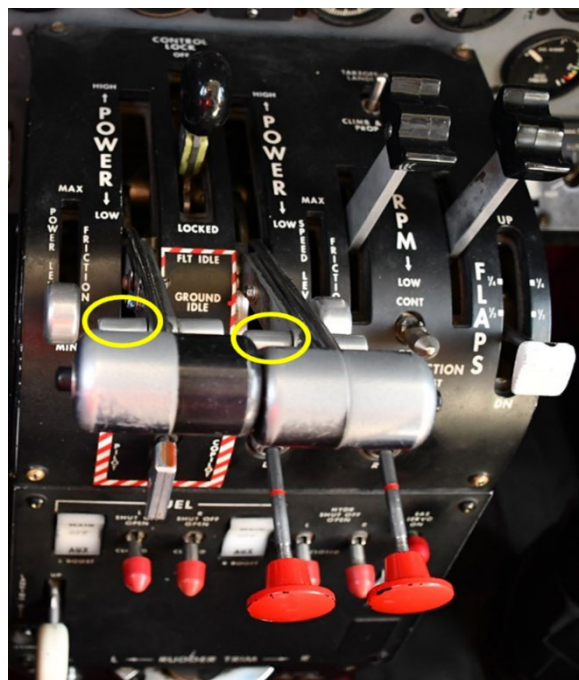
Figure 5. Throttle quadrant, showing the location of the finger-lift knobs (Source: TSB)

To ensure each power lever is not inadvertently moved aft of flight idle and, therefore, into BETA mode, there is a physical gate that stops the power lever lift latch arms. To enter BETA mode, the pilot must pull finger-lift knobs (Figure 5) upward against spring pressure. This action raises the lift latch arms, allowing them to clear the physical gates and permitting the power levers to be moved aft of the flight idle stop.
