# AIR TRANSPORTATION SAFETY INVESTIGATION REPORT A24W0016

## **COLLISION WITH TERRAIN**

Hanley Heli Service Inc.  
Bell Helicopter Textron 206L (helicopter), C-GCHM  
Fort Chipewyan Airport (CYPY), Alberta, 4 NM ESE  
12 February 2024

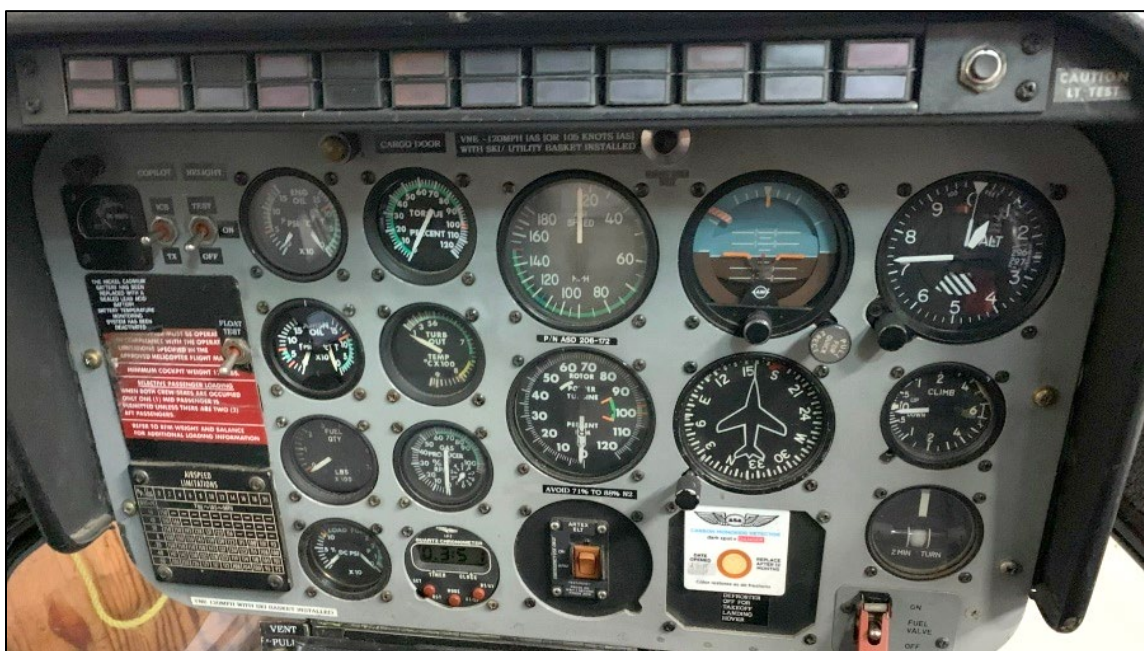
The flight instruments were configured in the standard “T” format, intended to facilitate a pilot’s ability to maintain an effective instrument scan (Figure 4).

Figure 4. The occurrence helicopter’s instrument panel, configured in the standard “T” format (Source: Third party, with permission)

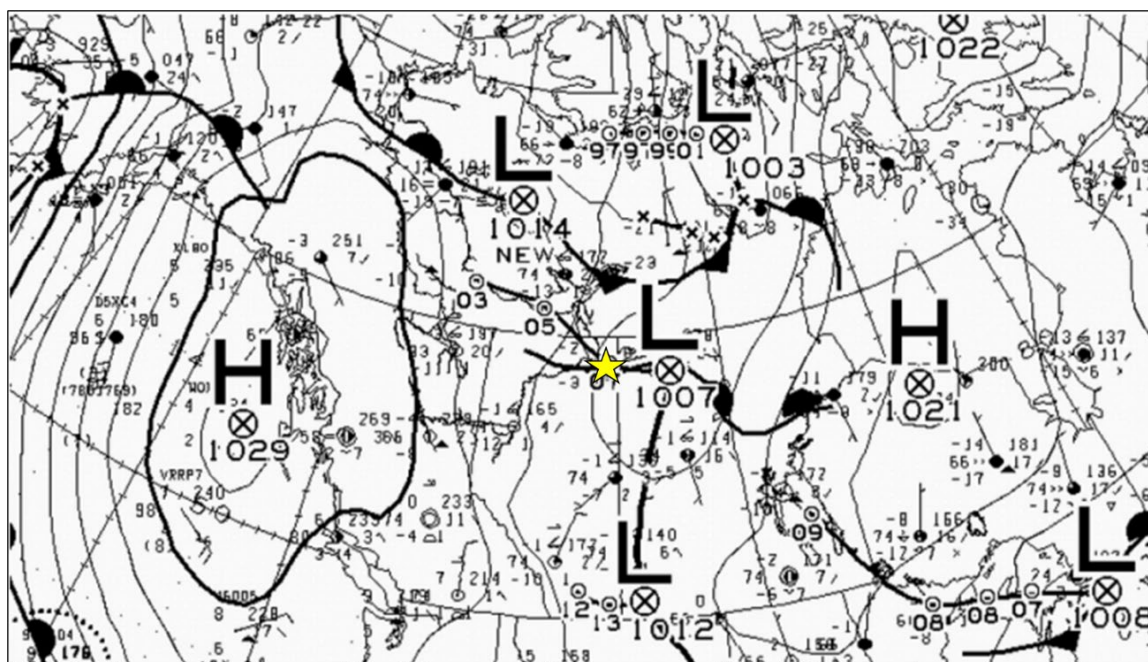
According to that assessment, at around 0500 on 12 February 2024, a low-pressure system (low) had developed in the vicinity of Great Slave Lake, Northwest Territories, and moved east-southeast passing to the east of Lake Athabasca by 1700 on 12 February 2024 (Figure 6). This low resulted in widespread cloud over northern Alberta as well as developing and intensifying snow and flurries as the low travelled into northern Saskatchewan.

Figure 6. Surface analysis valid at 1700 on 12 February 2024. The star at the centre of the figure represents the approximate location of the accident. (Source: Canadian Meteorological Centre, with TSB annotations)
