RAILWAY INVESTIGATION REPORT
R02C0013

DERAILMENT

CANADIAN PACIFIC RAILWAY
FREIGHT TRAIN NO. 275-03
MILE 30.2, ALDERSYDE SUBDIVISION
CARMANGAY, ALBERTA
03 MARCH 2002

Report Number R02C0013

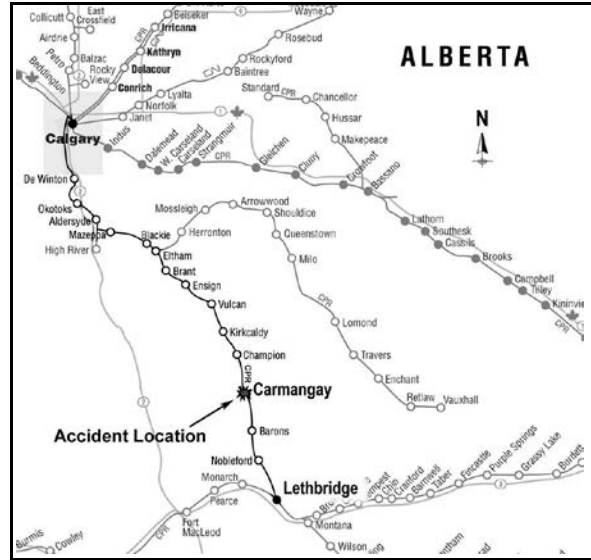
On 03 March 2002, at 1310 mountain standard time (MST)¹, Canadian Pacific (CP) freight train number 275-03 (the train) departed Alyth Yard, Calgary, Alberta, and proceeded southeast destined for Lethbridge (see Figure 1). En route, it passed by three hot box and dragging equipment detectors and no anomalies were reported.
