**AVIATION INVESTIGATION REPORT
A11Q0036**

THREE HELICOPTERS REFUELLED WITH WRONG FUEL TYPE

**ROBINSON R44 RAVEN II (HELICOPTER) C-FNZO
FORESTVILLE, QUEBEC
01 MARCH 2011**

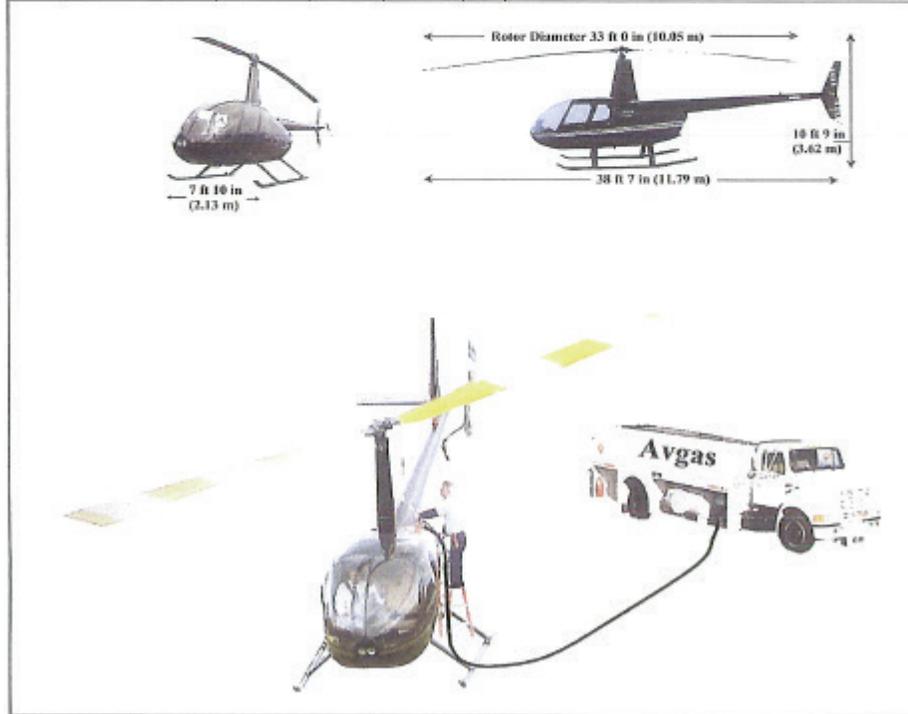
DIMENSIONS:

Rotor Diameter	33 / 0	ft / in	10.05	m	Wheel Base	---	ft / in	---	m
Length Overall	38 / 7	ft / in	11.97	m	Skid Track	7 / 0	ft / in	2.13	m
Length W/O Rotor	---	ft / in	---	m					
Height	10 / 9	ft / in	3.62	m
