# AIR TRANSPORTATION SAFETY INVESTIGATION REPORT A23W0103

## LOSS OF CONTROL AND COLLISION WITH TERRAIN

AFS Aerial Photography Inc.  
Cessna 152, C-GRCA  
Claresholm Industrial Aerodrome (CEJ4), Alberta  
28 August 2023

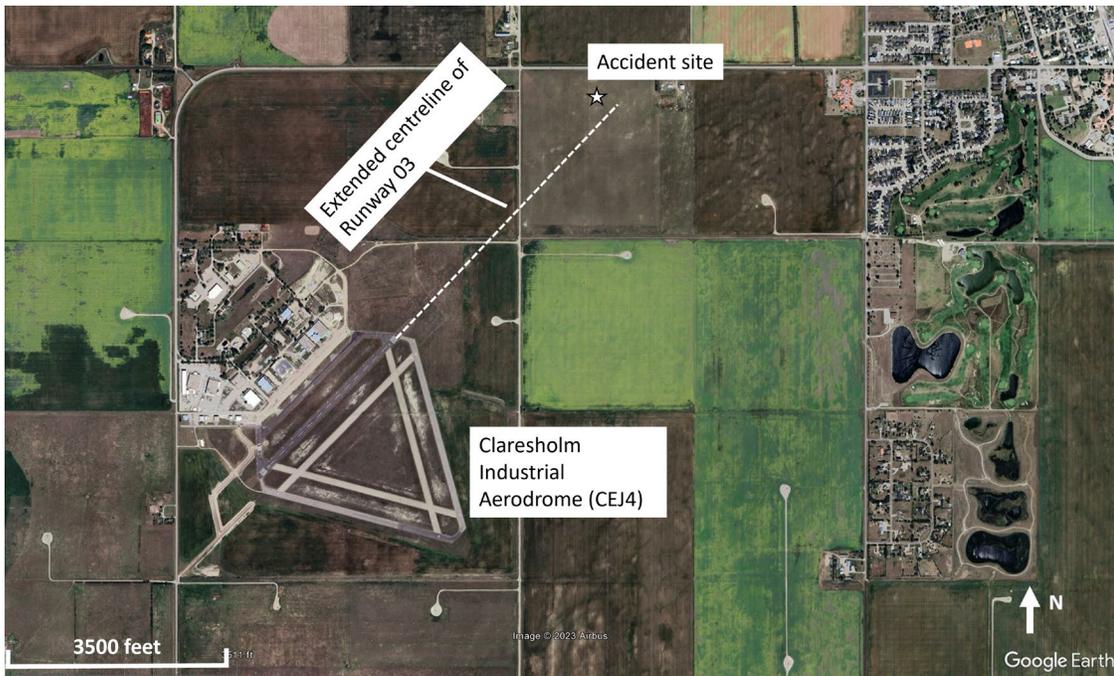
Figure 1. Map showing the aerodrome and accident location (Source: Google Earth, with TSB annotations)

The aircraft impacted the ground 5200 feet from the departure end of Runway 03 and 215 feet left of the extended centreline (Figure 1). Several eyewitnesses were on scene shortly after the accident, and police and fire rescue services followed 5 minutes later. The pilot received fatal injuries. The aircraft was substantially damaged; there was no post-impact fire. The 121.5 MHz emergency locator transmitter activated.
