Marine Transportation Safety Investigation Report M17C0220

MECHANICAL FAILURE AND SUBSEQUENT FIRE

Tug *Brochu*
Port-Cartier, Quebec
15 September 2017

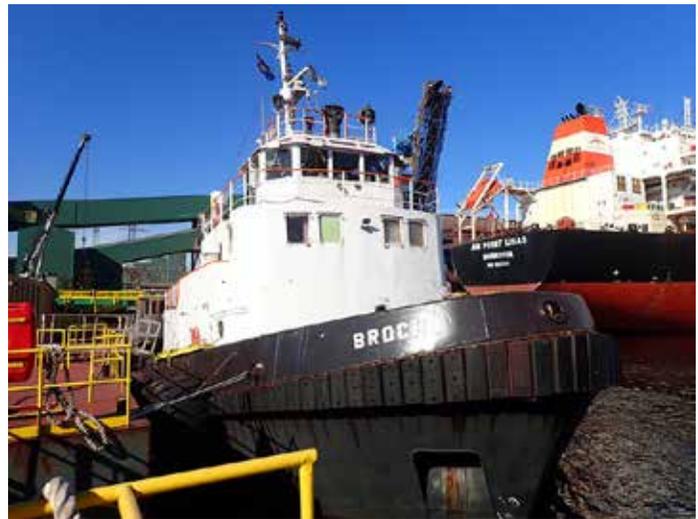
Figure 1. The *Brochu*

The *Brochu*¹ is a steel-hulled harbour tug that is 30.45 m in length with a gross tonnage of 389.68 (Figure 1). The tug's superstructure and machinery spaces are located amidships. The tug has 2 conning positions: 1 on the port side and 1 on the starboard side. The navigation equipment consists of 2 very high frequency (VHF) radiotelephones, an echo sounder, an electronic chart display, a radar, and a global positioning system. The tug has a maximum bollard pull of 35 tonnes.

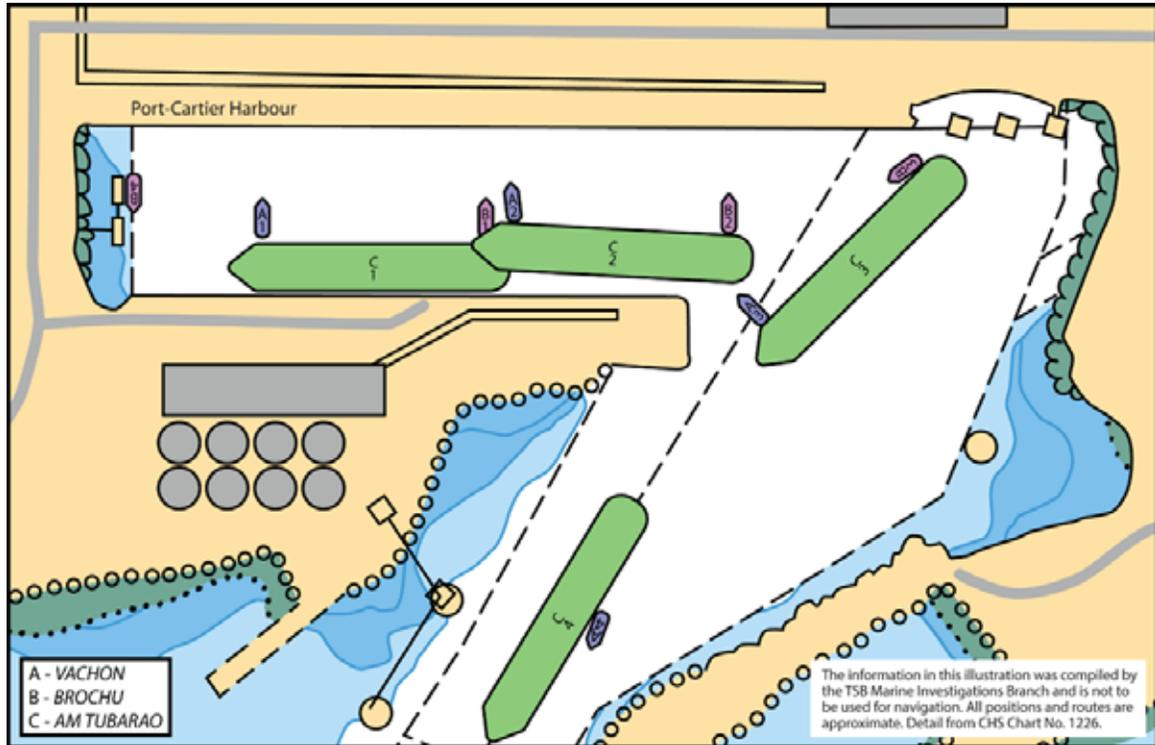
Figure 2. Stages of manoeuvring the *AM Tubarao* out of Port-Cartier Harbour

The plan was for the tugs to manoeuvre the bulk carrier out of the harbour by pulling the bulk carrier away from the dock, then pulling it astern while its engine was astern to enable the bow to pass the dock corner. After the bow was clear of the corner, the *Vachon* would position the bow of the bulk carrier toward the centre of the harbour channel, and both tugs would guide the bulk carrier into the channel. Once the bulk carrier was clear of the channel, the tugs would retrieve their towing lines, pick up the pilot, and return to their berth (see Figure 2 for a depiction of manoeuvre B4).

At 0419, the *AM Tubarao's* mooring lines were cast off and the pilot ordered the tugs to pull at different power levels (between 0% and 80% power, as needed) in order to help the bulk carrier move away and maintain a safe distance from the dock (see Figure 2, manoeuvre C2).
